**Controlled intervention: monitoring the dismantlement and
reconstruction of the flying buttresses of two Gothic churches**

E. Verstrynge*¹, L. Schueremans¹, P. Smars²

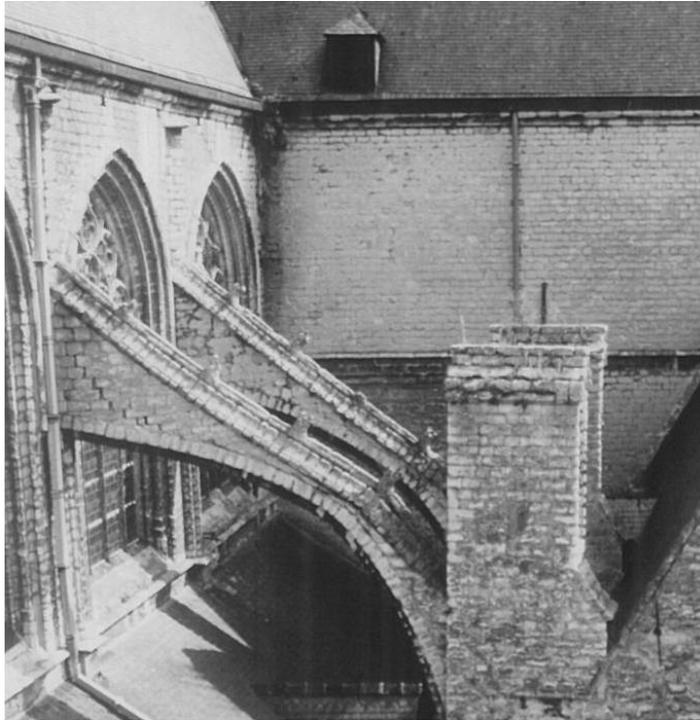
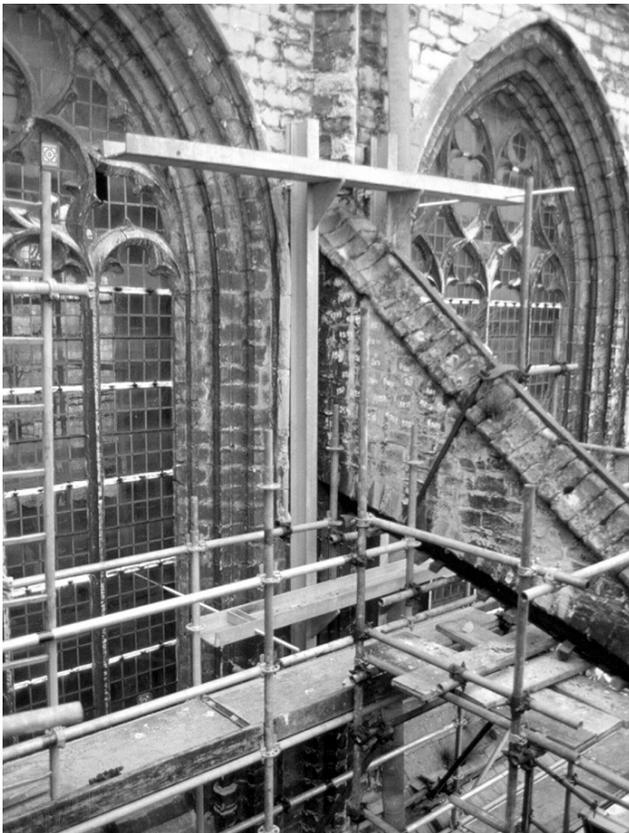
Due to large differential settlements between the main nave and the piers of the flying buttresses, the flying buttresses experienced very important cracks and deformations in vertical but also in horizontal plane, Figure 3. Due to water infiltrations and time-dependent degradation, the masonry lost most of its coherence. Calculation and engineering judgment revealed a situation particularly critical: small movements could have lead to collapse. Because of their dangerous shape and overall bad condition, stability could not be guaranteed with a sufficient margin of safety and it was decided (in 1999) to dismantle the flying buttresses and install provisional tie-rods to ensure stability. Before the intervention, the flying buttresses were photographed with a semi-metric photogrammetric camera and the stones were numbered. The dismantled elements are now stored in the chapels of the church, ready to be reused if reconstruction is decided in the framework of an overall restoration plan.

Figure 3: Buckled flying buttresses (left, photo: P. Smars 1994 in Van Balen, 1995) and provisional system with tie-rods to replace the flying buttresses (right, photo P. Smars, 2000).

For each set of flying buttresses, four tie-rods were installed as indicated in Figure 1 and 3. Each tie-rod was equipped with a load cell to monitor the forces during dismantling. The tie-rods were post-stressed during the intervention, to control the distance between both walls of the main nave. The latter was recorded by means of invar-wire measurements.

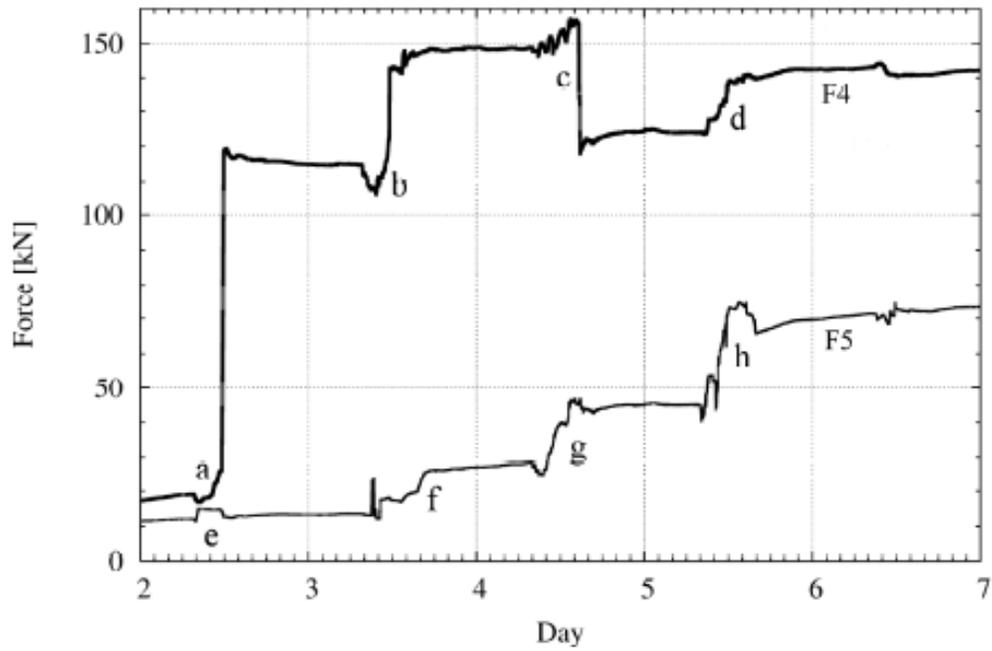
Sudden changes (a and b in Figure 4) correspond to fastening of the tie-rod screws. The strongest increase happened in a, when the screws were tightened up by 2 mm. The forces increased by 92.5 kN, which is consistent with a deformation of 2 mm of the four tie-rods. But the displacement of the wall, measured with the invar-wire system was only 0.29 mm. The drop in c is an attempt to balance the forces in section F4 and F5. During the intervention, the maximum displacement was 0.86 mm in section F4. It has to be noted that the displacements were measured just under the level of the lower tie-rods and correlation is therefore difficult. This position was chosen for practical reasons. The invar measurements were made manually and could only be made from an accessible point: a metallic walkway built previously.

Figure 4: Forces in the tie-rods during the dismantling of the flying buttresses
 F4: sum of the forces in the four western tie-rods; F5: sum of the forces in the four eastern tie-rods; a & e, b & f: dismantlement of two western flying buttresses (section F4); c & g, d & h: dismantlement of two eastern flying buttresses (section F5)

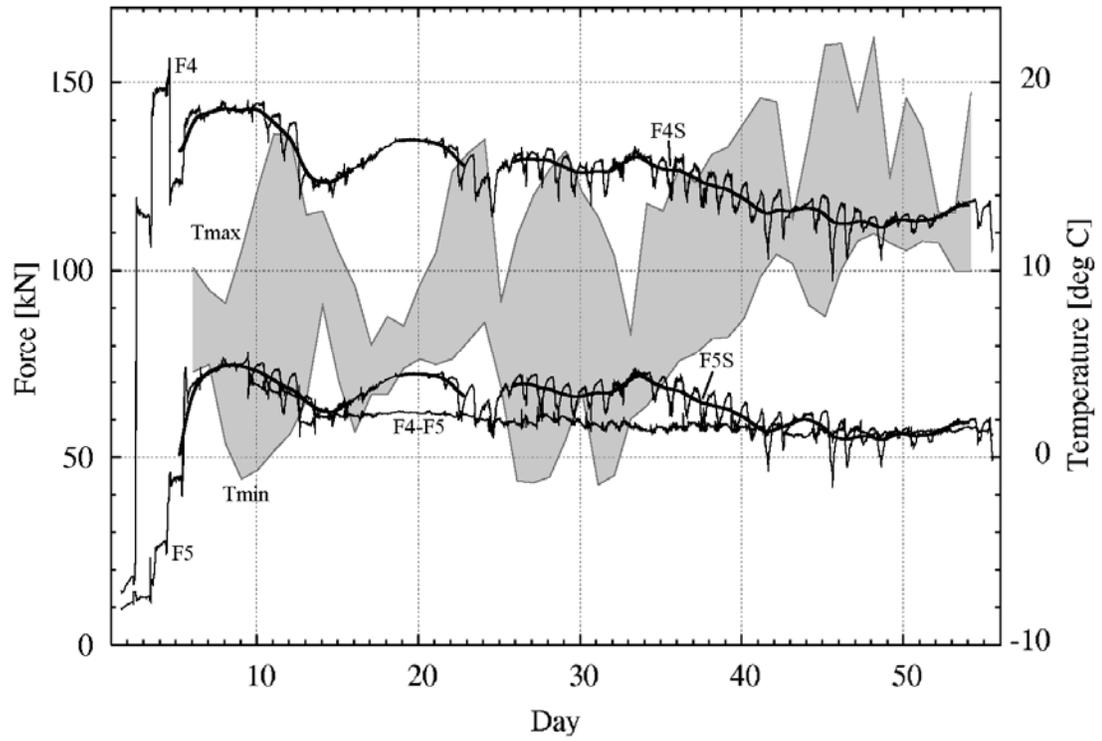
It can be observed that the forces in the tie-rods slightly decrease over a longer period of time. Forces also appear to decrease when temperature increases. A study on the influence of temperature was presented by Smars (Smars et al. 2006). Temperature effects are complicated to analyse, as they trigger deformations of the tie-rods and of the walls, which are not perfectly rigid. In order to better understand the influence of the temperature variations on the thrust of the vault, it is advisable to perform long-

Figure 5: Forces in the tie-rods over a period of 56 days (F4-F5); smoothed signals (F4S-F5S); exterior temperatures: daily minimum (Tmin) and maximum (Tmax)

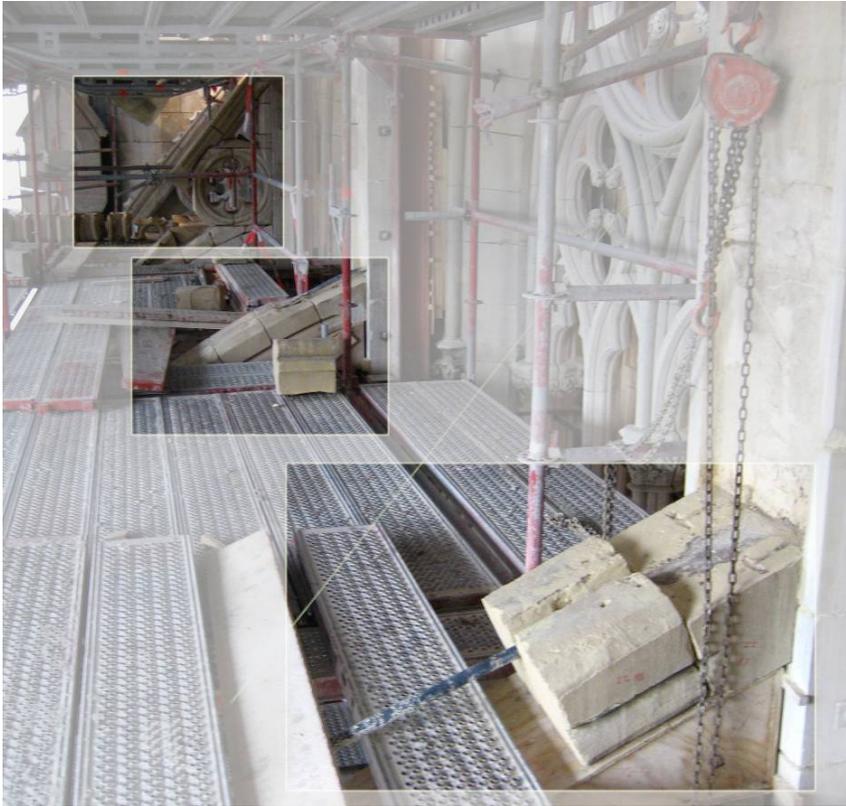
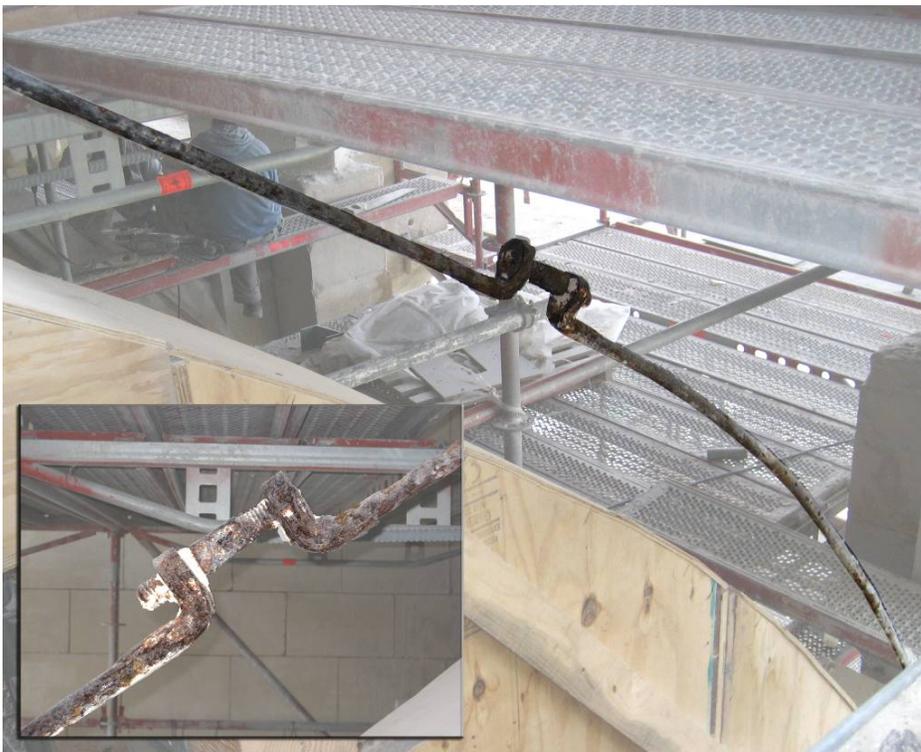
During dismantlement of the flying buttresses, it was observed that long, curved iron anchors were present in the flying buttresses, in a groove above the voussoirs of the inferior arch, Figure 9. These iron bars were anchored to a vertical bar both in the nave wall and in the pier. It could be argued that these anchors enable the flying buttresses to take up tensile loading, such as introduced by wind loading, or would enable the flying buttresses to work as a beam. However, this would not be necessary due to the overall compression state of a flying buttress. Also, the shape of the anchors makes that this resistance to tension would be very limited.

Some of the anchors were heavily corroded, especially the ones which were present in the flying buttresses positioned on the western wall (which has the highest wind and rain load). On this side of the wall, also cement mortar was found in the joints of the flying buttresses from past restoration works. At reconstruction, a hybrid cement-lime mortar was applied.

One of the anchors broke during dismantlement of the flying buttress and its properties were tested in the lab. The anchor had a diameter of 29.8 mm and the maximum tensile force was 189 kN, at which the metal anchor ruptured in a brittle manner.

Figure 9: Three phases in the reconstruction of the flying buttresses and close-up of one of the iron anchors

As the strength of the anchor was higher than expected (270 MPa), the broken metal bar was replaced by a new one and all anchors were, after corrosion treatment, re-encased in the brickwork of the flying buttresses.

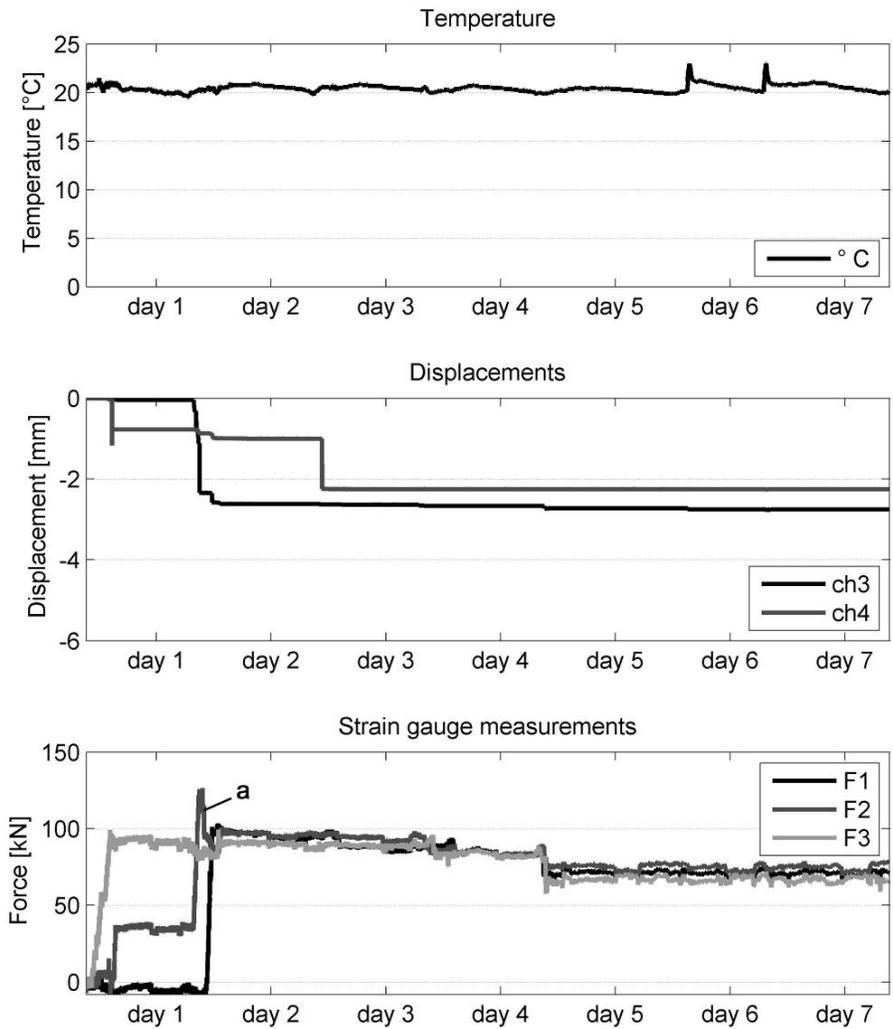
Pre-stressing was applied with hydraulic jacks and the sequence of pre-stressing (F3-F2-F1) is clearly visible on the graph. Pre-stressing of F2 was interrupted and proceeded the next day. The forces in F2 were lowered (point ‘a’ in Figure 11) to decrease the displacements of the walls; however, this unloading did not influence the displacements. A pre-stress of 140 kN was applied on set F1 and F3, a slightly lower force of 120 kN was applied on set F2 to limit deformations. The average applied force of 100 kN, as presented in Figure 11, was measured by means of the strain gauges. This value is lower than the actually applied forces as strain gauge measurements could only be started after installation of the tie-rods, as explained above. The difference between the data from the pressure in the hydraulic jack and the strain gauges is approximately $4 \cdot 10 \text{ kN} = 40 \text{ kN}$, as estimated before. The results of the strain gauge measurements are therefore only used to comment on the evolution of the forces on the long term in a qualitative manner.

At the end of the pre-stressing process, the deformations were limited to 2.6 mm, which is slightly higher than the preset value of 2 mm.

Figure 11: Monitored temperature, relative lateral displacements of the nave walls and forces in the tie-rods during the first week (day ticks on X-axis are positioned each day at midnight)

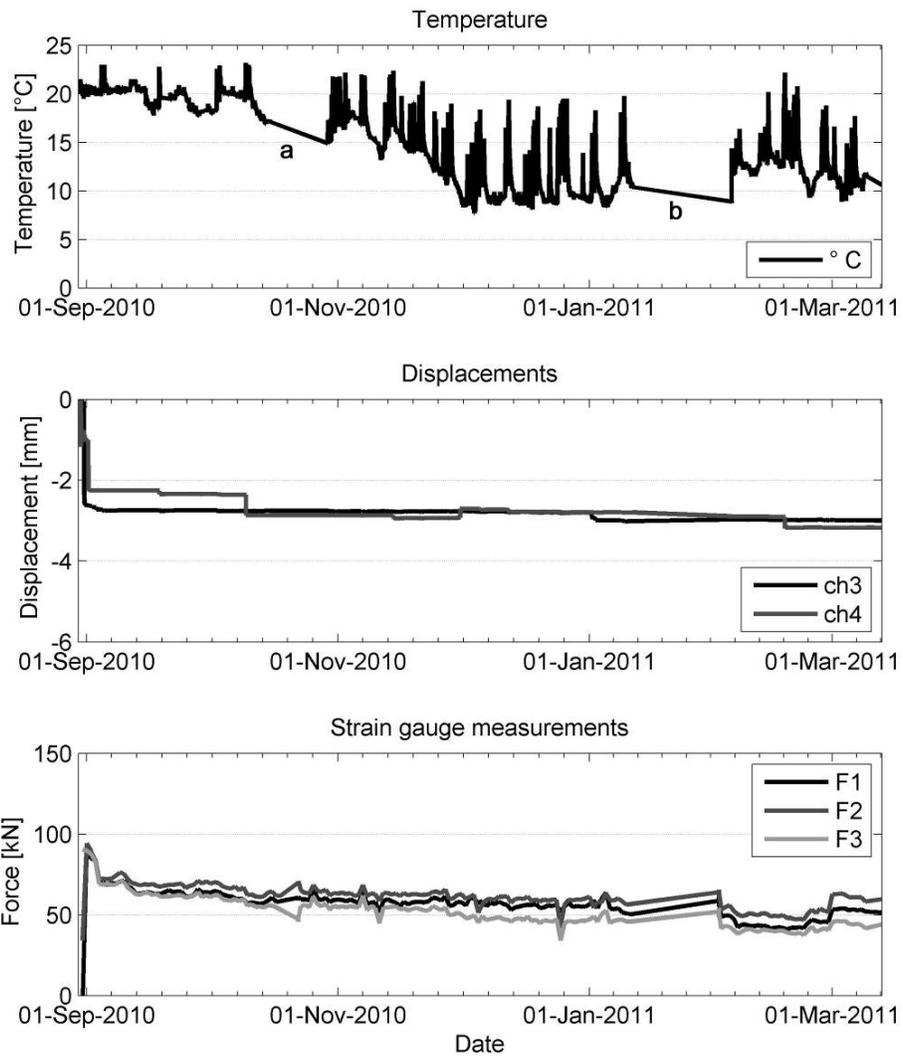
After the first week, the forces in the tie-rods and the displacements remain rather constant, see Figure 12. To smooth the curve, the presented force data are taken each day at 1 am. Unfortunately, no data are available during two rather extensive power cuts (a and b). The continuation of the long-term measurements after the power cuts was not significantly affected by these problems. A slight decrease of the forces and increase of the displacements is noticeable over the measuring period of 6.5 months. At the end of the monitoring period, an average force of about $50 + 40 = 90$ kN remains present in each set of tie-rods, which is still higher than the preset value of 67.5 kN. Again, the larger fluctuation in forces at the end of the monitoring period is due to re-installation of the pinnacles and disconnection of the steel props.

Figure 12: Monitored temperature, relative lateral displacements and forces in the tie-rods during the full monitoring period (no data available during power cuts: a and b)
