Magnetic field imaging and light induced capacitance alteration for failure analysis of Cu-TSV interconnects

Ingrid De Wolf^{a,b,*}, Kristof J.P. Jacobs^b, Antonio Orozco^c

This paper discusses Cu-filled Through Silicon Via (TSV) failure analysis cases where known FA methods were used in an alternative way. Results are shown using magnetic field imaging (MFI) on a cross-sectioned chip to detect a leakage current path, and MFI and Light Induced Capacitance Alteration (LICA) to detect opens in TSV daisy chains.

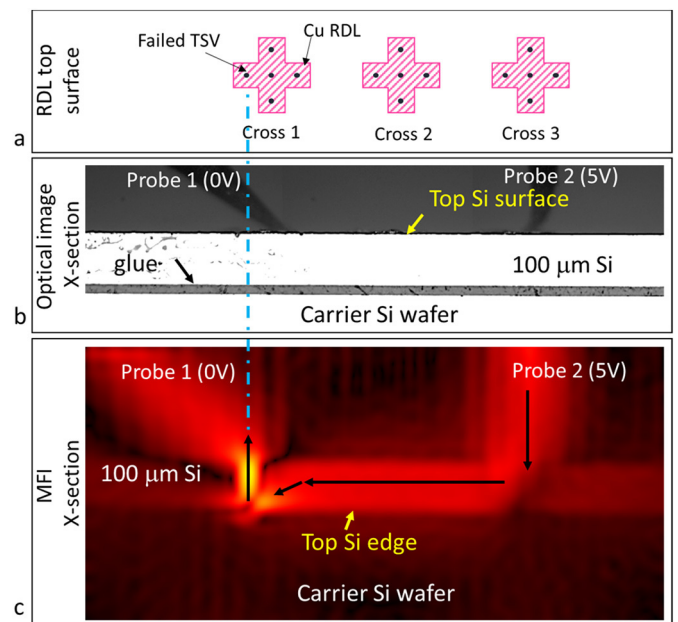
The sample was tilted to expose the cross-section and the probes were again placed on Cross 1 (0 V) and 3 (5 V), now probing from the side. Fig. 3a indicates the position of the RDL-crosses at the top Si surface on which the probing is done. Fig. 3b shows an optical image of the X-section. The probes are visible at the top side. The thinned Si, glue and carrier wafer are also visible. The TSVs in the thinned Si are not visible in this optical image, they are covered by Si. Fig. 3c shows the current density image from MFI. Black arrows indicate the direction of

Fig. 3. a. The position of the RDL-crosses at the top Si surface on which the probing is done. b. Optical image of the X-section. c. MFI measured current density image on the cross-section. (For interpretation of the references to color in this figure, the reader is referred to the web version of this article.)

the current flow. The current density is denoted by color, from bright yellow (higher current density) to lower density (red), to black, denoting no current or within noise level. At the 5 V probe, the injection point, a weak broad current path is visible pointing to the fact that current distributes rather uniformly through the whole conducting structure, the RDL cross and then the different TSVs. Also in the thinned Si, the signal is weak and visible across the full width, pointing the presence of the leakage path. But near probe 1, the current density is higher (brighter) both near the bottom of the thinned Si and along a vertical line in the Si, that corresponds to the TSV that contains the fault. Note that because the current accumulates through the failure and into a single TSV, the current density is higher (bright yellow in

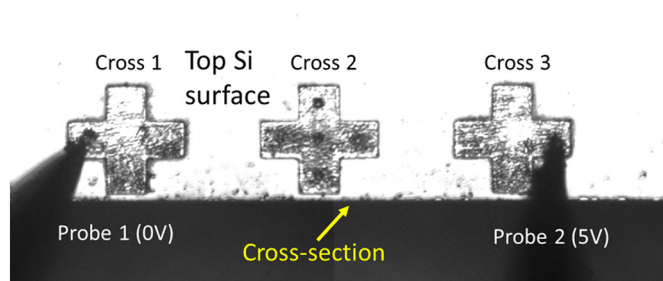
First an MFI-image was measured as conventionally done, from the top-side of the sample. Probe 1 was placed on Cross 1 and 0 V was applied. Probe 2 was placed on Cross 3 and 5 V was applied (see Fig. 2). No meaningful MFI signal could be obtained from the top side of the sample. This indicates that the leakage path is most likely located near the bottom side of the 100 μm thick Si. Indeed, as the leakage current is low, a large distance from the current path to the sensor makes the intensity of the field weak, and no discernible signal can be detected. Scanning on the cross-section side is one way to reduce the separation distance and it could allow us to see the leakage path.

So, next, MFI was done on the cross-section of the sample, thus reducing in principle the distance between current and sensor. The cross-sectioning was done by polishing parallel to the crosses, stopping just before reaching them, so leaving some Si present. Fig. 2 shows the top view microscope image from the sample, taken with the MFI system.

Fig. 2. Microscope image from the top of the polished sample. Probes are placed on Cross 1 and Cross 3.

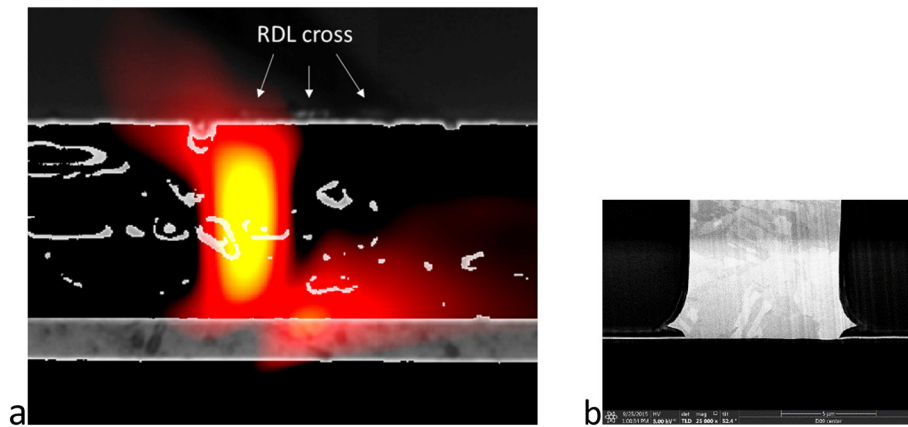
Fig. 4. a. MFI scan focusing on the position under cross 1. b. Cross-section MCI image showing the breakdown position and current leakage path between two TSVs. (For interpretation of the references to color in this figure, the reader is referred to the web version of this article.)

Figs. 3 and 4 than when it distributes over the 5 TSVs, as at the other probe point and the Si). These results demonstrate that MFI on a cross-section sample is indeed possible. Part of the current runs through the 5 TSVs of Cross 3, which is the reason that a weaker signal is seen at that position. But near Cross 1, the current only flows through one of the 5 TSVs, explaining the higher density (brighter image). The blue dashed line, comparing the position of this TSV with the position of Cross 1, indicates that this is the left TSV of this Cross. This is confirmed in Fig. 4a, showing an overlay MFI - optical image in that region. The metal of the RDL cross is visible, especially the centre part (which is closer to the cross-section edge). The bright MFI image corresponds with the location of the TSV at the left side of the cross. A FIB cross-section at the bottom of this TSV, shown in Fig. 4b, shows that this TSV

had notching near the bottom, causing a high local electrical field and thus local breakdown of the liner. This was caused by a processing related problem at the bottom part of the TSVs.

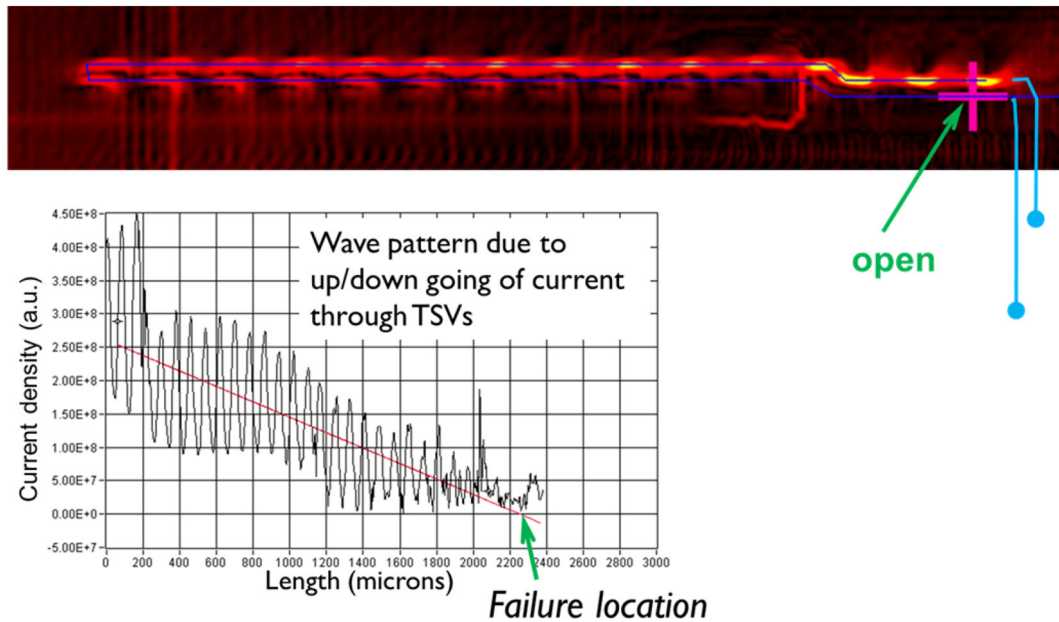
Fig. 6. Top: Current path obtained by MFI. Bottom: Estimation of failure location from the current decrease.

As shown in Fig. 6, a clear MFI signal was detected in the chain. The current path runs from the right top 2, to the left and comes back to the right along the bottom, i.e. the injected RF signal travels through the full daisy chain, decaying in intensity towards the open location where it should vanish [3], stopping close to the first TSV, indicating that the open is likely located there. This could not be confirmed (sample loss).

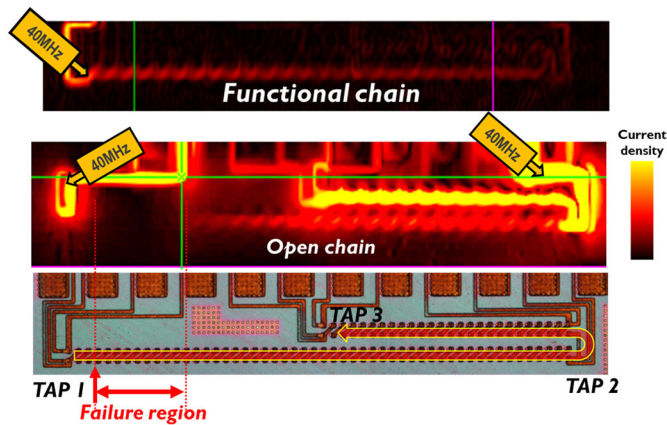
Fig. 8. Top: Current path obtained by MFI on a functional chain. Bottom: MFI image of a defective chain.

The structure was analysed using MFI and LICA. Fig. 8 (top) shows the MFI measurement result performed on a functional chain and

(bottom) on the defective chain. In the functional chain, an RF signal was observed along the full length of the chain indicating that all TSVs are electrically connected. For the defective chain, we observed a region without a signal, indicating electrical interruptions in the chain. By performing the measurement with RF signal injection at both chain terminals, it was found that the open position must be located close to TAP 1, and that the chain has at least two defects separated by 180 μm (i.e. the width of the region with no MFI signal). It must be noted that an impedance difference between the functional and failing samples results in different coupling of the RF signal to other adjacent circuits. For this reason, there are signals visible in the failing sample that are not (or not so evident) visible on the functional sample. Focus must be kept in comparing the difference between RF signal propagation along the TSV daisy chain (TAP1-TAP2-TAP3 connection). Through optical inspection of the wafer backside at the detected defective region, we could attribute the failures to a backside metal layer misalignment and confirm that physical defect locations are in agreement with the MFI data and indeed are open failures.

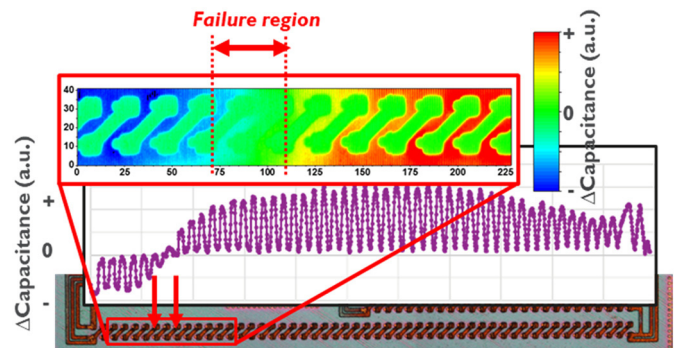
Fig. 9. LICA result on a defective chain.

Next, a similar sample was analysed using LICA. Fig. 9 shows the LICA performed by simultaneously measuring the electrical capacitance of both chain terminals with respect to the Si substrate. The waveform in purple represents the LICA signal for the laser scanned across the length of the chain, from TAP 1 towards TAP 2. Due to the differential measurement configuration, the laser induced change in electrical capacitance can either have a negative or positive amplitude, depending on which side the laser spot is positioned with respect to the defect site. With the laser spot positioned towards the left site of the defect, a negative change in electrical capacitance is induced, whereas the opposite occurs with the laser spot on the right side of the defect. When the laser is focused at the defect site, the LICA signal is at zero amplitude, as the light-induced charge induces an equal change in both capacitance meters connected at TAP1 and TAP2.

Performing a high resolution 2D scan (shown in multi-color) allowed us to more accurately pinpoint the defect site. Similarly, as the case for the MFI sample, the open failure is located in the same region close to TAP 1. These results indicate that both techniques can be used to find open locations in TSV daisy chains. The spatial resolution of LICA seems higher than the one of MFI. On the other hand, LICA needs access of the laser to the Si substrate in order to be applicable, while MFI does not need optical access. This makes both techniques complementary. Regarding measurement time, the 1-D LICA linescan needed ~20 min., whereas the MFI measurement could be performed typically
