Fracture analysis of one/two-piece clinically failed zirconia dental implants

Objectives: Analyzing factors that may have led to fracture of zirconia implants by macro/micro-fractography.

Methods: Six one-piece and ten two-piece full-ceramic zirconia implants from two manufacturers, Z-Systems and CeraRoot, were retrieved after clinical failure. The time-to-failure ranged from 3 to 49 months. Optical and scanning electron microscopy (SEM) were used to analyze the fracture planes at the macro- and microscopic level. Treatment planning, surgical protocol, fracture-origin location and characteristic fracture features were assessed.

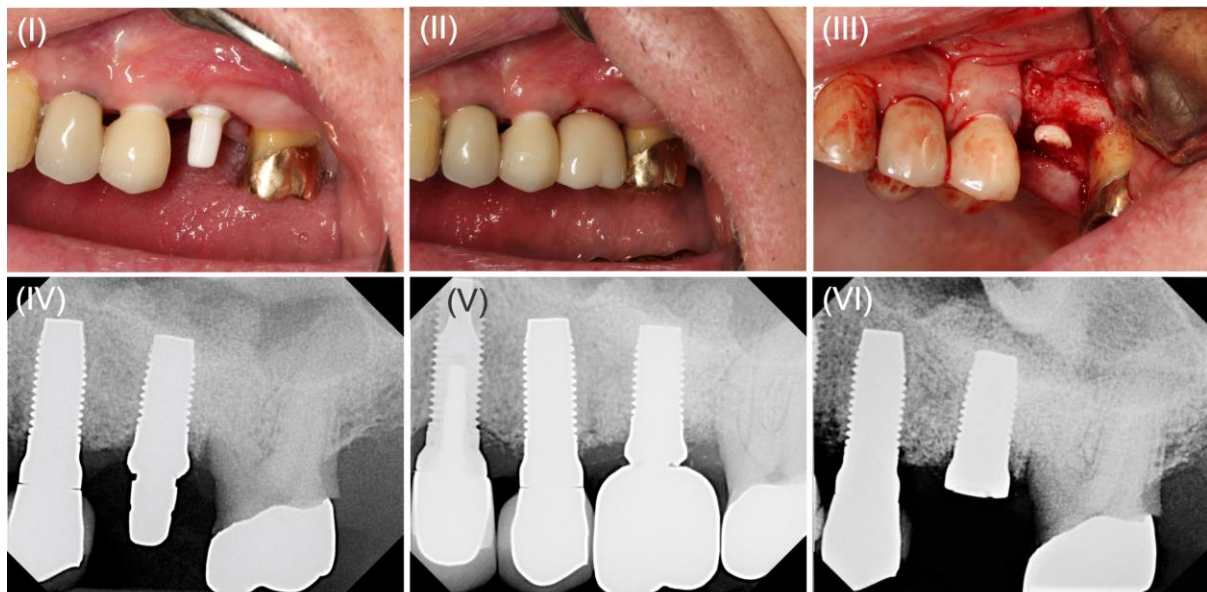
(a) Z-Systems 2p-45m implant

Fig. 1. Radiographic and clinical images of a Z-Systems 2p-45m implant and a CeraRoot 1p-3m implant. (a) Z-Systems 2p-45m implant: (I) Clinical images showing that the abutment and implant neck were heavily ground and prepared by the clinician prior to final restoration; (II) A disproportionately large crown was placed on the implant; (III) Surgical removal of the fractured implant. (IV) Radiograph taken prior to final restoration, demonstrating the grinding of the abutment and implant neck by the clinician; (V) Radiograph taken at the time of crown loosening due to fracture; (VI) Radiograph taken at the time of implant fracture (after 45 months of clinical service). (b) CeraRoot 1p-3m implant: (I) Five months following implant placement with the implant exposed and ready to be restored; (II) Peri-implantitis observed 2 years and 4 months following implant placement; (III) Osseous surgery and implantoplasty to treat the peri-implantitis; (IV) Periapical radiograph taken 1 month following osseous surgery;

(V) Clinical photo taken 1 month following osseous surgery; (VI) Implant fracture three months following osseous surgery.

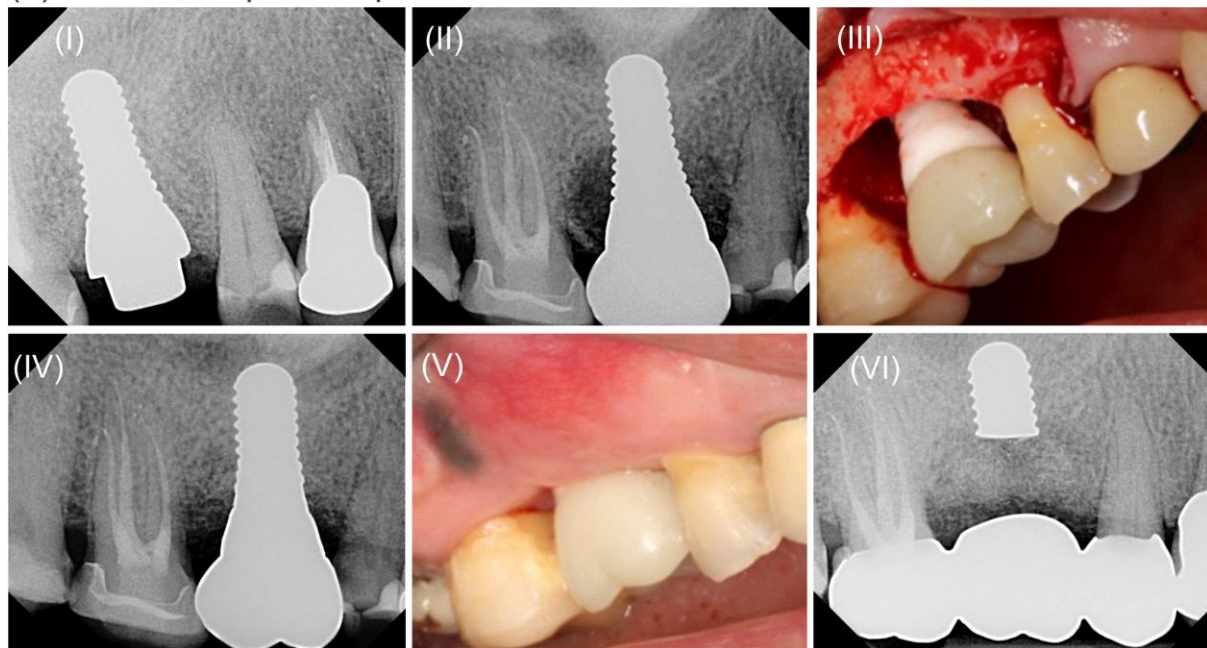
(b) CeraRoot 1p-3m implant

Regarding the CeraRoot implants, implantoplasty was performed on the surface of a CeraRoot one-piece implant (CeraRoot 1p-3m) for treatment of peri-implantitis, as shown in

Fig. 1b. Implantoplasty was performed using a rotary instrument equipped with a diamond bur (Henry Schein, Melville NY, USA) to remove the topographic and geometric features (i.e., implant threads) as well as to smoothen the surface. Surface cleaning and disinfection was performed with 0.2% chlorhexidine digluconate. The intraosseous compartment was grafted with an allogenic particulate graft. The graft was compartmentalized with a collagen porcine absorbable membrane. The implant fractured 3 months following implantoplasty. The second CeraRoot case, as shown in Fig. S3, was placed in an entirely grafted bone.

Regarding the fracture cause of the CeraRoot one-piece implants (CASE 5), the surface chipping observed for the CeraRoot 1p-3m implant (Fig. 7a) may have been induced by implantoplasty of the endosseous portion of the implant. In this particular case, implantoplasty was conducted to smoothen the surface of the implant's threads in order to remove the implantitis-related bacterial biofilm [48]. Ideally, one should smoothen sharp edges and reduce surface roughness without causing damage. In the case of the CeraRoot 1p-3m implant, implantoplasty was conducted in an attempt to clean the surface and remove the threads, a procedure widely recommended for Ti implants [49-51]. However, chipping damages were identified at the remaining 'threads'. Although implantoplasty may be a common procedure to treat peri-implantitis around titanium implants [52], its application needs to be re-considered for zirconia implants as it can destabilize the zirconia-surface grains and influence the fracture strength of the zirconia implant [53]. Nevertheless, besides the potential induction of defects by implantoplasty, the early failure at 3 months of the CeraRoot 1p-3m implant following implantoplasty may also be due to heavy bone loss with little bone support left, as can be seen from clinical images in Fig. 1b-II, combined with a high bending moment with stress concentration at the weakest implant link. Regardless of the implant-surface modification (implantoplasty) being performed or not, the survival rate of implants treated for peri-implantitis was reported to be primarily influenced by the amount of bone loss at the time of treatment [54]. Further studies on the effects of implantoplasty of zirconia implants should be conducted.

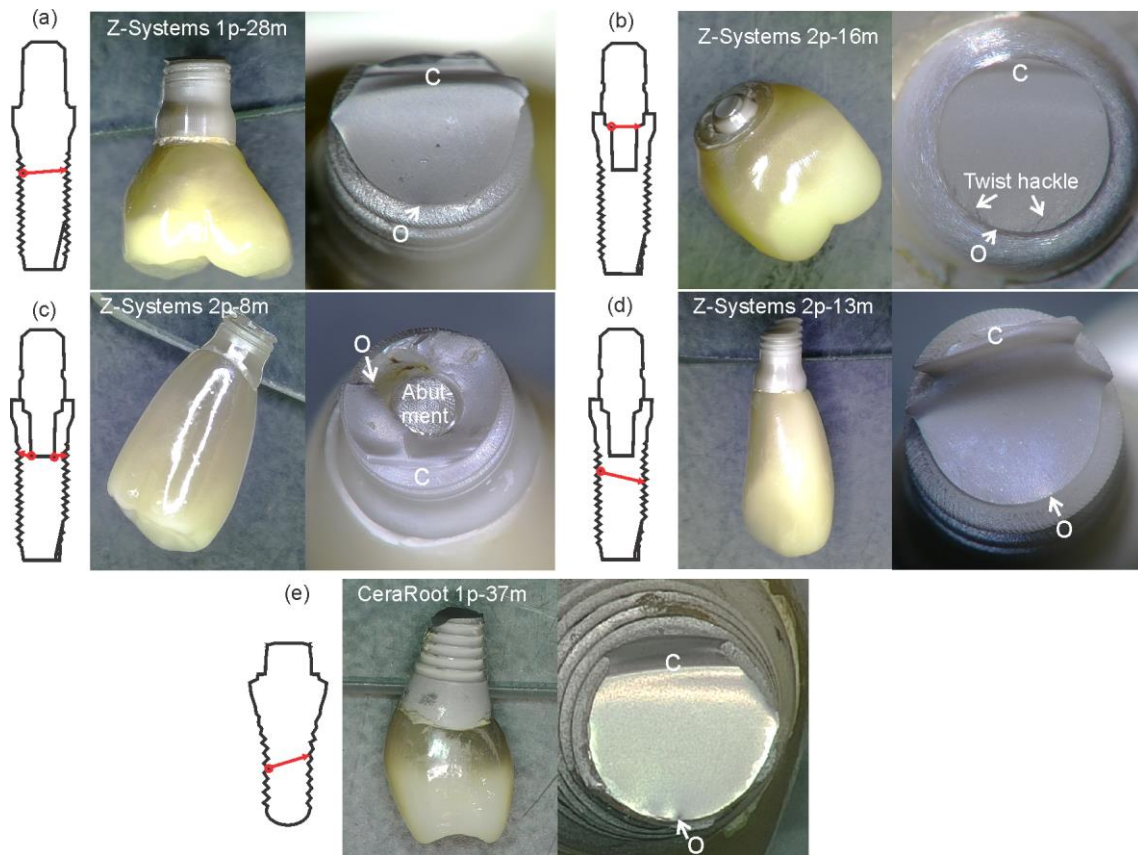
The general fractographic images taken by light microscopy and the representative fractographic features for the five different fractographic behaviors observed are presented in Fig. 2. Compressive curls are observed on the fracture surface of all 16 recovered implants and the fracture origin was located on the opposite side of the compressive curl. Table 2 classifies the implants into five different cases according to the fracture modes and the implant manufacturer (CASE 1-4 for Z-Systems implants and CASE 5 for CeraRoot implants). More detailed information for each implant is provided in the supplementary document Table S1.

All one-piece implants fractured in the endosseous part in the constriction region between two threads where the cross-section of the implant is the narrowest. The four Z-Systems one-piece implants included Z-Systems 1p-13m/28m/34m and Z-Systems 1p(t)-49m (Fig. 2a, i.e., CASE 1 with corresponding SEM shown in Fig. 3). For two-piece implants, three different fracture-initiation locations were observed: (1) Six two-piece implants, including Z-Systems 2p-3m/16m/28m/29m/30m/32m with a time to failure varying from 3 to 32 months, fractured at the abutment neck (Fig. 2b, i.e., CASE 2 with corresponding SEM shown in Fig. 4). Compared to other conditions, the fracture surfaces appeared rougher with larger twist hackle formed along the abutment's fracture-surface periphery next to the origin, while compressive curls were rather smaller. (2) Three Z-Systems two-piece implants, including Z-Systems 2p-8m/45m and Z-Systems 2pBL-29m, failed at the inner surfaces of the abutment-implant connection or the implant-screw connection (i.e., inner threads) (Fig. 2c, i.e., CASE 3 with corresponding SEM shown in Fig. 5). The abutment was exposed for all three fractured two-piece implants, while the crack-propagation direction was different for each implant. (3) One Z-Systems two-piece implant (Z-Systems, 2p-13m) failed at the implant body (i.e., the endosseous implant part) (Fig. 2d, i.e., CASE 4 with corresponding SEM shown in Fig. 6). The location of this fracture origin was similar to that of the one-piece implant in the constriction

At last, the two CeraRoot one-piece implants, including CeraRoot 1p-3m/37m (Fig. 2e, i.e., CASE 5 with corresponding SEM shown in Fig. 7), had the same fracture mode as the Z-Systems one-piece implants. They also fractured in the endosseous part in the constriction region between two threads where the cross-section of the implant is the narrowest.

Fig. 2. Representative images of recovered crown-implant parts and fracture surfaces for the five different fractographic behaviors observed: (a) Z-Systems one-piece implant having failed at the endosseous part, i.e., CASE 1 with corresponding SEM shown in Fig. 3. (b) Z-Systems two-piece implant having failed at the abutment neck, i.e., CASE 2 with corresponding SEM shown in Fig. 4. (c) Z-Systems two-piece implant having failed at the inner surfaces of the abutment-implant connections with the abutment having been exposed, i.e., CASE 3 with corresponding SEM shown in Fig. 5. (d) Z-Systems two-piece implant having failed at the endosseous part/fixture, i.e., CASE 4 with corresponding SEM shown in Fig. 6. (e) CeraRoot one-piece implant having failed at the endosseous part, i.e., CASE 5 with corresponding SEM shown in Fig. 7. The compression curls and the fracture origins are marked by 'c' and an arrow and 'o', respectively. The red circle and arrow on the implant illustration show the fracture origin and the main crack-propagation direction.

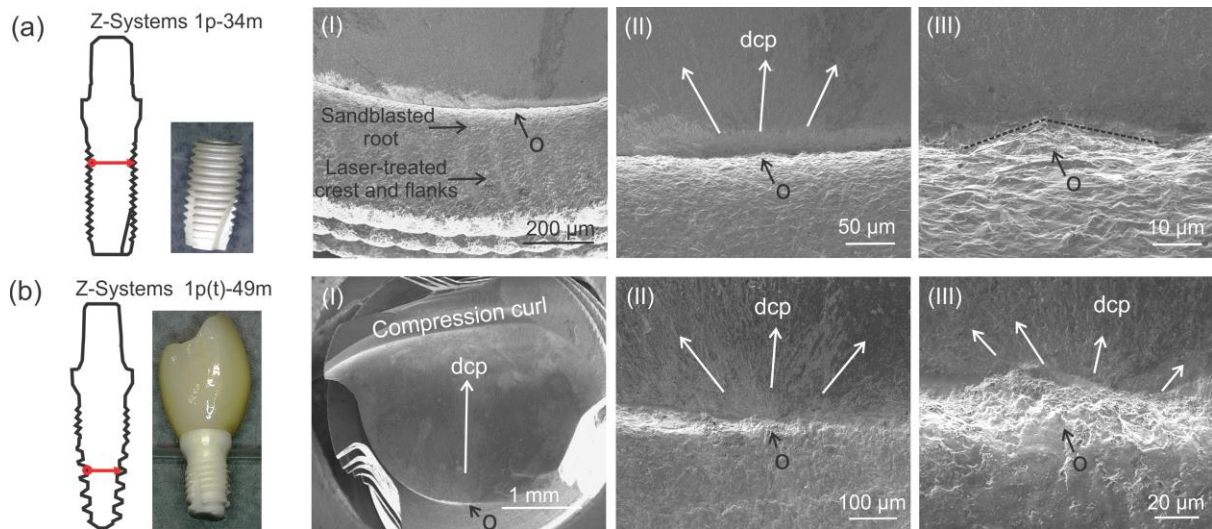
The representative cases for Z-Systems one-piece implants (Z-Systems 1p-13m/28m/34m and Z-System 1p(t)-49m) with (t) standing for tapered are shown in Fig. 3a,b. Irrespective of the parallel-walled (Fig. 3a) or tapered (Fig. 3b) implant designs, all recovered one-piece Z-Systems implants were fractured at the endosseous part between two threads. Laser-modified surface structures characterized by symmetrical parallel grooves were identified at the thread crest and partially at the flanks. The root between two threads, where the fracture originated, was only sandblasted without further laser modification (Fig. 3a-I). A wide v-notch shaped cut was present at the implant surface connected to the fracture origin (Fig. 3a-II,III). The fracture of another type Z-Systems 1p(t)-49m tapered one-piece implant was similar, with a v-shaped deep cut having also been observed at the fracture origin at the implant outer surface between two threads (Fig. 3b).

The implant design (one- and two-piece) was shown to have a clear influence on the crack-initiation locations (Table 2). All investigated one-piece implants fractured between two threads at the endosseous part (CASE 1 and CASE 5), with the fracture origin being located at the implant surface. This was independent of the specific implant shape and implant manufacturer, as the parallel-walled one-piece Z-Systems implant (Z5m, Fig. 3a), the tapered one-piece Z-Systems implant (Z5t, Fig. 3b), and the CeraRoot one-piece implants (Fig. 7) all failed at a similar location. The fracture origins of all Z-Systems and CeraRoot one-piece implants were clearly connected to surface flaws found at the constriction region between two threads. This was consistent with previous reports on one-piece implants with different shapes from other manufacturers [15, 16]. The v-shaped surface flaw observed at the fracture origin of the Z-Systems one-piece implants was probably caused by alumina sandblasting (CASE 1, Fig. 3). Although sandblasting and laser modification on Z-Systems implants are performed to promote osseointegration, they could have a significant impact on the zirconia implant's mechanical performance. Sandblasting of dental zirconia can be beneficial for an enhanced tetragonal-to-monoclinic phase transformation and generation of compressive stress [37-39], this depending on the sandblasting protocol (particle size, pressure and distance) [40-43]. The sandblasting-induced flaws and slow crack-growth effect may also counteract the strengthening effect, lowering the reliability [38, 39] and long-term fatigue performance of zirconia [44, 45]. In addition, although laser modification of Z-Systems implants induced columnar grains, tetragonal-to-monoclinic transformation and (micro-)cracks [29, 46], these laser-related surface damages were not involved in the fracture of the Z-Systems implants. This should be ascribed to selective surface modification by the laser. The laser treatment was applied to the thread crest and partially to the flanks (Fig. 3a-I), whereas the critical stress-

concentrated root between two threads was not laser-treated. Furthermore, all one-piece Z-Systems implants placed in a molar and pre-molar site had a diameter of 4 mm (Table 1), which is considered narrow for zirconia implants placed in the molar area and is not recommended by the manufacturer. Previous studies demonstrated that the fracture incidence of implants is associated with a decreasing implant diameter [15, 22, 47].

Fig. 3. Representative fracture surfaces of Z-Systems one-piece implants that failed at the endosseous part (CASE 1). (a) 1p-34m: (I) Overview of the fracture surface at low magnification; (II-III) Higher magnifications of the fracture surface showing the fracture origin. The implant external surface showed a v-notch shaped cut at the fracture origin (o). (b) Tapered 1p(t)-39m: (I) Overview of fracture surface at low magnification; (II-III) Higher magnifications showing the fracture origin. The implant surface showed deep cuts at origin (o). The direction of crack propagation (dcp) is indicated by white arrows.

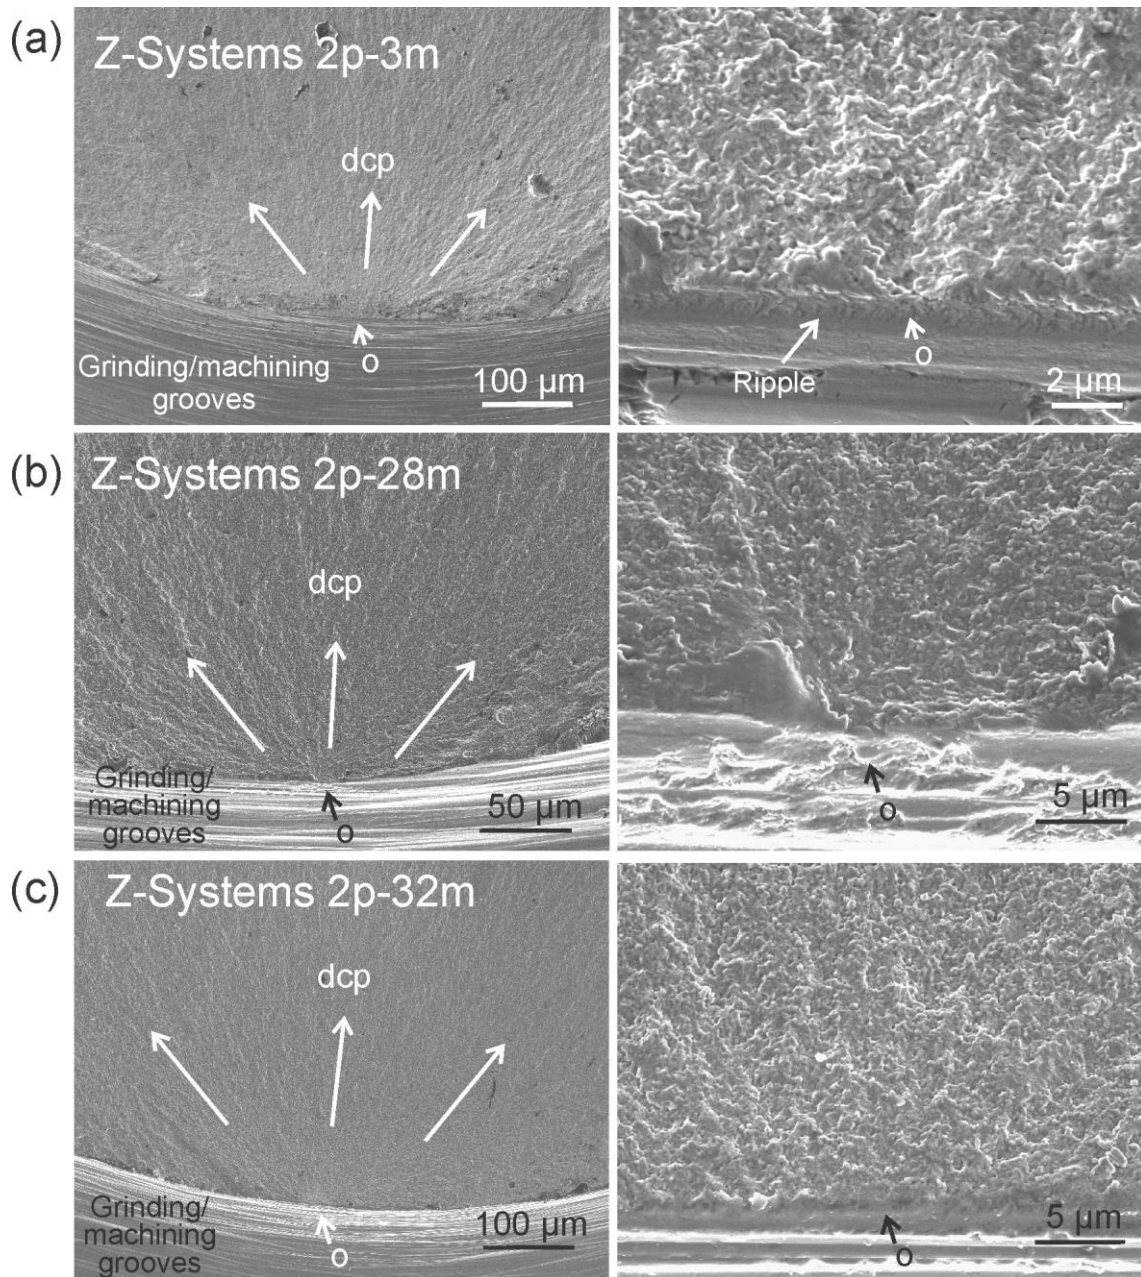
Representative fracture surfaces of the 6 Z-Systems two-piece implants (Z-Systems 2p 3m/16m/28m/29m/30m/32m) that failed at the abutment neck are presented in Fig. 4, i.e. the case imaged by optical microscopy in Fig. 2b. Grinding/machining grooves along the cylinders

were visible at the abutment surfaces. The fracture origins were connected to the defects found in the grooves. Scars with a ripple pattern (Fig. 4a, Z-Systems 2p-3m) and a v-shaped cut spanning the grooves (Fig. 4b, Z-Systems 2p-28m) were both observed at the fracture origins. Although the grooves were also connected to the fracture origin of the Z-Systems 2P-32m implant, no defect was clearly identified within the grooves at the periphery of the fracture origin (Fig. 4c). This Z-Systems 2p-32m implant was the implant with the longest time to failure amongst this group.

In terms of two-piece ceramic implants, the abutment neck (Fig. 2b, Fig. 4; CASE 2) and the abutment-implant connection (Fig. 2c, Fig. 5; CASE 3) were critical regions. The majority (6 out of 10) of the studied two-piece implants fractured at the abutment neck (Fig. 2b; CASE 2). All 6 implants and their abutments were ground and re-prepared by the clinician prior to final restoration, this because of different reasons mentioned in the patient-treatment plans (Materials and methods, section 2.1). However, it was not clear which specific part of the abutment was ground and how the grinding/re-preparation was exactly performed by the clinician. Furthermore, the grooves observed at the abutment neck could have originated from the implant-manufacturing process as well. In any case, flaws at the abutment surface were evident and included ripple-shaped grinding scars and v-shaped sharp flaws (Fig. 4a, b). These surface defects were also connected to the fracture origin (Fig. 4a, b). Grinding has generally been reported to reduce not only the strength but also the reliability of zirconia ceramics [38, 39]. Previous *in-vitro* investigations on ceramic implants have also suggested that grinding zirconia implants negatively influences the fracture strength of the implants [55]. V-shaped sharp defects, as observed in Fig. 4b in particular, have been shown to degrade the material's fatigue resistance [56]. Furthermore, in contrast with one-piece implants, the abutment neck is one of the stress-concentration areas [57]. The abutment-surface quality of the two-piece zirconia implant is therefore very critical.

Fig. 4. Representative fracture surfaces of Z-Systems two-piece implants that failed at the abutment neck (CASE 2): (a) Z-Systems 2p-3m implant with the fracture origin connected to the ripple shaped grinding/machining scar; (b) Z-Systems 2p-3m implant with the fracture origin connected to the v-shaped deep cut; (c) Z-Systems 2p-32m implant, for which no clear defect was observed within the grinding/machining grooves that could be connected to the fracture origin. The direction of crack propagation (dcp) and the fracture origin (o) are indicated by arrows.

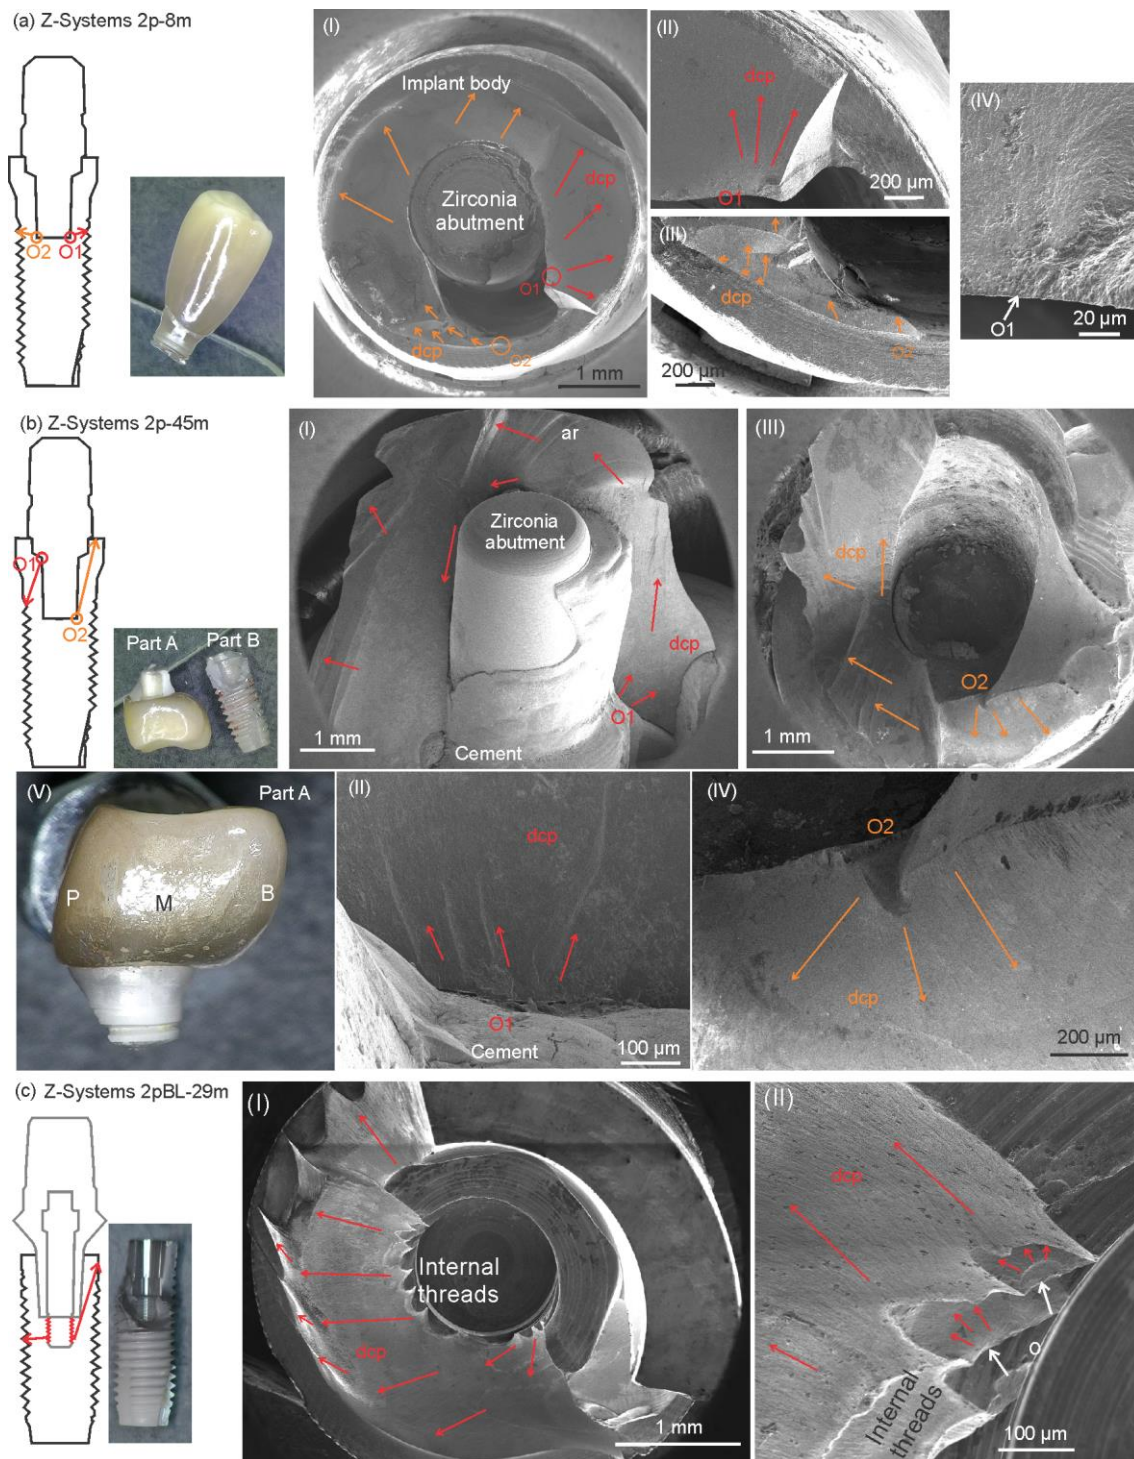
Fig. 5 shows the fracture surfaces of Z-Systems two-piece implants with fracture initiated at the inner surfaces, more specifically at the abutment-implant connection with angles (cemented implants in Fig. 5a,b) or at the implant-screw connections (i.e. at the internal threads for the screw-retained implant in Fig. 5c). In these three cases, the fracture patterns were complex and the crack-propagation directions were followed/mapped on the fracture surfaces to identify the fracture-initiation sites. For two-piece cemented and self-tapping tissue-level implants (Fig. 5a,b), the fracture-initiation sites involved the internal abutment-implant angles/connections, having resulted in zirconia-abutment exposure. Two fracture-initiation sites were identified for the failure of the Z-Systems 2p-8m implant (Fig. 5a); they were both at the inner connection angles located at the button of the abutment. Similarly for the Z-Systems 2p-45m implant (Fig. 5b), the internal abutment-implant angles were the critical points, but in this case, the angle at the abutment neck was identified as a critical fracture-initiation area as well (marked as origin 1-O1 in Fig. 5b). The fracture of the Z-Systems 2p-45m implant went downwards (for origin 1-O1) or upwards (for origin 2-O2). Regarding the two-piece screw-retained implant (Z-Systems 2pBL-29m), the internal threads were observed to be the weak

fracture-initiation areas. The crack propagation on the Z-Systems 2pBL-29m implant started from the internal threads and propagated horizontally along the implant walls or upward to the implant shoulder. Importantly for all these three cases, no defect was observed at the fracture-initiation sites. Furthermore, no matter how the fractures propagated horizontally or upwards/downwards, they all propagated radially from the internal connections (abutment-implant angles or internal threads) towards outside. Due to the complexity of the crack-propagation paths, some fracture-initiation sites may also not have been identified.

Three fracture cases out of 10 two-piece implants occurred at the inner abutment-implant connection (CASE 3). Microscopically, no critical defect was observed at the fracture-initiation sites at the inner implant surfaces (Fig. 5). A similar failure pattern at the abutment-implant connection without clear defect was reported for other two-piece zirconia implants fractured in *in-vitro* experiments [32]. In another *in-vitro* investigation, implants inserted at torque values ranging from 46 Ncm to 70.5 Ncm all fractured following a pattern similar to that observed in the current investigation; the fracture involved the bottom of the abutment-implant connection,

which had already reached a sub-crestal position [58]. The cause of failure was probably due to the high stress concentration along the abutment-implant connection. Presence of excessive mechanical force from disproportionately large crowns can also lead to failure of implants at the abutment-implant connection. In particular in the case of the Z-Systems 2p-45m implant, since the central axis of the implant was off-centered (Fig. 5b-V) and the contact loading was excentric from the implant's central axis (Fig. 8c), exaggerated bending and stress concentration may have been produced especially at the internal angles at the abutment-implant connection (Fig. 5b).

Fig. 5. Z-Systems two-piece implants with fracture-initiation sites observed at the inner surfaces at the abutment-implant connection (CASE 3). The crack-propagation direction (dcp) was marked with red and orange arrows, corresponding to the identified first fracture origin (O1) and second fracture origin (O2). Arrest lines (ar) were visualized for the Z-Systems 2p-45m implant. (a) Z-Systems 2p-8m two-piece cemented and self-tapping tissue-level implant. The upper part of the implant, the abutment and the crown were recovered. (b) Z-Systems 2p-45m two-piece cemented and self-tapping tissue-level implant. Two parts of the fractured implant were recovered. The fracture surface of part A was shown in I-II (red dcp); the fracture surface of part B was shown in III-IV (orange dcp). The central axis of this implant was off-centered due to the buccal extension, as can be seen in V. (c) Z-Systems 2pBL-29m two-piece

screw-retained bone-level implant. Only the zirconia implant was recovered (without screw and abutment).

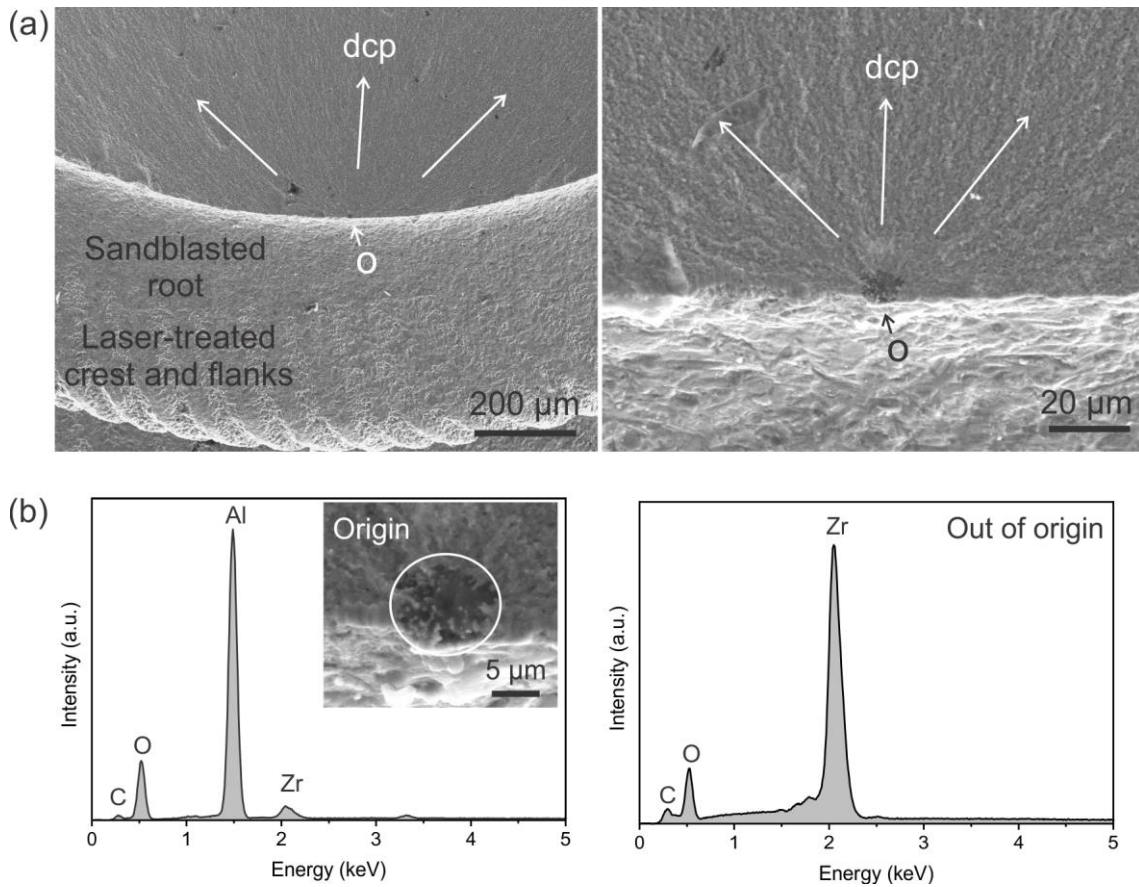
One two-piece implant (Z-Systems 2p-13m) failed at the outer surface of the implant body in the constriction region between two external threads of the endosseous implant part (Fig. 6a). The zirconia abutment was not exposed by the fracture. This was the only two-piece implant (out of 10) that failed at the endosseous implant region. A large precipitate of about 10 μm with darker contrast was observed at the fracture origin for this two-piece implant fracture. EDS revealed that the precipitate was Al_2O_3 , while the matrix region with lighter contrast represented ZrO_2 (Fig. 6b). Similar Al_2O_3 precipitates ($>2 \mu\text{m}$) were also randomly observed at other locations at the fracture surface, although not being the cause of crack initiation.

One single fracture of a two-piece implant (Z-Systems 2p-13m) occurred at the endosseous implant part (Fig. 6; CASE 4). The failure of this implant was probably due to several combined reasons. This implant was installed too buccally and the implant failed from palatal toward buccal (Fig. 8d). The alumina precipitate of $\sim 10 \mu\text{m}$ noticed in the area between two threads (Fig. 6) could also have contributed to this particular fracture. A small alumina amount of $\sim 0.25 \text{ wt\%}$ was added to dental zirconia to aid sintering and improve aging resistance [59]. Well-dispersed 0.25 wt\% alumina in the starting powder can almost completely be dissolved and is segregated as Al^{3+} at the zirconia-grain boundaries during sintering. Any excess alumina will present as individually dispersed alumina grains in the microstructure [60]. The presence of non-homogeneously dispersed large alumina precipitates in zirconia ceramics is not rare [61]. The particular failure of the Z-Systems 2p-13m implant emphasized the necessity of homogeneously dispersing the alumina addition.

Fig. 6. Z-Systems 2p-13m two-piece implant with a fracture-initiation site observed at the external surface between two threads at the implant endosseous region (CASE 4): (a) Fracture surfaces; (b) EDS showing the elemental composition of a darker precipitate observed at the fracture origin (left) and of the lighter contrast area away from the fracture origin (right) for comparison.

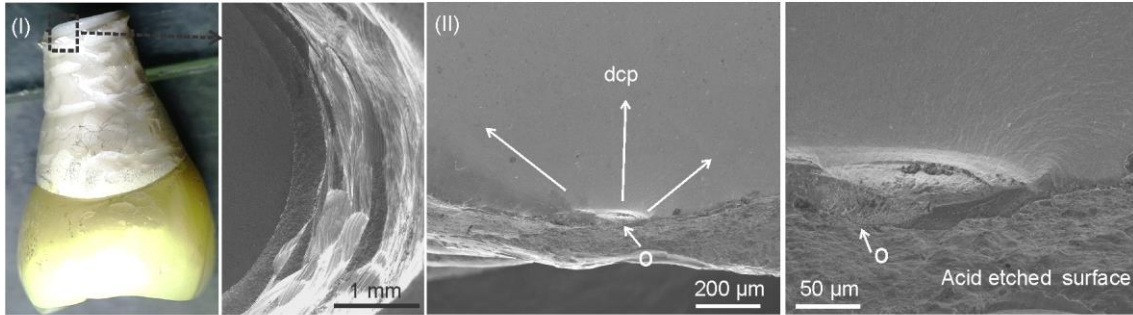
(a) CeraRoot 1p-3m

Similar to the Z-Systems one-piece implants, the two CeraRoot one-piece implants all fractured at the endosseous part of the implant, more specifically in the constriction region between two threads. The fracture origin was located at the external surface with hackle radiating from the implant surface in the direction of crack propagation (marked with arrows in Fig. 7). The implant surface of the CeraRoot 1p-3m implant clearly showed many damages/chips (Fig. 7a-

I) from the implantoplasty treatment, as compared to the non-treated CeraRoot 1p-37m implant (Fig. 7b-I). Higher magnification of the CeraRoot 1p-3m implant (Fig. 7a-II) displayed that the fracture origin was connected to the rough surface, while a large chipping defect of ~50 µm in depth was observed at the fracture-origin site. For the CeraRoot 1p-37m implant (Fig. 7b-II), a particular critical flaw was not identified at the site of fracture origin.

Fig. 7. CeraRoot one-piece implants with the fracture-initiation site observed at the external surface between two threads at the endosseous region (CASE 5). (a) CeraRoot 1p-3m: (I) Optical and SEM images showing the thread damages with many chips caused by implantoplasty; (II) Implant revealing a large chipping defect identified at the fracture-origin site (o), which was possibly related to surface implantoplasty; (b) CeraRoot 1p-37m: (I) Optical and SEM images showing the non-treated implant threads. (II) Implant without a critical defect having been observed at the fracture-origin area (o), as marked by the black square that is magnified in the right image.

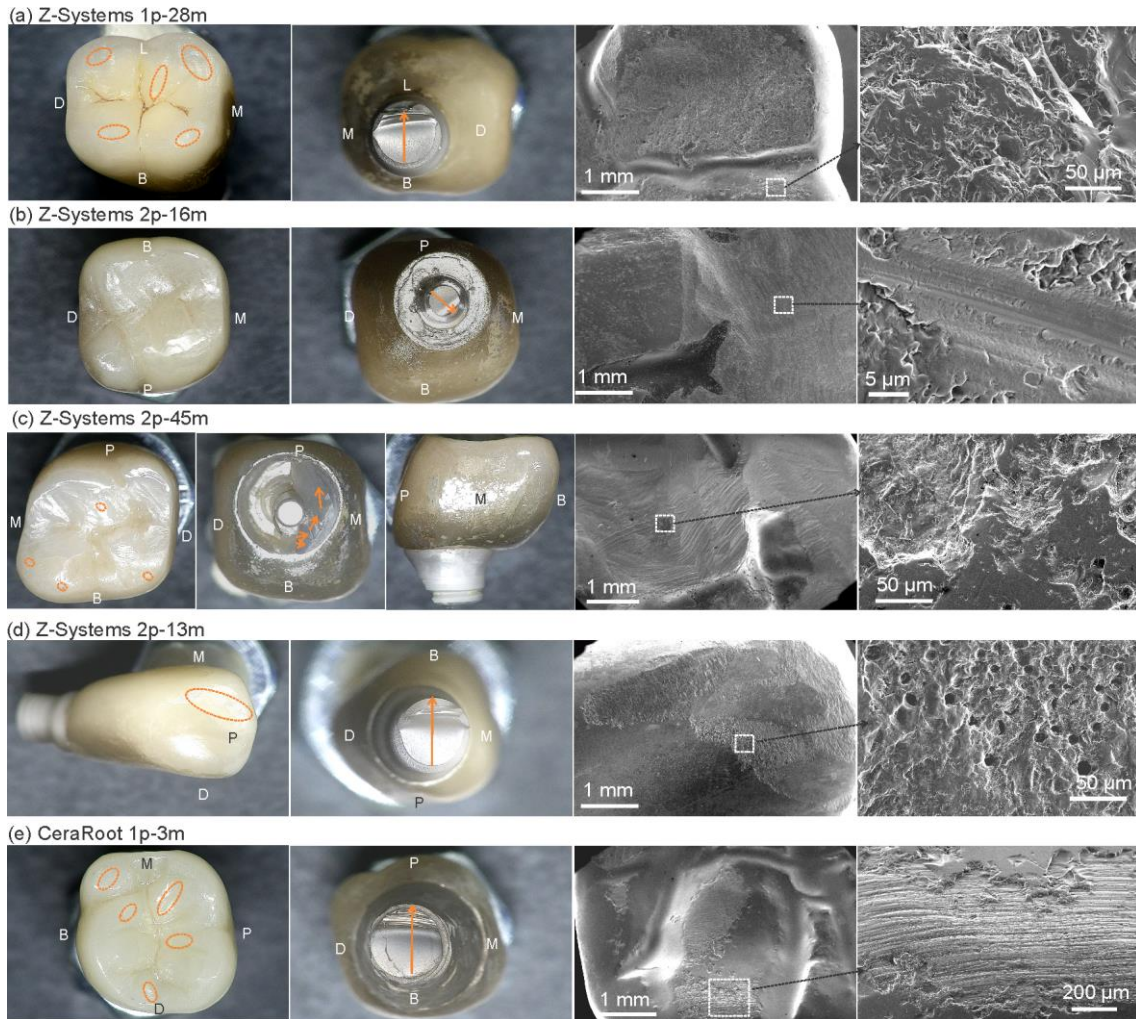
Fig. 8 shows the anatomical orientation and the surface conditions of the crowns that were placed on the representative implants of the five fracture cases classified in Fig. 2 and Table 2. All crowns were monolithic zirconia crowns. While the surface glaze was often worn out, indications of occlusal contacts were solely observed on the occlusal surfaces of some crowns (Fig. 8a,d,e). These contacts were judged to result from normal physiological functioning. In addition, the occlusal surfaces of several crowns showed heavy grinding marks (Fig. 8b,c), which probably represent intra-oral crown-surface adjustments carried out by the clinician. Occlusal contacts could hardly be observed in case of heavy grinding. In the case of the Z-Systems 2p-16m implant (Fig. 8b), almost the whole occlusal surface was heavily ground, while no clear evidence of wear facets was found. Similarly, on the crown surface of the Z-Systems 2p-45m implant (Fig. 8c), grinding grooves also covered almost the whole occlusal surface in the mesial-distal-palatal areas. Several small contacts were observed on the mesio- and distobuccal cusps. What is important for this specific Z-Systems 2p-45m implant is that the crown had a large bulky buccal extension, by which the central axis of the implant was off-centered.

Fig. 8. The crown orientation (B = buccal, D = distal, M = mesial, P = palatal, L = lingual) and the crown-surface condition on the representative implants for each case. (a) Z-Systems 1p-28m from CASE 1. (b) Z-Systems 2p-16m from CASE 2. (c) Z-Systems 2p-45m from CASE 3. The buccal bulk extension makes the central axis of the implant off-centered. (d) Z-Systems 2p-13m from CASE 4. (e) CeraRoot 1p-3m from CASE 5. The orange arrow indicates the direction of crack propagation. The orange circles indicate the areas with occlusal contacts.

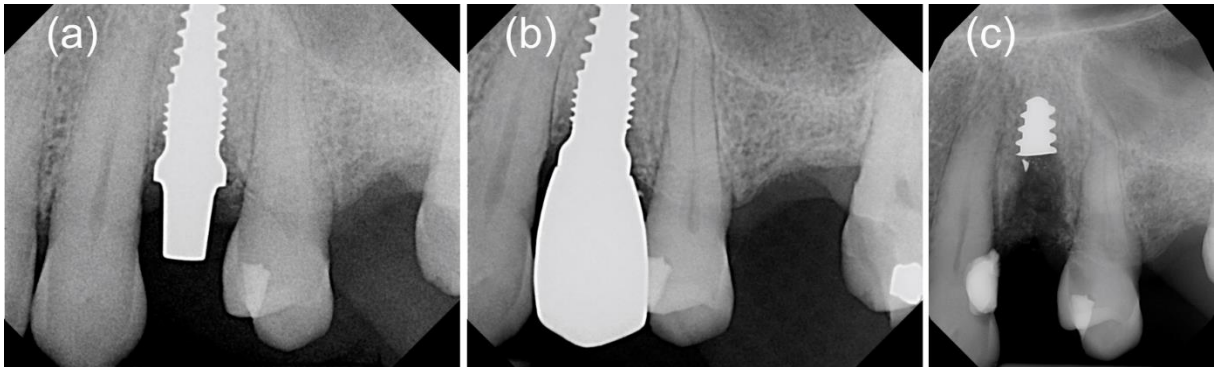
Fig. S1. Radiographic images of a tapered one-piece Z-Systems implant (1pt-49m): (a) Implant placed; (b) Implant with solitary crown; (c) Implant fracture after 49 months of clinical service.

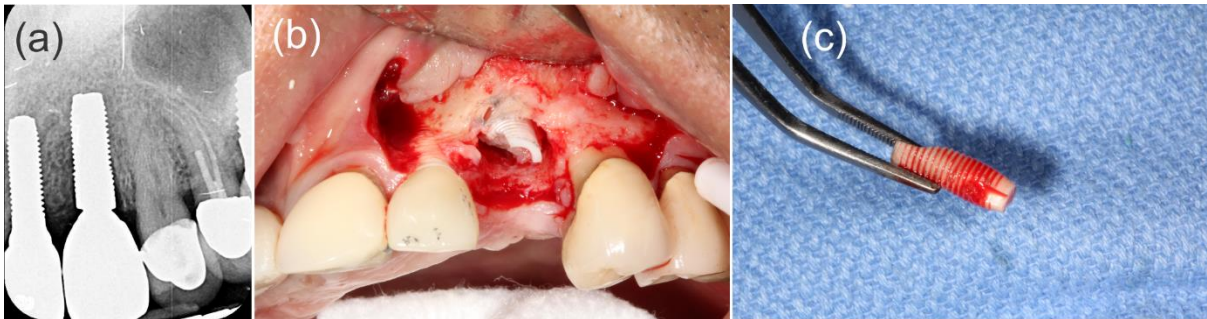
Fig. S2. Radiographic and clinical images of a fractured Z-Systems 2pBL-29m implant and its removal (a-c).

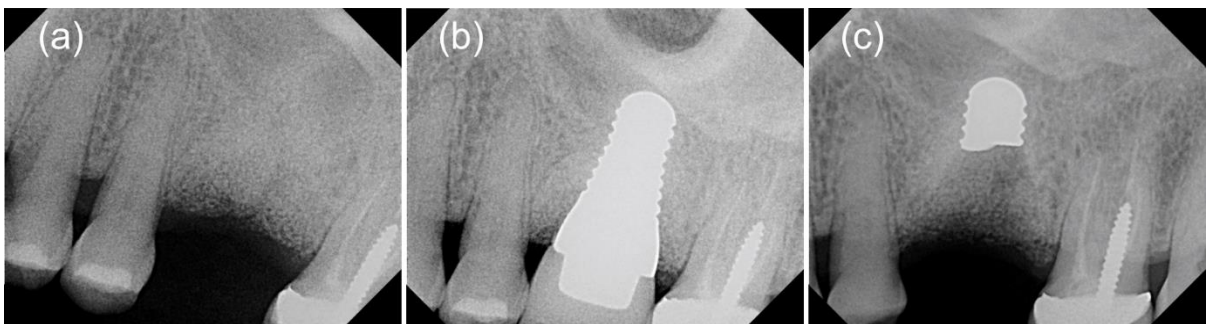
Fig. S3. Radiographic images of a CeraRoot 1p-37m implant (a-c): (a) Periapical radiograph prior to implant placement; (b) Periapical radiograph at final restoration; (c) Periapical.

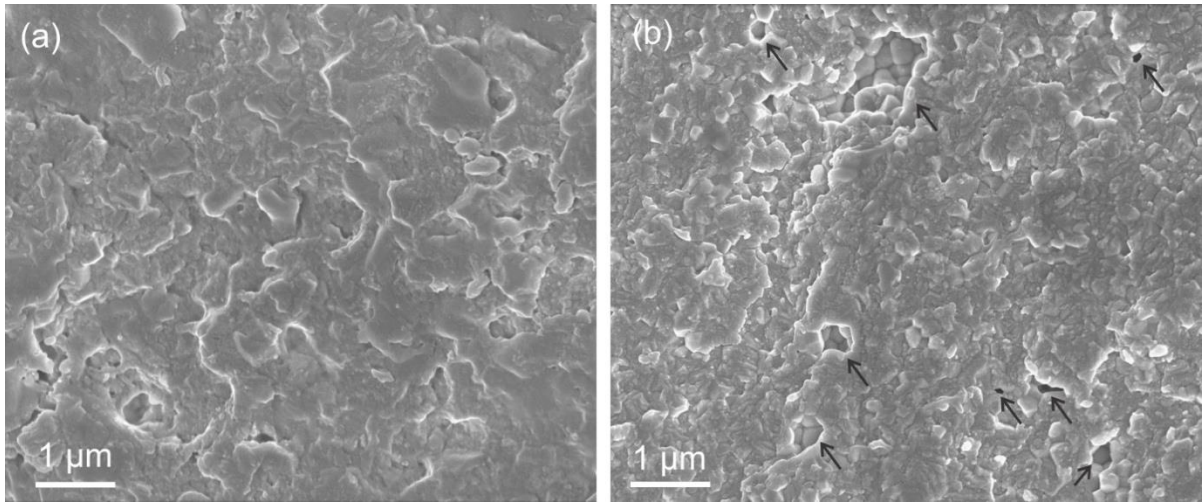
The fracture patterns of zirconia grains in the Z-Systems and CeraRoot implants consisted of mixed inter- and transgranular fractures (Fig. S4 in the supplementary document). Residual porosities, marked with black arrows in Fig. S4b, were observed in the CeraRoot implants. Nevertheless, these pores were not identified as the critical defects causing failure of the CeraRoot implants. The Z-Systems implants looked denser with pores rarely having been detected. The zirconia grains of the CeraRoot implants were much finer than those of the Z-Systems implants.

Fig. S4. Fracture of zirconia grains for a Z-Systems implant in (a) and a CeraRoot implant in (b).
