Development of an appropriate grout for the consolidation of the column foundations in Our Lady's Basilica at Tongeren (B).

Synopsis:

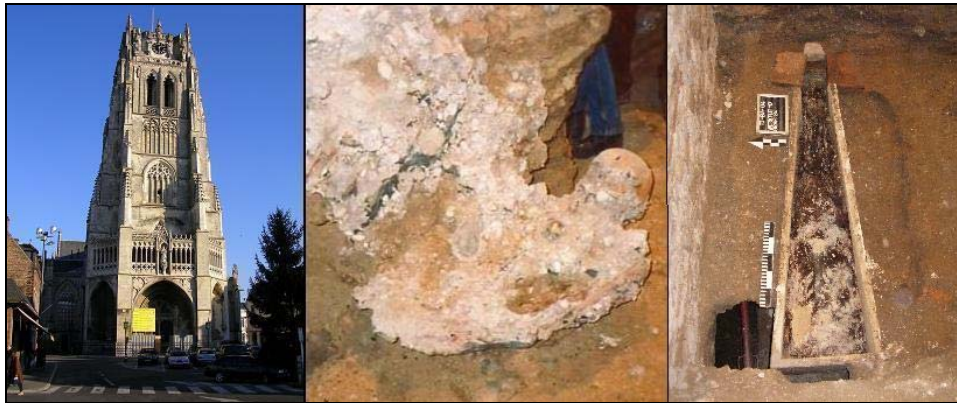
Fig.3 -- Left: tower of Our Lady's Basilica at Tongeren (Belgium)
 Middle: unwanted "consolidation" of a skeleton caused by the pronounced fluidity in time of the injected cement based grout (phase I)
 Right: sarcophagus next to the chain wall (excavated in phase II)

Although the main objectives concerning the consolidation and strengthening of the foundation masonry was successfully executed with the cement based grout in phase I of the project, there were some disadvantages using this type of grout. Cement based grouts tend to remain very fluid for several hours, causing damage to several sarcophagi, located in the direct surroundings of the chain wall. Some valuable inscriptions on lime stone fragments were lost and even a skeleton was accidentally injected (see Figure 3).

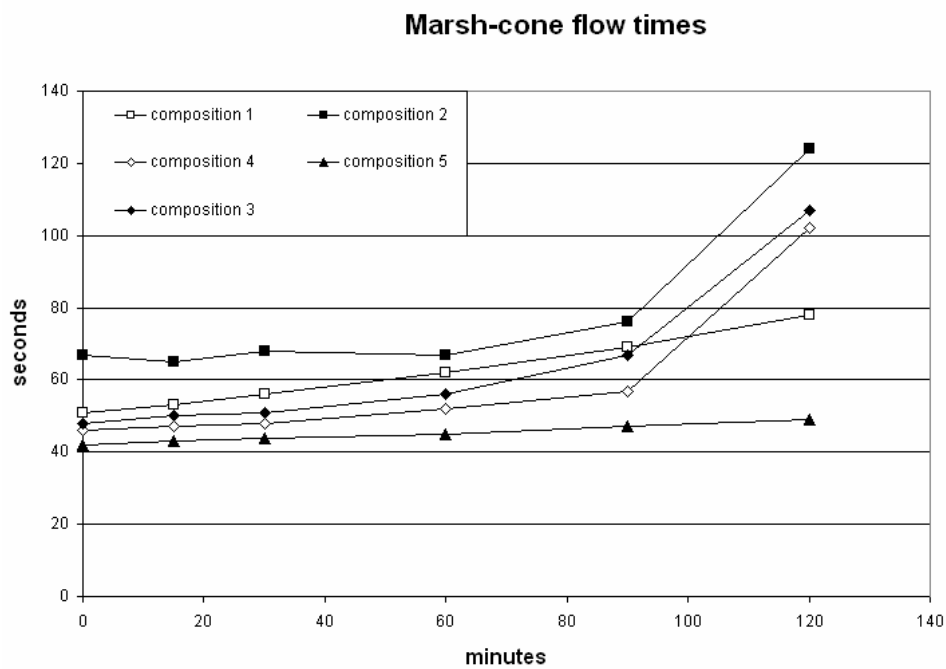
Fig.4 -- Marsh-cone flow times of the different compositions tested for phase II. The flow times were measured after 0', 15', 30', 60', 90' and 120'

the funnel. Figure 4 gives the Marsh cone flow times of the different compositions tested for phase II. The flow times were measured after 0', 15', 30', 60', 90' and 120'. As mentioned before, it is the aim to develop a grout who's fluidity stays constant the first one and a half hour and then decreases rapidly. Figure 4 clearly shows that compositions with an air hardening lime content above 30 % fulfil this special condition needed to prevent the filling of the valuable artefacts.

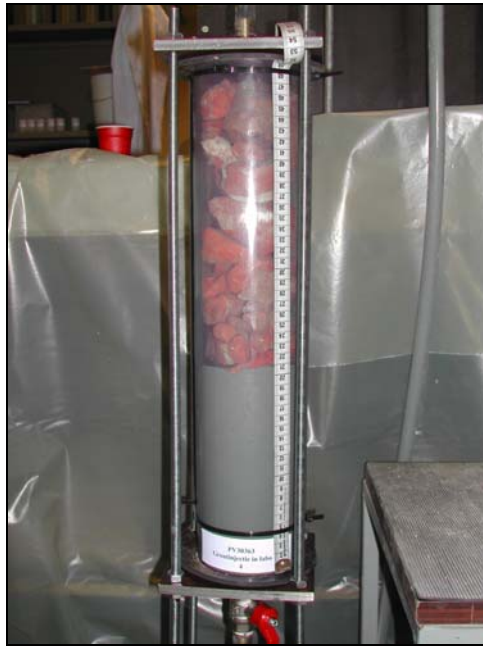
Fig.5 -- Injection with grout (composition 3) under a hydraulic fall of 1 m of a tube, filled with brick material from the site. The curing period was 28 days.

The first one consisted of the injection with grout under atmospheric pressure of a Plexiglas column, filled with brick, natural stone, and mortar from the site (see Figure 5). The grout injected was composition 3. It was observed that in all cases the grout filled completely the present voids. In Table 6, the compressive strengths on samples made in the laboratory by means of injection under a hydraulic fall of 1 m of a tube filled with the different kinds of materials found in the foundation. The curing period was 28 days.

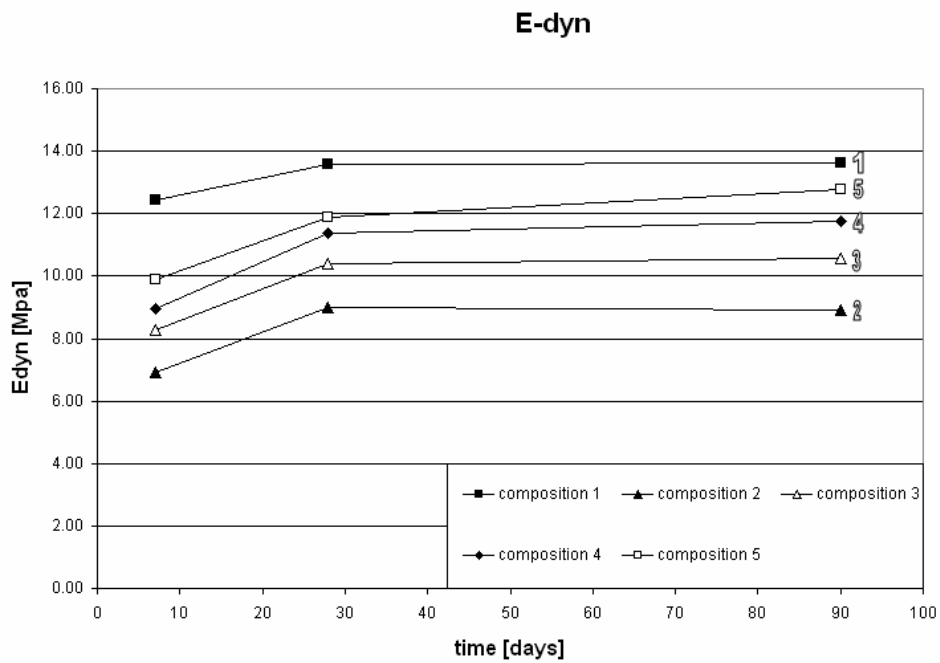
Fig.8 -- Dynamic modulus of elasticity of the different compositions, measured after 7, 28 and 90 days.

Compressive strength, dynamic modulus of elasticity -- The tests were done on samples 40x40x160 mm according to the Belgian standard NBN B14-208. The tests will be executed after 28, 90, 180, 365 and 730 days. Also the dynamic modulus of elasticity will be measured after 7, 28, 90, 180, 365 and 730 days (cfr. NBN B15-229). At the time of writing, the tests were executed after 7, 28 and 90 days. Figure 7 gives the evolution of the compressive strengths of the different compositions, measured after 7, 28 and 90 days. Higher cement content results in higher compressive strengths. Figure 8 shows the dynamic modulus of elasticity of the different compositions, measured after 7, 28 and 90 days. The same conclusion applies here, higher cement content results in higher compressive strengths

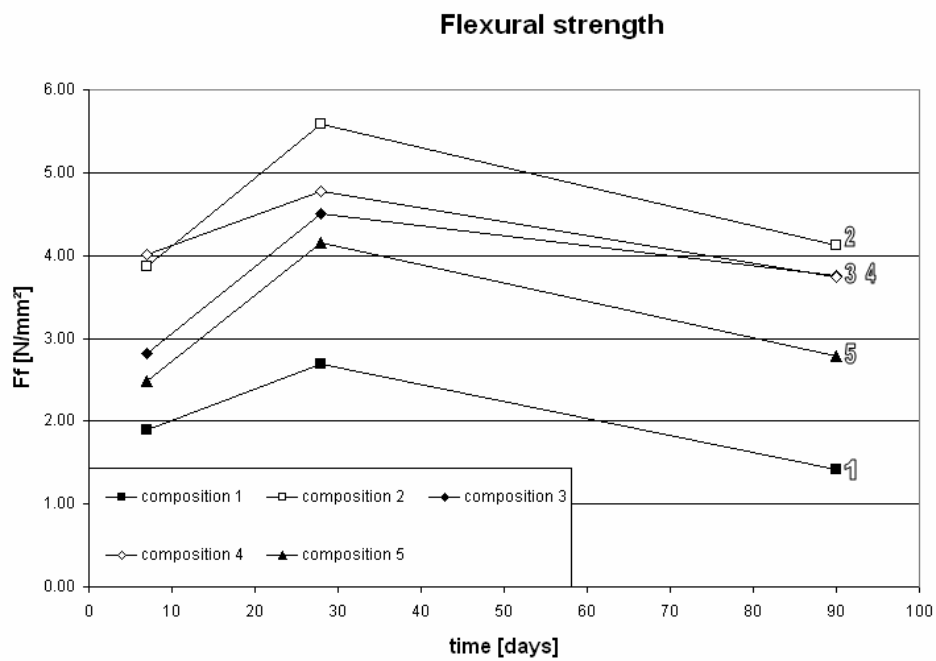
Fig.9 -- Flexural strengths of the different compositions, measured after 7, 28 and 90 days.

Flexural strength -- Figure 9 shows the evolution of the flexural strengths of the different compositions, measured after 7, 28 and 90 days. The initial flexural strength (after 7 days) depends on the amount of cement. Less cement results now in higher initial flexural strengths. It is believed that slaked lime makes the grout more hygroscopic and tough, diminishing micro cracking in the hydraulic phase of the curing. After 28 days the flexural strengths augmented for all the compositions and again lesser content of cement results in higher flexural strengths. After 90 days however, it is observed that the flexural strength diminishes for all the compositions. A possible explanation is that, although the R.H. is higher than 96 % and therefore

carbonation is thought to be limited, the carbonation initiates between 28 and 90 days because of the high CO₂-content of 3 %. A simple carbonation test using phenolphthalein showed that the outer skins of the samples were indeed carbonated after 90 days. The drop of flexural strength is probably due to microcracking occurring at the interior of the samples. It is assumed that the reason of this microcracking is the difference between areas of the grout situated towards the exterior of the specimen that are carbonated and other areas towards the interior, that are still hydrating. Hydration causes chemical shrinkage and induces tensile stresses (and thus microcracking) at the interface of a carbonated (and thus inert) part of the material and a non carbonated (and thus hydrating) part of it. A similar phenomenon was already observed and described in ⁶ for grouts containing silica fume. A new PhD.-research recently started at the Department of Civil Engineering of the Katholieke Universiteit of Leuven, studying this competition between carbonation and hydration*. The evolution of the compositions will further be followed during the coming two years.

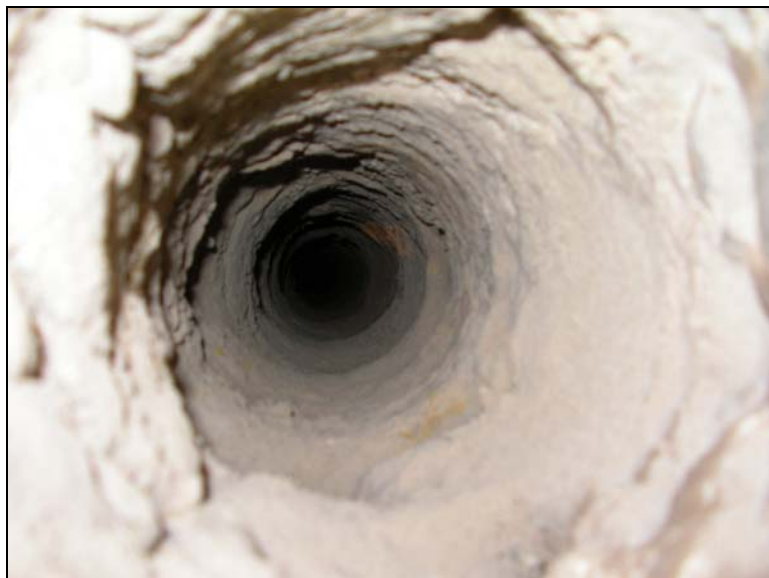
Fig.10 -- View from the surface of the hole drilled in the injection test area.

Some test injections were performed on site with composition 4. Three injection holes were drilled, forming an equilateral triangle with a distance of 60 cm, and filled with grout under atmospheric pressure. After curing, a core was drilled in the equilateral triangle. Due to the presence of very hard stone material in the foundations and the resulting difficulties experienced during the drilling of the core, the core itself did not present a good image of the injection degree of the masonry. To verify the injection, an endoscopical survey of the drilled hole was executed. Figure 10 gives a view from the surface of the hole drilled in the injection test area. The endoscopical survey of the hole showed a well consolidated foundation masonry. The injected grout itself was also tested and controlled. Every day the Marsh funnel flow time evolution was checked and every 3000 litres some samples of 40x40x160 mm were moulded according to the Belgian standard NBN B14-208 for compression and flexural strength. Also the dynamic modulus of elasticity was measured (cfr. NBN B15-229). The physical and mechanical properties of the grout samples tested correlated with the results from the laboratory tests.
