Application of the acoustic emission technique for assessment of damage-accumulation in masonry.

E. Verstrynge (1), S. Ignoul (2) L. Schueremans (1), D. Van Gemert (1), M. Wevers (3)

Original article reference: Verstrynge, E., Ignoul, S., Schueremans, L., Van Gemert, D., Wevers, M. (2008). Application of the acoustic emission technique for assessment of damage-accumulation in masonry. International Journal for Restoration of Buildings and Monuments, 14 (3), 167-178: 2008.

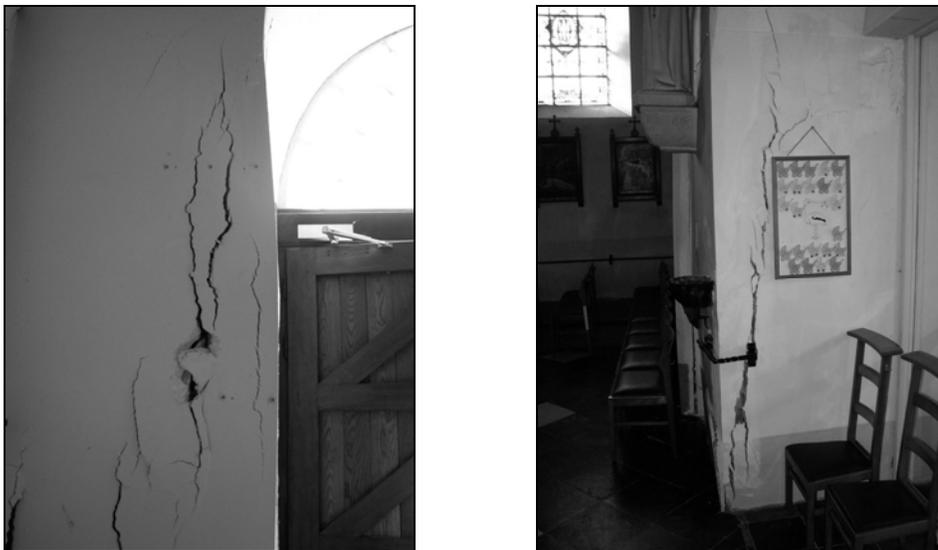
Since the sudden collapse of a number of historical buildings (Civic Tower of Pavia, 1989; Noto Cathedral, 1996, both in Italy; Sint-Willibrordus church in Meldert, July 2006; Maagdentoren in Zichem, June 2006, both in Belgium), much effort has been made in order to analyse and describe the long-term behaviour of historical masonry [1, 9]. Long-term behaviour is a general descriptive term for the combined behaviour of deterioration of the material in time and the time-dependent deformations of masonry under high sustained stresses (creep phenomenon). The time-dependent behaviour which eventuates in failure of a structure, partly or in total, is being described by means of rheological models [4, 5]. These models aim to describe the three phases of a typical creep process in masonry, including phases with decreasing, constant and increasing creep rate. Based on these phenomenological models, attempts are made to predict the time to failure of the masonry, taking into account the material characteristics and the evolution of the stresses within the masonry over time. In order to evaluate creep behaviour, the time-dependent deformations are monitored within a structural element. In some cases, this monitoring period extends over a long period of time [2], but more often, the monitoring of cracks and deformations is started when stability problems arise. In some very critical cases, only a short monitoring period is enough in order to draw conclusions and take action. A typical example is the case of the bell tower of the Sint-Willibrordus church in Meldert, which collapsed on July 7, 2006. The three-leaf masonry of the tower was composed of two outer leafs in sandstone and an inner core with rubble masonry of smaller sandstone chunks and large amounts of lime mortar. The red-brown, rather porous sandstone contains iron oxide, which is responsible for its colour. The sandstone is known for having a large scatter on its strength characteristics and easy absorption of water, making it rather vulnerable for weathering influences. A visual inspection of the supporting corner pillars of the church tower, carried out before collapse, showed a large amount of vertical cracks, indicating that the masonry was heavily loaded and in bad condition, figure 1.

Fig. 1: Large vertical cracks in the supporting corner pillars of the church tower

This crack pattern was found on several of the supporting elements of the tower and a monitoring campaign was set up, including the monitoring of a number of cracks by means of a mechanical strain gauge. Within a period of two weeks, some crack openings showed an increase of 1mm and more and the advice was given to close the church and to start immediate strengthening and repair actions. Two weeks later, while the technical staff (who was removing valuable sculptures before the restoration) was having a lunch break, the tower collapsed. Fortunately, making no casualties [6].

Another issue is the placement of the sensors. During the experimental tests, the sensors are placed on each side of the specimen in an area where the highest damage is expected. For in situ measurements, the placement of the sensors should be considered carefully as large cracks in the structure (see figure 1) disable damage detection from the zone behind the voids. Especially in case of multi-leaf masonry, the different layers could be detached, disabling the area behind the void to be monitored by the acoustic emission technique.

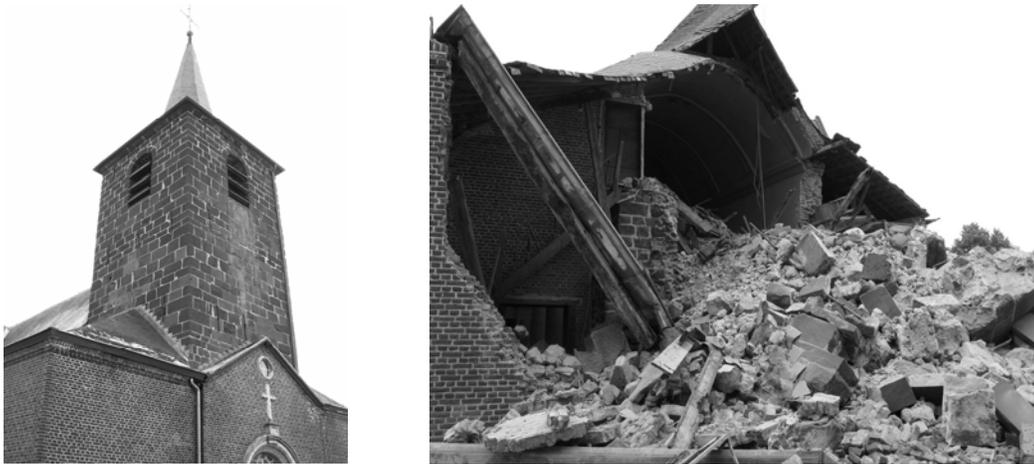
Fig. 2: Bell tower of the Sint-Willibrordus church in Meldert, before and after collapse on July 7, 2006

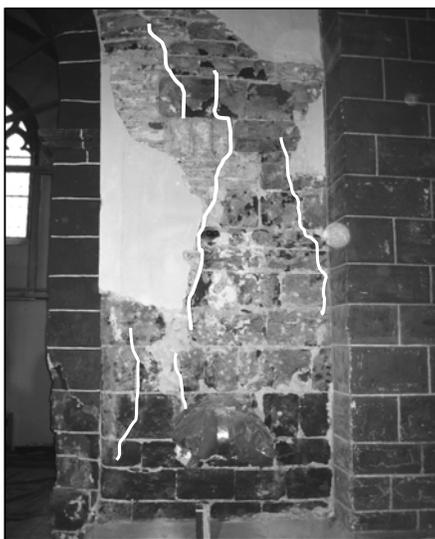
Comparable critical conditions were found at the bell tower of the Sint-Eustachius church in Zichem, Belgium. The crack pattern of one of the corner pillars is presented in figure 3. Again, typical vertical cracks were noticed after removal of the plasterwork. Urgent stabilization measures were taken, by wrapping the pillars with CFRP sheets in order to increase their load bearing capacity, figure 4.

Fig. 3: Crack pattern of corner pillar

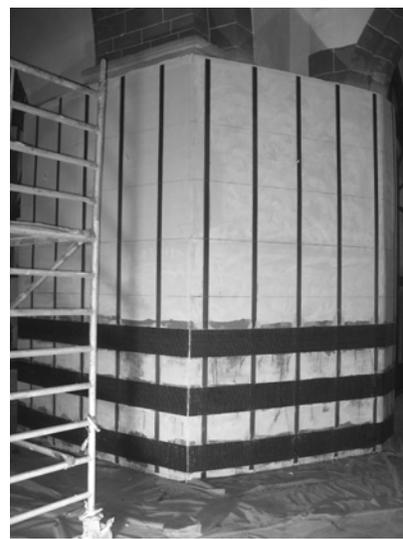
Fig. 4: Wrapping with CFRP sheets

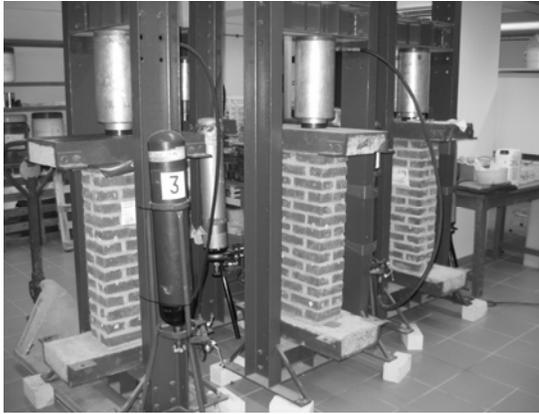
Two masonry columns (column nr. 28 and 30) were chosen out of a larger test program for masonry creep testing and for these specimens, both the deformations and the acoustic emission were monitored during the test. The masonry specimens were made with a base of 29 by 19 cm and a height of approximately 85 cm, which corresponds to 14 brick layers and a joint thickness of 1 cm. The height of the masonry wallets is at least three times larger than the thickness to assure a uniaxial stress distribution in the middle of the specimens. The masonry specimens are constructed with a blended cement-lime mortar. Separate steel frames were constructed and hydraulic jacks were used, in combination with a mechanical strain gauge to measure the deformations periodically. On each side of the test wallet, four horizontal and six vertical measuring bases were installed, from which the average value was calculated to describe the strain evolution in time. A more extended description of the full test program is given in [4], [8].

Although both masonry specimens are constructed with the same brick and mortar, their composition is not alike. Column 28 has failed during a previous stress increase. A vertical crack on the small sides runs all the way through the specimen, splitting it in two layers. The specimen has been repaired by grout injection. The creep test for this specimen is started at a low stress level of 50%. Measurement show that even at this level, there is already a large amount of damage and the specimen will not be able to withstand the same stresses as will column 30.

Fig. 7: Masonry specimens for creep test

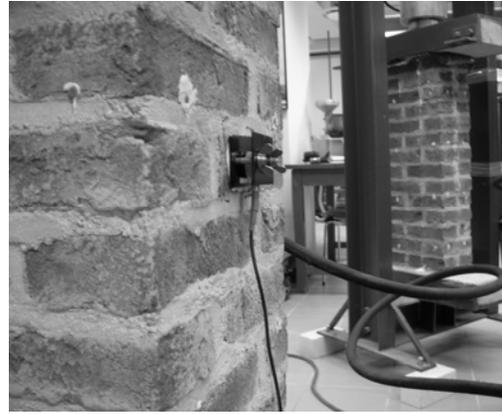
Fig. 8: Coupling of AE-sensor on masonry

The tests were carried out following the stress path as described above. Deformations were measured every month, using fixed measuring points and a removable strain gauge. The acoustic emission activity was detected by means of two AE sensors, one on each side of the specimen. The sensors are attached to the masonry by means of a thin metal plate which is carefully glued on the surface. A vacuum grease is used as a couplant in between the sensor and the metal plate. Between two measurements, the sensors were removed, while the metal plates stayed attached to the structure. The preamplifier gain is set to 34 dB and a threshold level of 34 dB is applied. The measurements were carried out with equipment from Vallen Systeme, type AMS-3 and AMSY-5. With the latter, four channels could be measured at the same time, enabling the monitoring of the two specimens simultaneously. With the AMS-3 system, only two channels could be measured and this two-channel configuration was sustained during the monitoring with the AMSY-5 equipment. The used sensors have a frequency range of 250-700 kHz, with a resonance at 375 kHz.

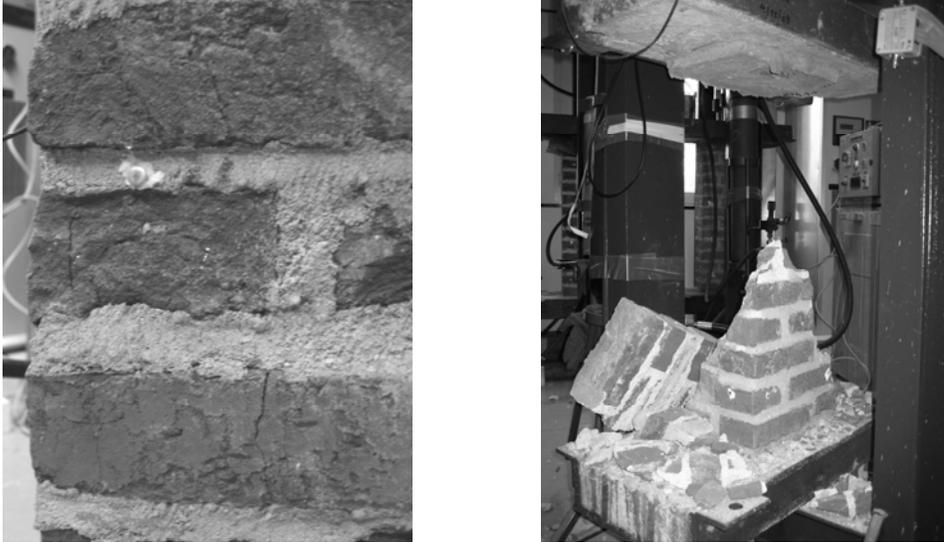
Fig. 9: Vertical cracks in the brick due to creep deformations before failure of the specimen; column 30 after failure
