# Assessment of material use in relation to climate in historical buildings

Başak İpekoğlu\*, Hasan Böke, Özlem Çizer

*Department of Architectural Restoration, Faculty of Architecture, İzmir Institute of Technology, 35430 İzmir, Turkey*

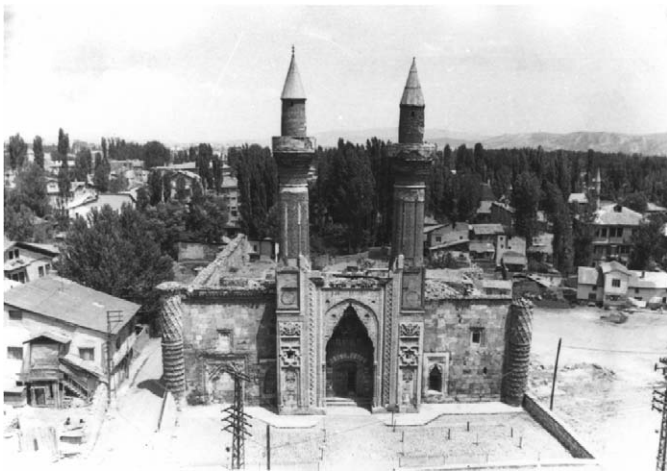
Fig. 1. Portal of Sivas Gök Madrasa, open-court type.

Most of the experiments in plan and the different types of madrasa constructions are seen in Early Anatolian Turkish Architecture, during the 12th and the 13th centuries. The Seljuk madrasas in Anatolia present two types of examples as open and closed madrasas. Although the examples of the madrasas with an open courtyard can be seen in all Islamic countries, those that have a central space, covered with a dome are especially developed in Anatolia. Thus, the madrasas of the Anatolian Seljuk period are composed of student rooms and iwans arranged around an open or a closed central space. During this period, the madrasas commonly had two or four vaulted iwans. One of these is at the entrance, the other is across it and the other two are on the sides that open to the central space. The common feature of both types was the huge and monumental portal (a monumental entranceway to a building) placed at the center of the entrance façade and covered with cut stone like the walls (Figs. 1 and 2). In general, the walls and the superstructures were constructed

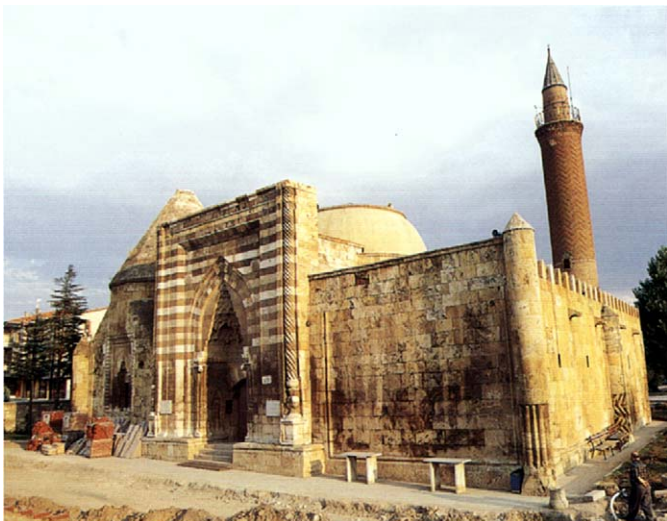
Fig. 2. Portal of Kırşehir, Caca Bey Madrasa, closed type.

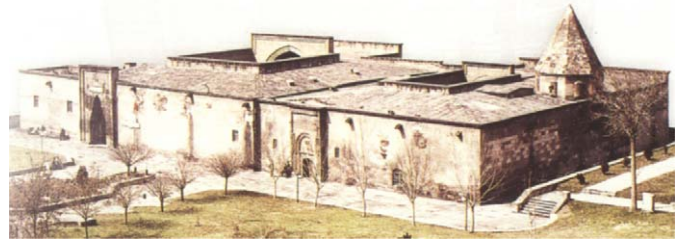
Fig. 3. Cut stone walls of Kayseri Çifte Madrasa (Gabriel A. Monuments Turcs d'Anatolie, vol. 1. Paris:E. de Boccard;1931).

from cut stone both on the outer and inner surfaces (Fig. 3). The intermediate parts were filled up with rubble stone and mortar.

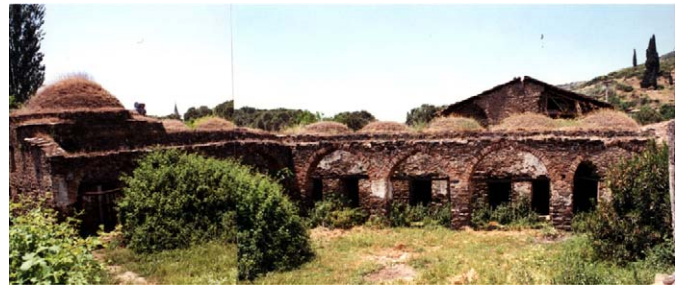
Fig. 4. Local construction technique composed of rubble stone, brick and mortar in random bond of Birgi Derviş Ağa Madrasa.

Madrasas were constructed continuously and increased in number during the Ottoman period developing as institutional buildings [5]. As for their planning, although at first the open and closed types were continued to be employed, later the vaulted iwans on the axes of the courtyard were removed and the madrasa rooms were designed in relation to the courtyard. Either in a single row, in two opposite rows, L formed or U formed. The spaces were covered with domes. The construction of madrasa buildings in small settlements in Western Anatolia, in addition to the ones built in larger cities like İstanbul, Edirne or Bursa, draw attention to the importance given to education. The ones built in such small settlements also reflect the general characteristics of Ottoman architecture. Although they were designed in moderate size, they reflect the local construction techniques and use of materials (Fig. 4).

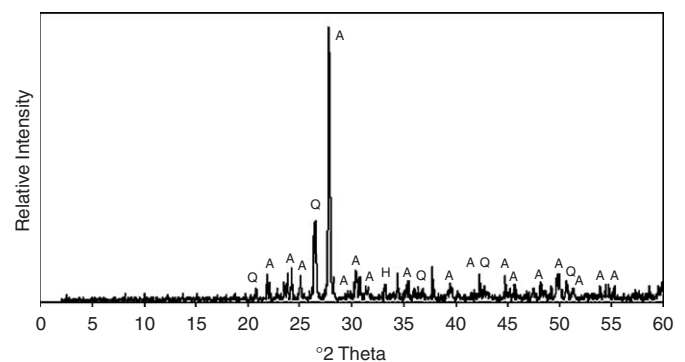
Fig. 5. X-ray diffraction (XRD) pattern of stones (A: albite, Q: quartz, H: hematite).

The stones used in the madrasas were identified as slate by mineralogical and petrographical analysis. The slate mainly consists of feldspar and quartz minerals (Fig. 5). Chemical composition analyses carried out by SEM/EDS indicated that these minerals were mainly composed of silicon (Si), aluminum (Al) and iron (Fe) elements. Slate is

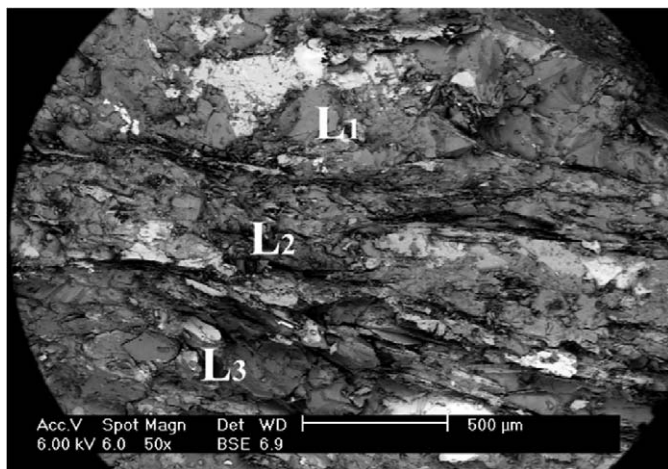
Fig. 6. Back-scattered electron (BSE) images of the detachments as in the form of layers in stones ( $L_1$ ,  $L_2$ ,  $L_3$  layers).

Soluble salt contents of the stones on relatively undeteriorated parts were around 0.2% while on the relatively deteriorated parts up to approximately 1 m from the ground, this ratio reached up to 0.6%. Mainly nitrate and chloride ions were detected from the qualitative analyses. Since the highest amounts of these ions were found in the soil, it can be suggested that rising damp is the source of the salts. The stones, which contain the highest amounts of salts, were detached as in the form of layers. Besides salts, clay minerals were determined in the zones of detachment of the layers (Fig. 6). Both salts and clays caused deterioration of stone in the form of detaching layers that form the fabric of the stone during the cycles of wetting and drying.

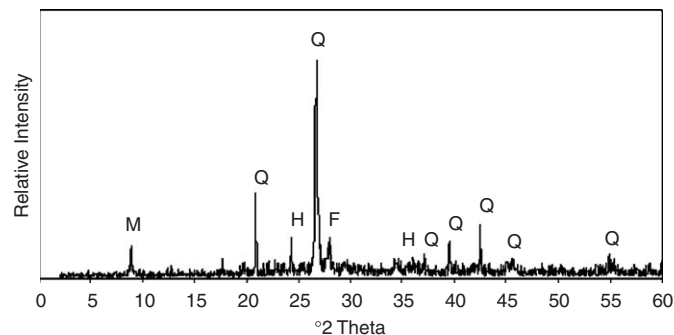
Fig. 7. XRD pattern of bricks (Q: quartz, H: hematite, F: feldspar, M: muscovite).

It was determined that the bricks were mainly composed of quartz, feldspar, hematite and muscovite by XRD analyses (Fig. 7). Considering these results, it can be said that calcite-poor clay was used in the production of the bricks. In the chemical composition, analyses carried out by SEM/EDS indicated silicon (Si), aluminum (Al) and iron (Fe). Observation of hematite in the XRD analyses showed that the firing temperatures of bricks were  $850^\circ\text{C}$  or higher [15].

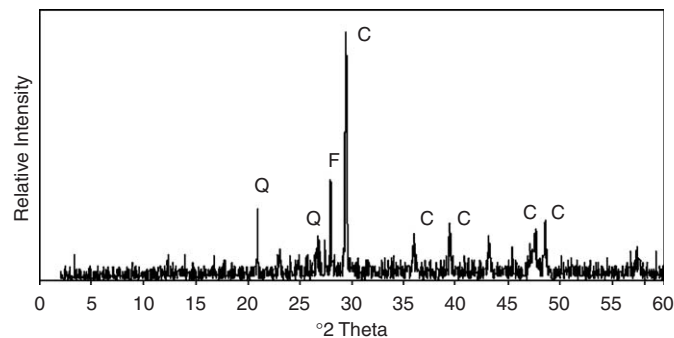
Fig. 8. XRD pattern of mortars (C: calcite, Q: quartz, F: feldspar).

In the buildings, lime mortars were used as binding material in the joints of brick and stone bonds. XRD analyses of mortars showed that they were mainly composed of calcite, quartz and feldspar minerals (Fig. 8). Calcite is derived from carbonated lime; quartz and feldspar from aggregates. Chemical compositions of white lumps in the mortars, determined by SEM/EDS, indicate that they were composed of high ratios of calcium oxide, around 95%, and low ratios of magnesium oxide, around 2%. These values showed that lime used in the preparation of the mortars contained low amounts of magnesium oxide (fat-lime).

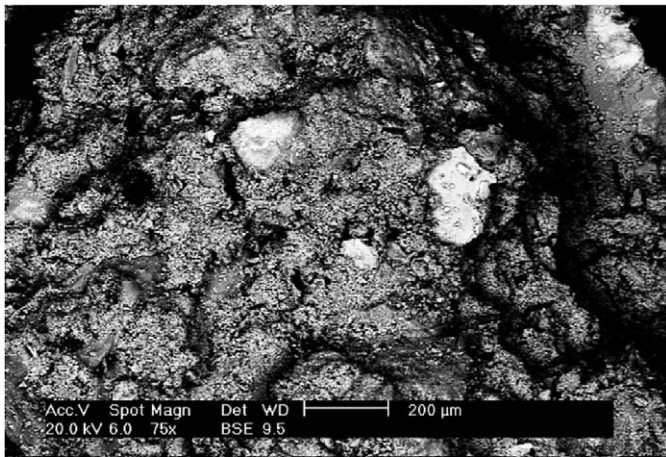
Fig. 9. BSE image of detachments between lime matrix and aggregates and fissures in the relatively deteriorated mortars.

Interface between lime matrix and aggregates is free from pores and cracks in the mortars on the relatively sound parts. This observation may indicate a well-mixing process of the lime with the aggregates. In the mortar samples on the relatively deteriorated parts up to approximately 1 m from the ground, the observation of detachments at the interface between lime matrix and aggregates and fissures in the matrix could be explained by the crystallization of soluble salts carried from the earth by the rising damp (Fig. 9).

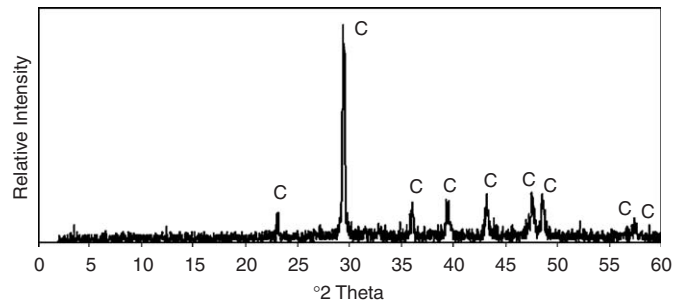
Fig. 10. XRD pattern of the top-layer plasters (C: calcite).

Top-layer plasters were composed of 97% binder and lower amounts of fine aggregates (3%). Mainly calcite peaks were observed in their XRD patterns (Fig. 10). Calcite crystals were in micritic structure and contained 95% CaO (Figs. 11 and 12). These results indicated that pure lime was used in the production of the plasters.

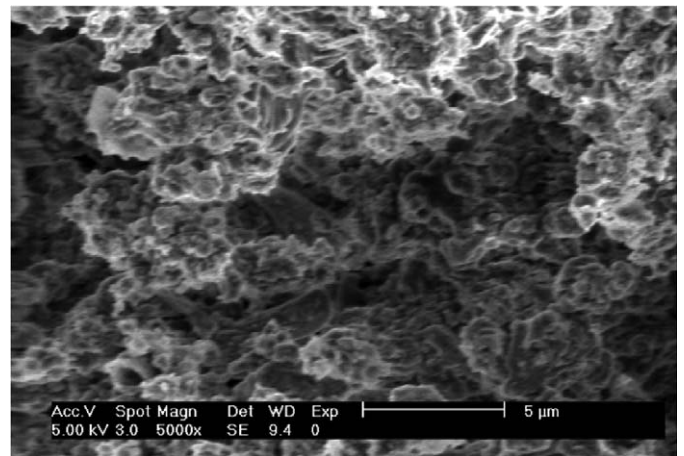
Fig. 11. Secondary electron (SE) image of micritic calcite crystals in the top-layer plasters.

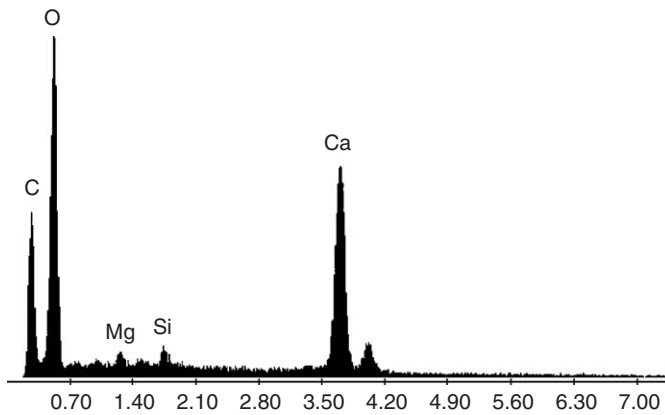
Fig. 12. Energy-dispersive spectroscopy (EDS) analysis of micritic calcite crystals in the top-layer plasters.

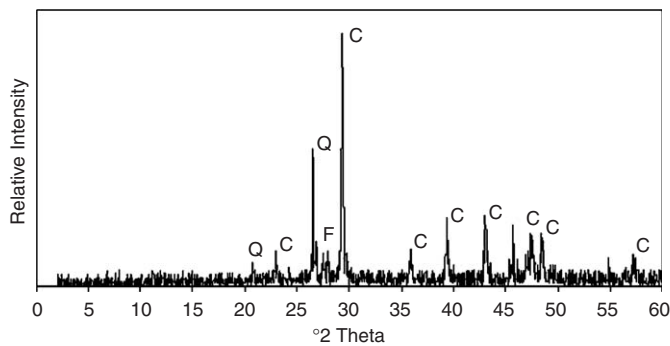
Fig. 13. XRD pattern of the under-layer plasters (C: calcite, Q: quartz, F: feldspar).

Besides calcite mineral, quartz and feldspar peaks coming from aggregates were observed in the XRD patterns of the under-layer plasters (Fig. 13). As observed in the top-layer plasters, calcite crystals were in micritic structure.

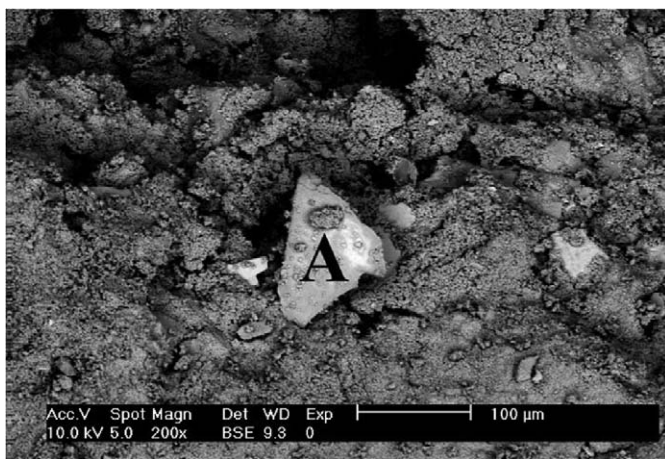
Fig. 14. BSE image of detachments between aggregates and plaster matrix in the relatively deteriorated plasters (A: aggregate).

Interface between aggregates and binder, pores and cracks were observed in the plasters on the relatively deteriorated sections (Fig. 14). It can be asserted that these formations, which caused to the disintegration of plasters, originated from the rising damp and the salts that were carried from the earth as in the mortars.

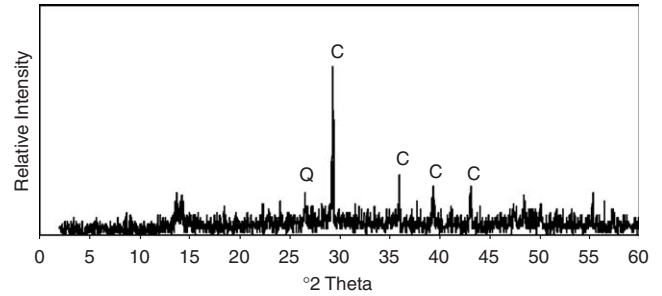
Fig. 15. XRD pattern of horasan plaster (C: calcite, Q: quartz).

Calcite and quartz peaks were determined by XRD analyses of horasan plasters (Fig. 15). Calcite originated from the carbonated lime and quartz from the brick aggregates. Besides mainly calcium, low percentages of

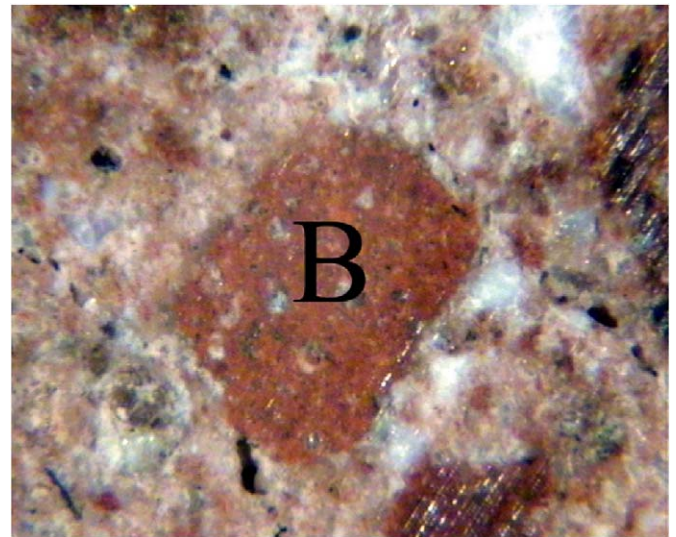
Fig. 16. Stereo microscope image of the brick aggregate (B) in the horasan plaster matrix.

Brick fragments were adhered well with the lime and the interface between the lime matrix and brick fragments was free from cracks (Fig. 16). In these plasters, calcium silicate hydrate and calcium aluminate hydrate formations were also detected in the results of the reaction between lime and brick fragments [17]. These products acquire hydraulic properties to horasan plasters (Fig. 17). Horasan plasters were applied as an isolation material on the superstructures of numerous historical buildings due to their hydraulic properties.

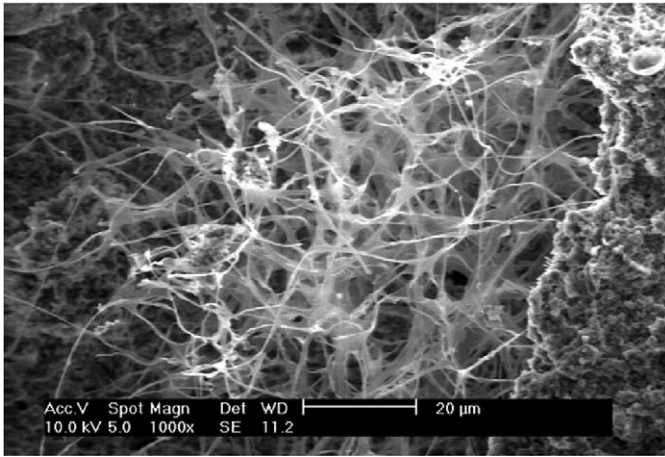
Fig. 17. SE image of calcium-silicate-hydrate (C-S-H) formations in the horasan plaster.

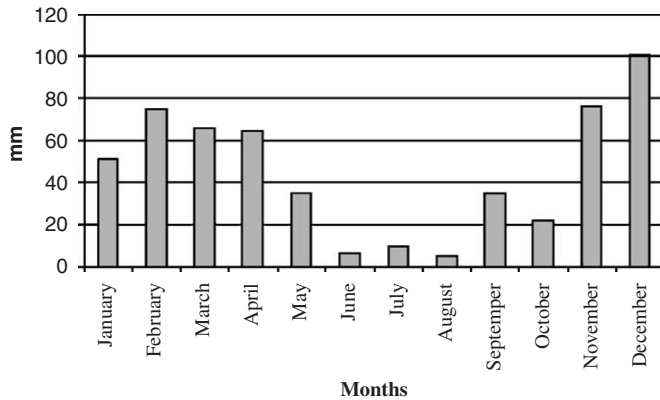
Fig. 19. Average values of the average monthly values of rainfall between the years 1994 and 2004 (General Directorate of State Meteorological Affairs, Ankara).

During the summer months, the average rainfall is low while wind speed is high (Figs. 19 and 20). This situation reduces the humidity in the building creating more dry air. During spring, autumn and winter months, the average rainfall is high while wind speed is low, and this increases the dampness problems in the buildings due to the increase in the humidity in the air.

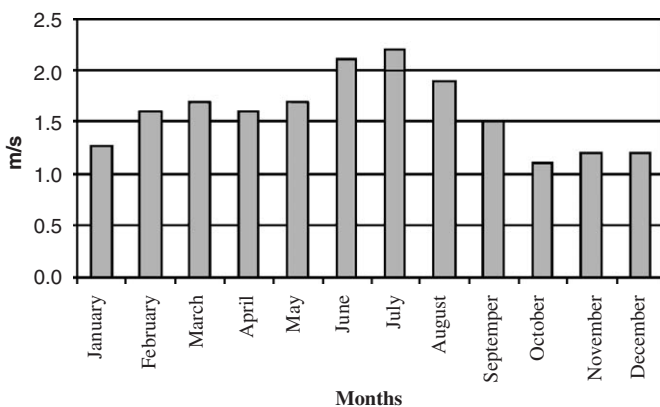
Fig. 20. Average values of the average monthly values of wind speed between the years 1994 and 2004 (General Directorate of State Meteorological Affairs, Ankara).
