**8IMC\_223**

Observation of the failure mechanism of  
brick masonry doublets with cement and lime  
mortars by microfocus X-ray computed  
tomography

HENDRICKX R.; BRUYNINCKX K.;  
SCHUEREMANS L.; KERCKHOFS G.;  
VERSTRYNGE E.; WEVERS M.;  
VAN BALEN K.

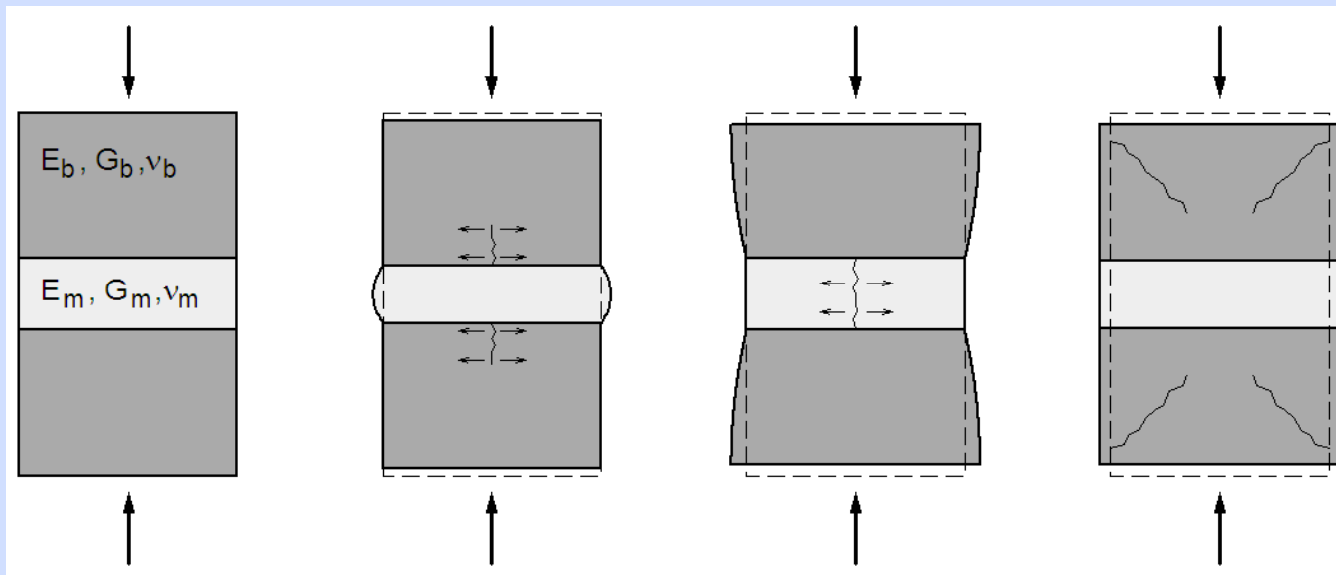
Different failure modes according to Hilsdorf 1969:

- if the brick's stiffness is higher than the mortar's stiffness, the mortar will tend to expand more laterally, which causes tensile stress in the brick;
- if the mortar's stiffness is higher than the brick's stiffness, the brick will tend to expand more laterally, which causes tensile stress in the mortar;
- if stiffnesses are comparable, a homogeneous behaviour is expected, with typically the formation of conical shear planes.

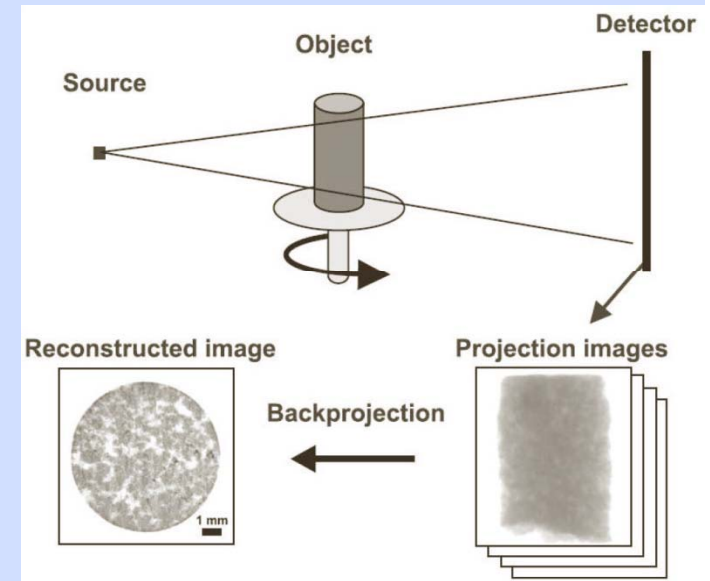
- Cylindrical object placed between source and detector
- Images taken every rotation step of  $1^\circ$ , over  $180^\circ$
- Reconstruction of horizontal slices from the raw data.

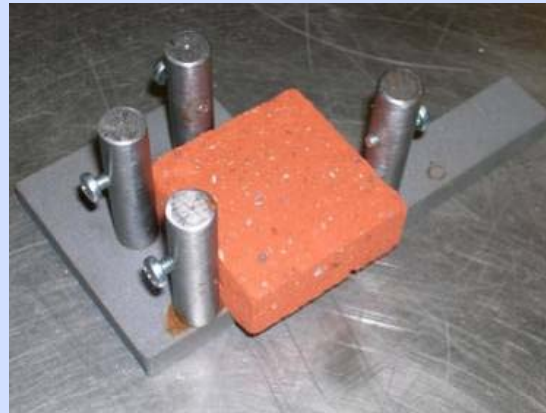
Step 1: brick bottom layer

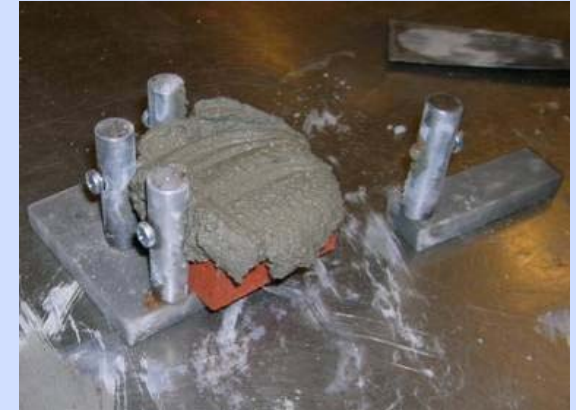
Step 2: hybrid mortar layer

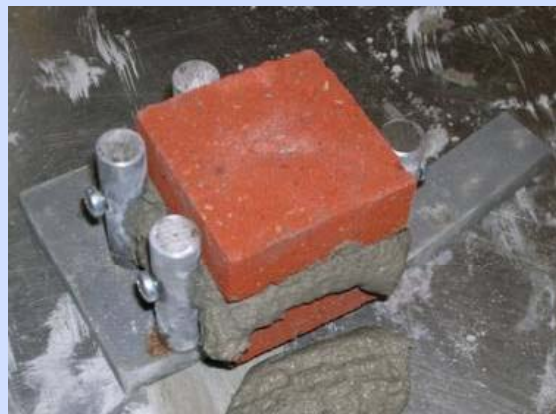
Step 3: parallel brick top layer

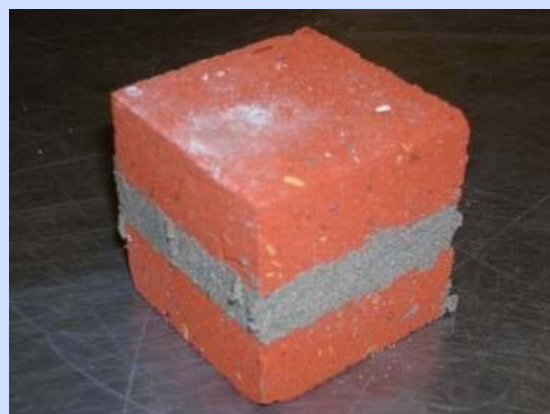
Step 4: sample before core drilling

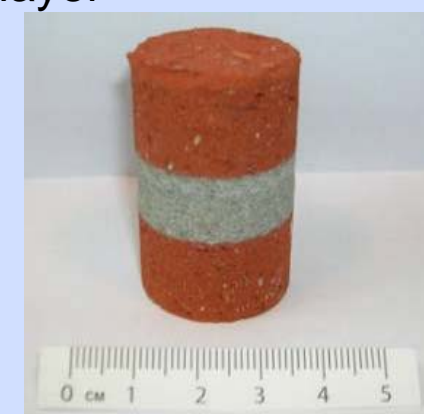
Test sample –  
d=29mm – h=48 mm

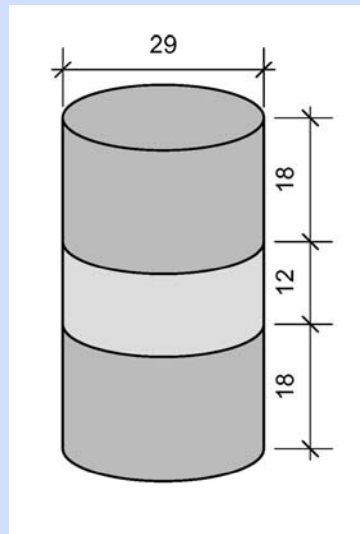
specimen geometry

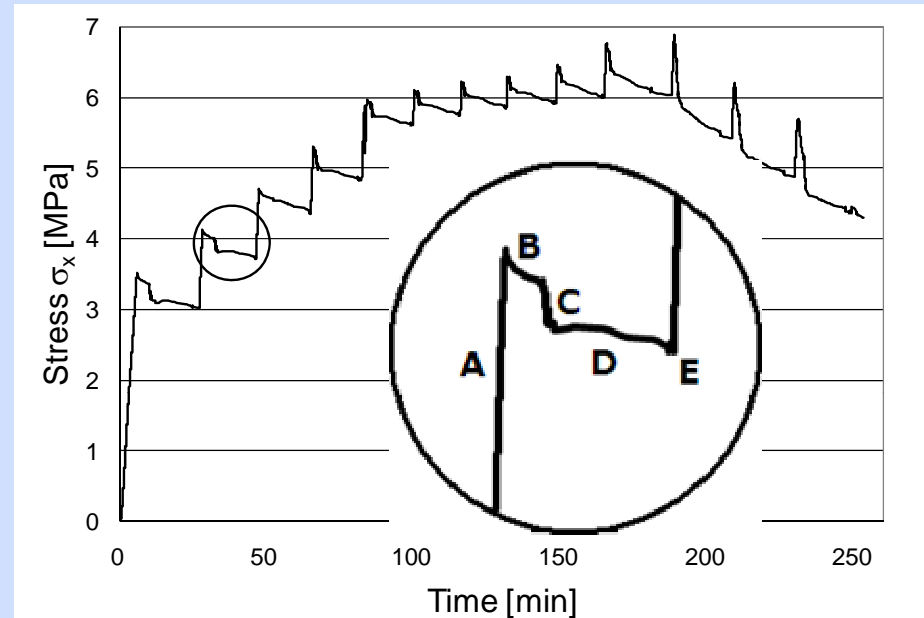
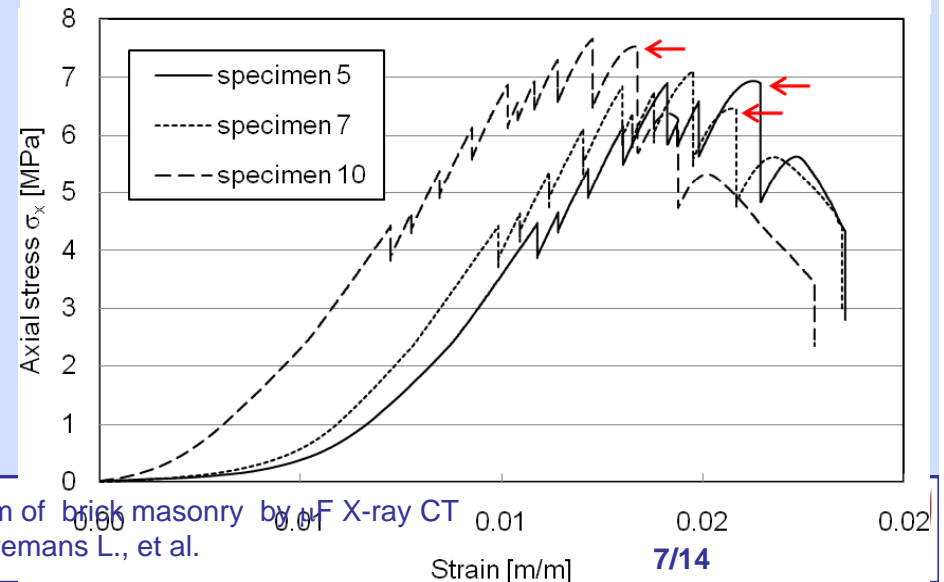
- Preliminary determination of compressive strength of specimens
- procedure in steps, rate-controlled but fixed at determined stress-levels
- each step has 5 stages
- data acquisition during stage D
- importance of relaxation after fixing the displacement during each step

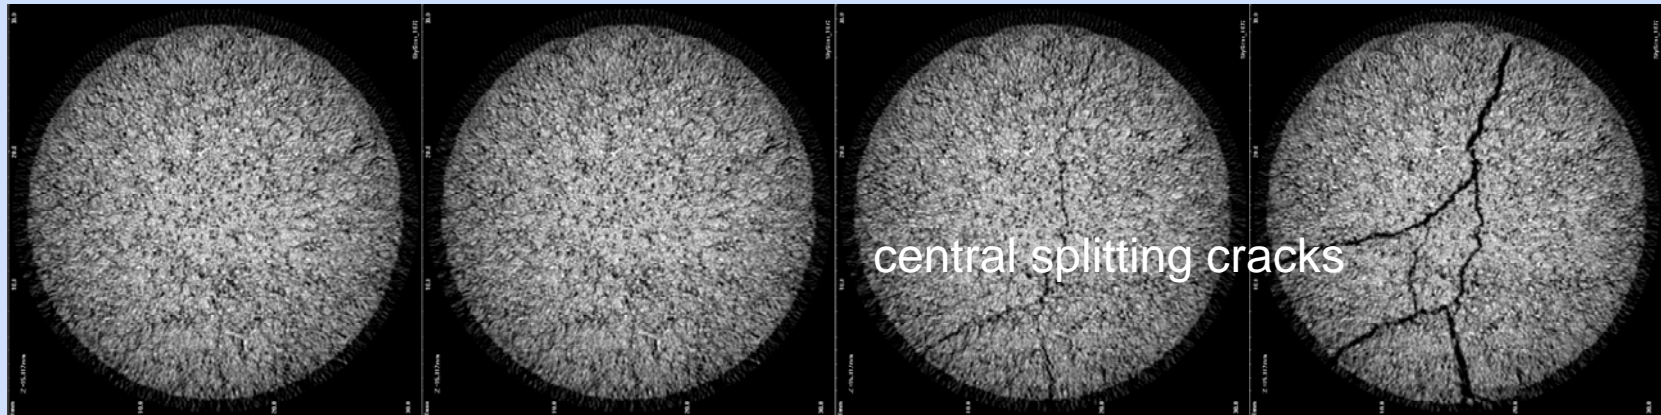
4 load steps in specimen with cement mortar: section through symmetry plane

First processed data consists of horizontal slices, that can be stacked to 3D images or vertical sections

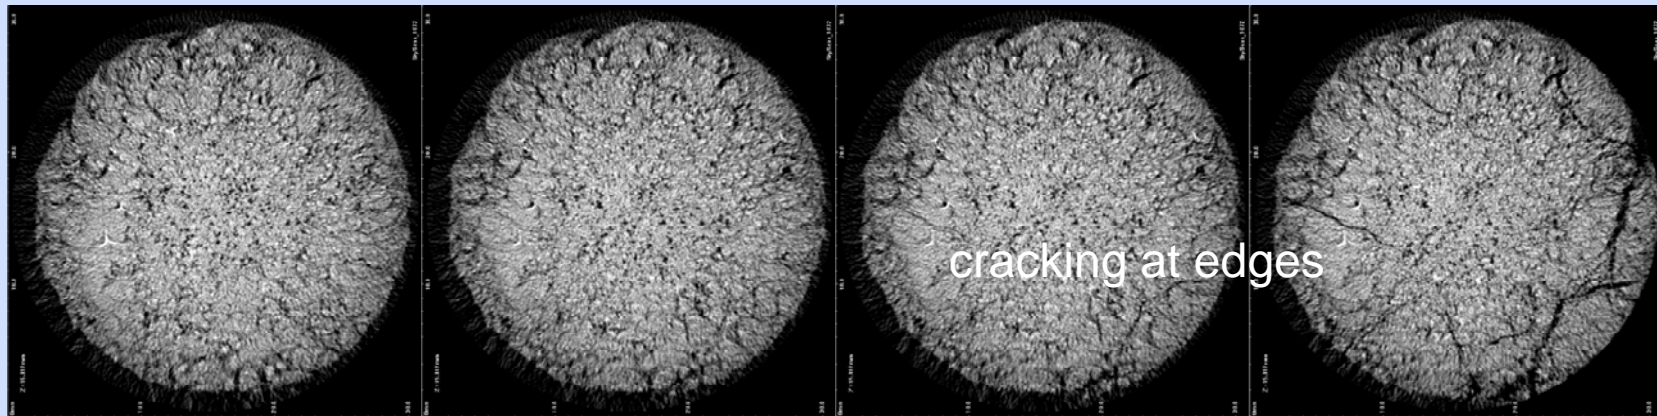
4 load steps in specimen with hydraulic lime mortar

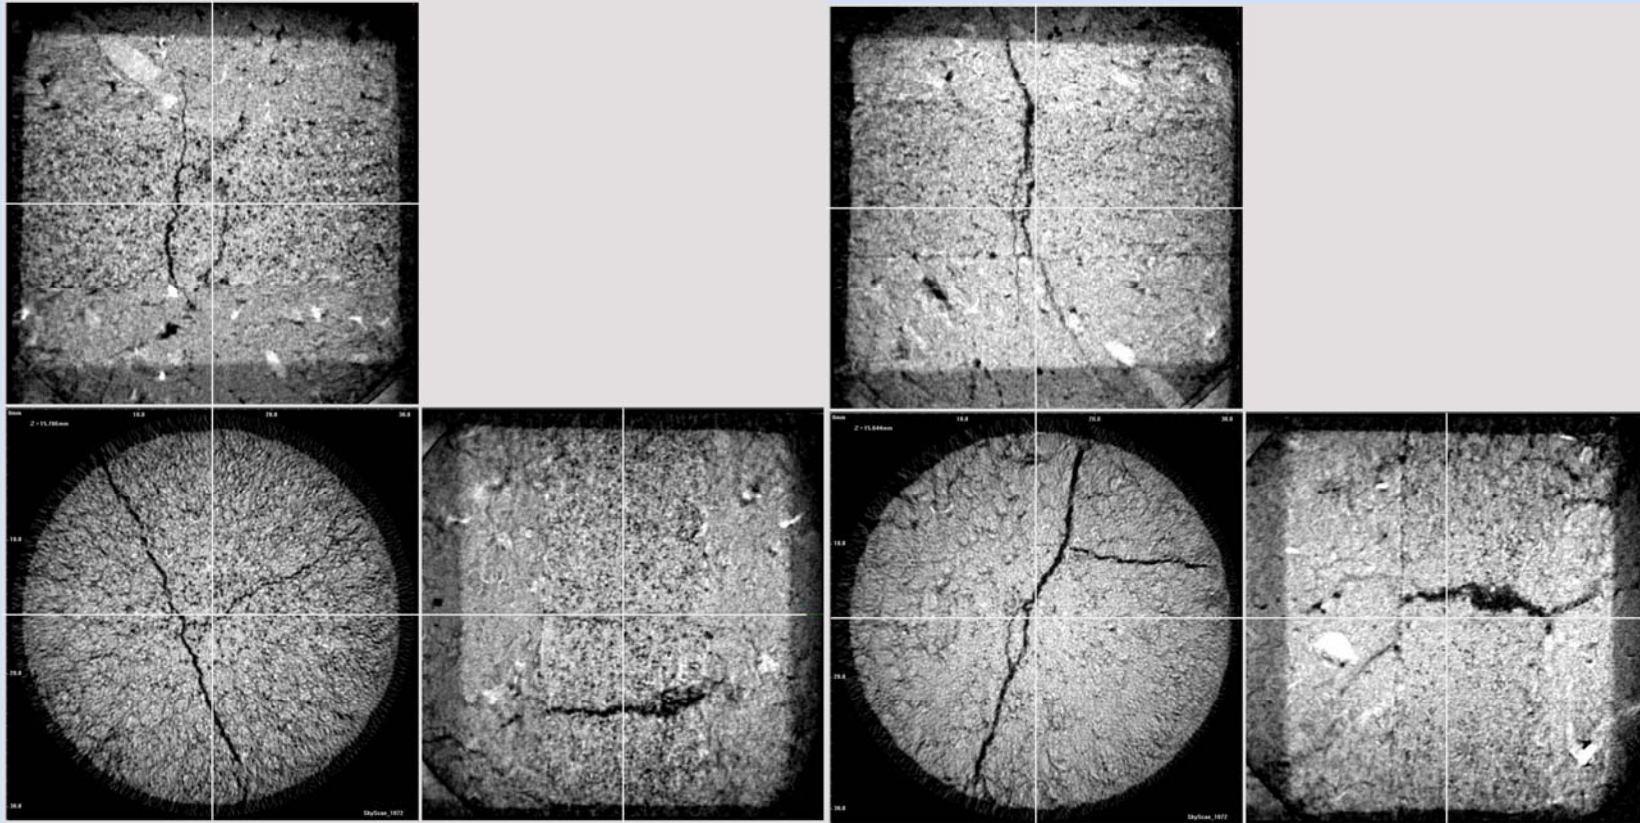
Stack of slices used to produce 3 orthogonal sections

Cement mortar specimen 7.

Lime-cement mortar specimen 6.

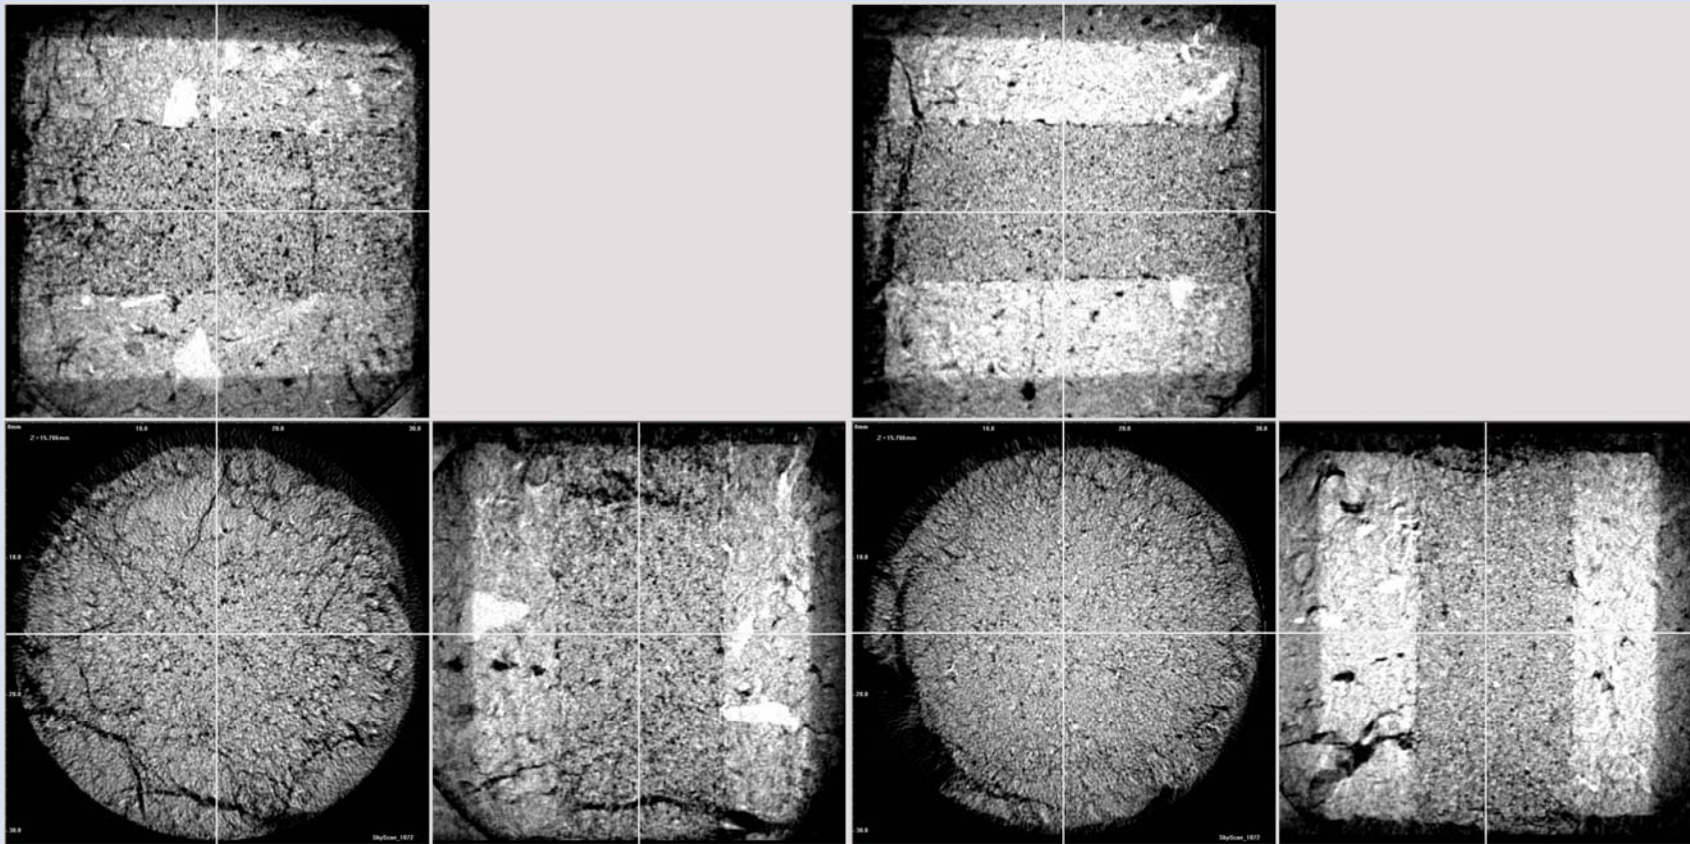
Hydraulic lime mortar specimen 7.

Uncarbonated lime hydrate mortar specimen 9.

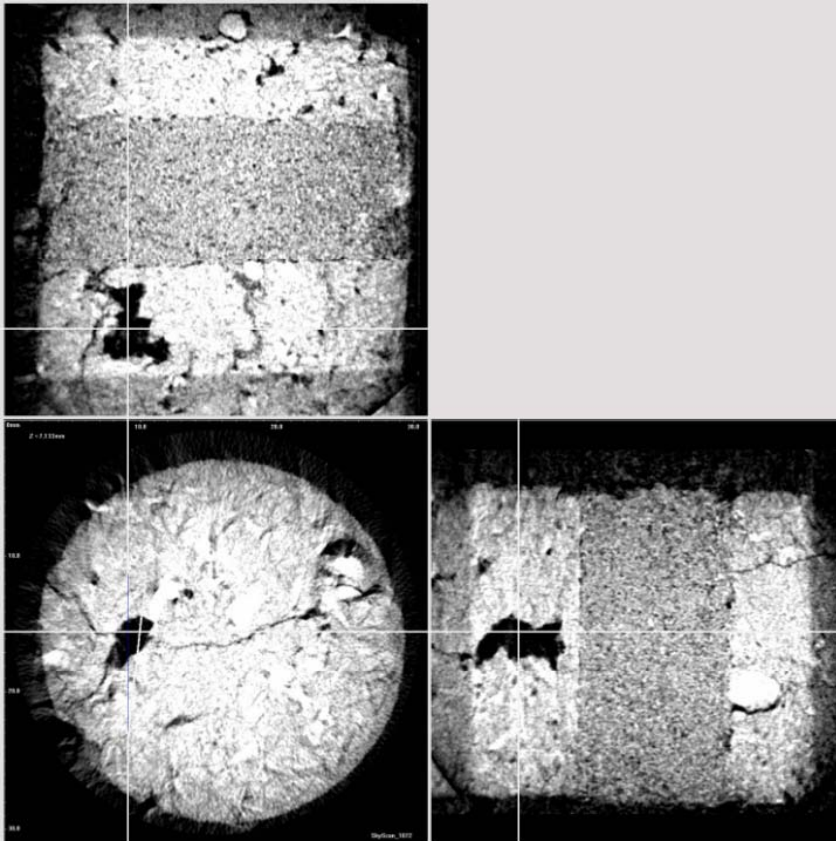
Carbonated lime hydrate mortar specimen 3.

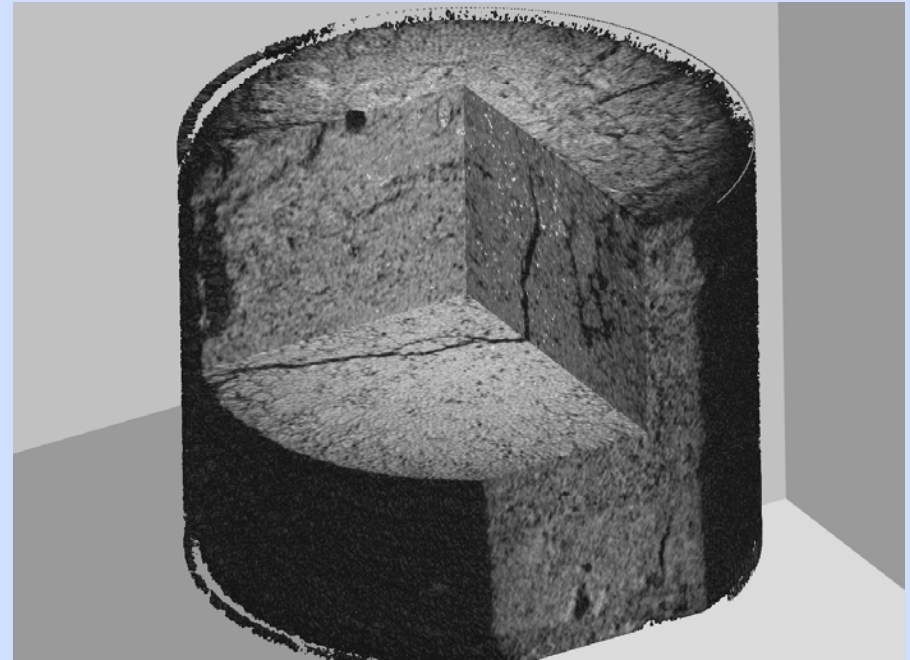
3D rendering of lime-cement mortar specimen 6.

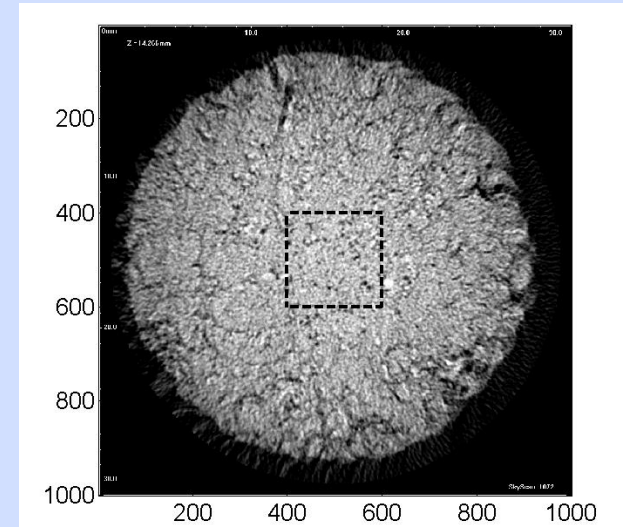
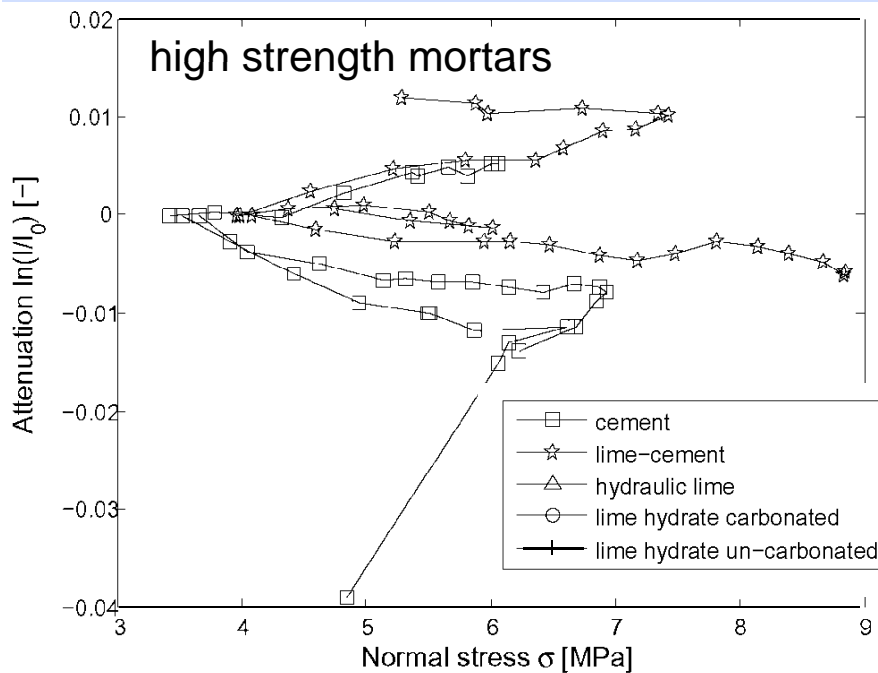
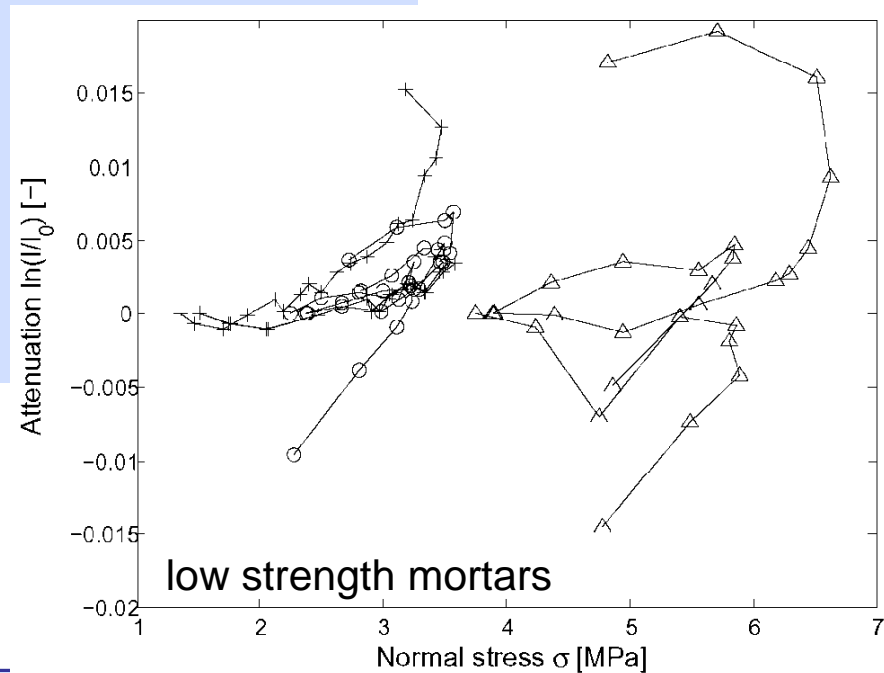
- Average value of attenuation in mortar taken from central area in the slice of the symmetry plane.
- Plotted as a function of increasing normal stress.
- Unclear evolution for the high strength mortars.
- Clear increase for uncarbonated lime mortar and hydraulic lime mortar, indicates compaction.
