Addressing the need for standardization of test methods for self-healing concrete: an inter-laboratory study on concrete with macrocapsules

Development and commercialization of self-healing concrete is hampered due to a lack of standardized test methods. Six inter-laboratory testing programs are being executed by the EU COST action SARCOS, each focusing on test methods for a specific self-healing technique. This paper reports on the comparison of tests for mortar and concrete specimens with polyurethane encapsulated in glass macrocapsules. First, the pre-cracking method was analysed: mortar specimens were cracked in a three-point bending test followed by an active crack width control technique to restrain the crack width up to a predefined value, while the concrete specimens were cracked in a three-point bending setup with a displacement-controlled loading system. Microscopic measurements showed that with the application of the active control technique almost all crack widths were within a narrow predefined range. Conversely, for the concrete specimens the variation on the crack width was higher. After pre-cracking, the self-healing effect was characterized via durability tests: t

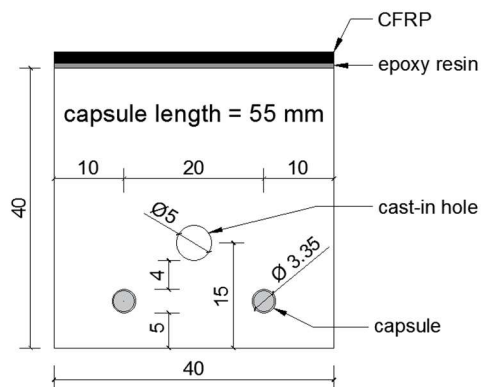
Fig. 3. Cross-section of mortar specimens with capsules (dimensions in mm).

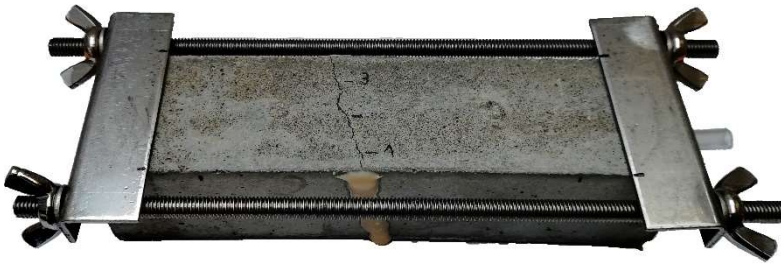
Fig. 4. Screw jacks used for actively restraining the crack width of a mortar specimen.

After cracking the mortar specimens, they were restrained using screw jacks. The final mean crack width w measured by all labs after the active crack width restraining process is given in Fig. 12. This figure shows the individual values, as well as the mean crack width of the series (horizontal lines) and the 95 % confidence interval on this mean (error bars) for both REF and CAPS specimens. The green shaded band indicates the desired crack width range (290-310 μm). Lab 3 and lab 4 did a pre-test on a separately sent batch of specimens to familiarize themselves with the test technique, these are denoted by lab 3* and lab 4*. The crack width of many of these specimens fell outside of the intended range. Additionally, the screw jacks were not applying a significant pressure on the specimens, because the crack width of these specimens was rather limited after crack creation by three-point bending. In the repeated test the crack was opened further so that the screw jacks were fulfilling their intended use of pushing the two halves of the specimens back together. As a consequence of the higher variation on the crack width in the pre-test, the water flow results were also inconsistent (see section 3.2.3). On top of this Lab 4* only had 4 instead of 6 REF specimens due to damage of one specimen during shipping and the uncharacteristic eccentric cracking of another specimen. Therefore, the

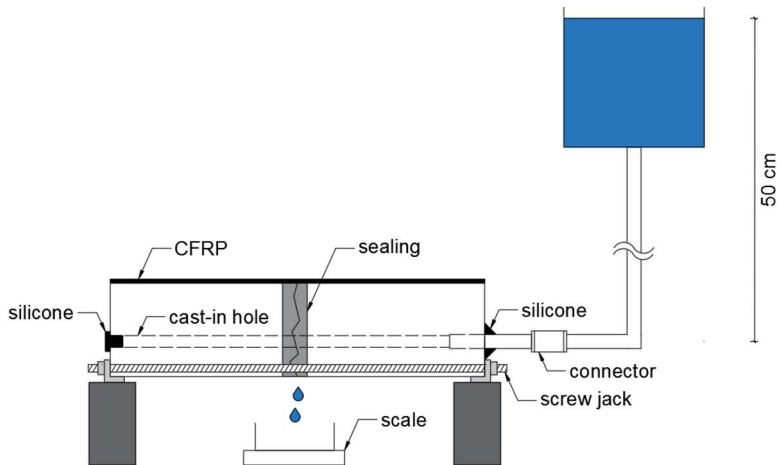
Fig. 5. Water permeability measured by a constant head water flow test [33].

To measure the water permeability of the specimens a water flow test was used [10, 33, 34, 44, 45]. Prior to executing the test, specimens were stored dry in an indoor climate with their crack facing downwards for at least 1 day to allow the PU to polymerize. Afterwards, specimens were submersed in demineralized water for 24 to 48 hours to prevent any influence on the results from water absorption by the matrix. The specimens were then taken out of the water and were surface dried. To connect the specimens to the water flow setup, the cast-in hole was enlarged on one side to a diameter of 6 mm over a length of 25 ± 5 mm using a drill. This was done prior to cracking to prevent the vibrations from influencing the crack. A short tube (length of ± 60 mm, $\text{Ø}_{\text{external}}$ 6 mm, $\text{Ø}_{\text{internal}}$ 4 mm) was then inserted in the cast-in hole and a watertight connection was ensured using silicone. The other side of the cast-in hole was sealed completely (e.g. with silicone or a rubber stopper), see Fig. 5. The inserted tube was connected to a tube (length of 130 ± 10 cm, $\text{Ø}_{\text{external}}$ 6 mm, $\text{Ø}_{\text{internal}}$ 4 mm) in contact with an open water reservoir. Instead of drilling and inserting a short tube, lab 4 used a plastic sleeve with a changing diameter so that on one side it could fit inside the cast-in hole and on the other side it could slide over the tube which connected with the water reservoir. The water head, measured from the cast-in hole in the specimens up to the water level, was kept constant

throughout the test at 50 ± 2 cm by topping up with demineralized water whenever required. Water from the reservoir flowed through the tubes into the cast-in hole, from where it could leak out of the specimens via the crack. Only the water leaking out of the crack mouth, i.e. the bottom side of the specimens, was considered. Therefore, the sides of the specimens were sealed prior to saturation by using aluminium tape, silicon sealant, or a viscous glue (e.g. viscous methyl methacrylate, see Fig. 4). The first 60 s that water was leaking from the crack were not recorded in order to measure only a fully developed flow and to allow water bubbles to be flushed from the system. Subsequently, the weight of the water which leaked from the crack was recorded for a minimum duration of 6 min.

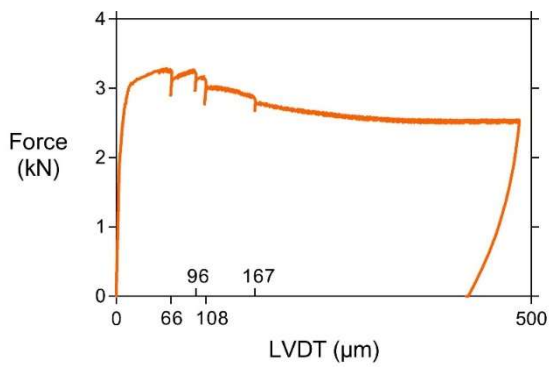
Fig. 6. Load displacement graph of a CAPS specimen showing capsule rupture at 66, 96, 108, and 167 μm .

From the data recorded during crack creation by three-point bending, controlled by using a displacement-controlled loading system, it was possible to plot load-displacement graphs. In the case of CAPS specimens, small drops in the load indicated the rupture of capsules. Fig. 6 shows the load displacement graph of a representative concrete specimen with 4 capsules. In the represented case the 4 capsules broke at: 66, 96, 108 and 167 μm of crack mouth opening. For some specimens it was not possible to discern a discrete load drop for all of the contained capsules. The reason for this could be noise on the data or simultaneous breaking of multiple capsules. It has been reported for the type of capsules used in this study that the crack width at rupture at the location of the capsule is approximately 25 μm [48]. This value was surpassed in all specimens; therefore, it can be assumed that all capsules inside of the concrete specimens ruptured.

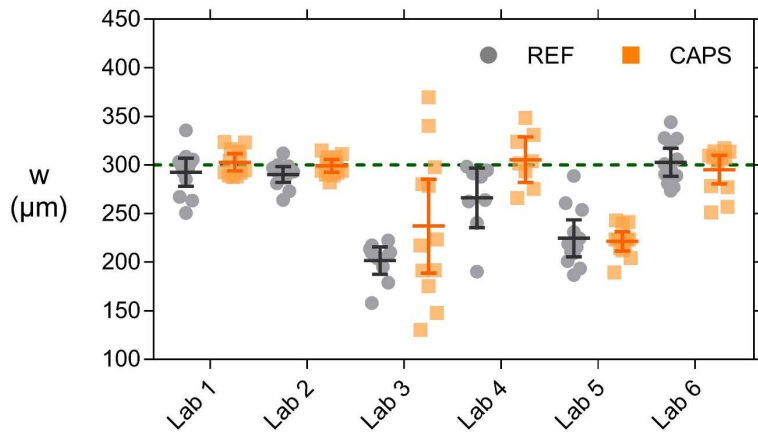
Fig. 7. Crack width w of individual concrete specimens for which the mean of the series are indicated by horizontal lines and error bars give the 95 % confidence interval on this mean. The horizontal dashed line indicates the target crack width of 300 μm .

After cracking, the crack width w at the bottom side of the concrete specimens was measured. Fig. 7 shows the individual mean crack width of each specimen, as well as the mean of the series (horizontal lines) and the 95 % confidence interval on this mean (error bars) for both REF and CAPS specimens. The horizontal dashed line indicates the target crack width of 300 μm . It is evident that there was quite some variation on the results, even though 2 minimal outliers (one of lab 3 REF and one of lab 4 REF) and 2

behaviour of cracked specimens in general. Looking at Table 6 and Fig. 7 it can be seen that the variation on the crack width of some series was rather large. It has been reported in literature that there is a linear relationship between the crack width and the sorption coefficient, although it has been indicated that the goodness of fit ($R^2 \approx 62\%$) is not very high as a result of the crack tortuosity which also has an influence [26]. The third and fourth explanations are operator sensitivity and imperfect waterproofing (e.g. caused by deficient adherence or creases in the aluminium tape). They might explain why the variation on the results for uncracked samples of lab 3, 4, 5 and 6 is more pronounced than the variation measured by lab 1 and 2. Operator sensitivity plays a role in all tests. Here specifically it might have manifested in the following aspects: the degree of moistness of the cloth to remove the excess water on the surface of the specimens prior to weighing, water which remained on the surface of the specimens or inside the notch during weighing as a result of a too fast execution, the height of the water level during the test, the frequency of water addition in the reservoir to compensate for the absorbed water, etc. This operator sensitivity can of course be expanded with random errors (e.g. differences in the height of the notches), systematic errors (e.g. accuracy of the scales) and different environmental factors (e.g. differences in temperature and relative humidity during the test or during oven drying). Some labs who removed the aluminium tape immediately after testing noted that the concrete was moist in certain areas away from the crack, such as at the edges of the specimens. Additionally, it was also reported that there was capillary water uptake between two layers of tape, depending on how the aluminium tape was folded at the edges.

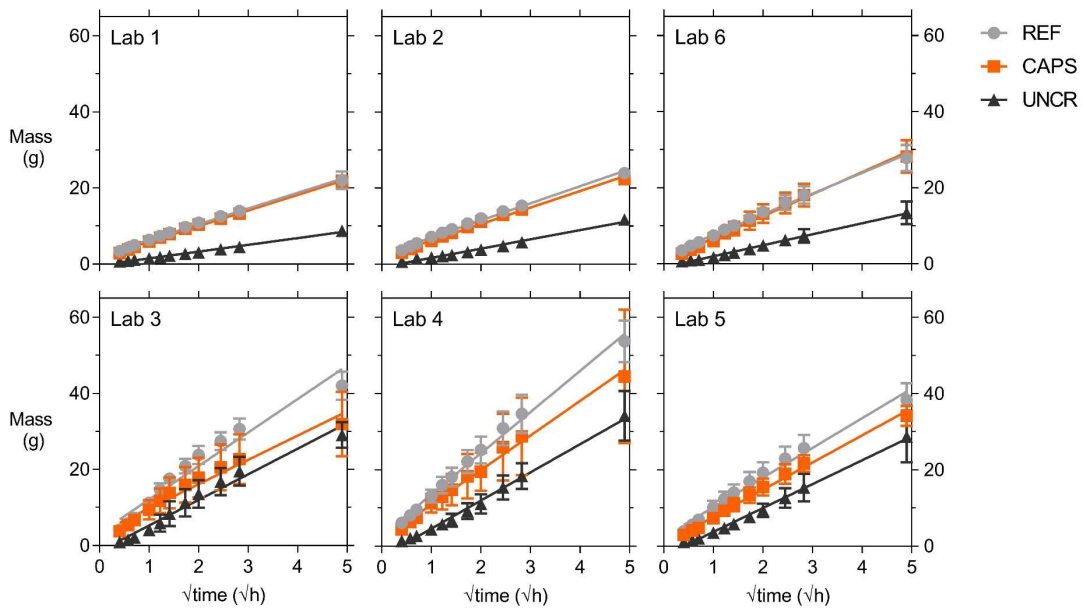
Fig. 8. Cumulative mass gain versus the square root of time of REF, CAPS and UNCR specimens (waterproofed with aluminium tape) of all 6 labs with the linear regression line. Error bars indicate the standard deviation.

the specimens was determined. The limited size of the specimens allowed for an easy and manageable handling of the specimens, as opposed to larger and heavier concrete specimens reported in literature [49]. Fig. 8 shows the average cumulative mass gain plotted versus the square root of time for the specimens of all 6 labs. In the case of the cracked series (REF and CAPS), the average was calculated using the results of 8-12 specimens, see Table 5. For the uncracked series (UNCR) the results of 3 specimens were used. The water ingress in the uncracked specimens of lab 5 might have been slightly different as these specimens were not provided with a notch. For lab 1 the exposed area with a width of 14 mm centred around the crack was also enforced on the sides of the specimens and not only on the bottom as was the case for the other labs, except lab 4 for which this was also not done. For lab 4 the exposed area was equal to the width of the notch (on average 4 mm), both on the bottom and side surfaces. Without the lateral water proofing water will also have entered into the concrete from the sides, but this effect will not have been dominant since lab 1, 2 and 6 show a similar behaviour.

In order to calculate the sealing efficiency according to equation 1, the slope of the linear regression curve was determined both for waterproofing with aluminium tape and again for waterproofing with coating. It was noted that for nearly all cracked specimens the value after 24 hours of water contact fell below the regression curve, which was also the case when the specimens were waterproofed with aluminium tape (see Fig.

8). In contrast, the uncracked specimens showed an opposite behaviour; the measurement after 24 hours was slightly above the linear regression curve (except for the specimens of lab 3). Upon a closer examination of the results for waterproofing with aluminium tape and also for waterproofing with coating, it appeared that there was a transition around 6 hours for the cracked specimens at which the slope slightly decreased. This might have been the result of saturation of the concrete at the top of the specimens. When cracked specimens are placed in contact with water, the cracks fill up with water almost **instantly**, as has been studied by neutron imaging and X-ray radiography on mortar samples [27, 50, 51]. This allows for a fast transport of water to the concrete above the crack tip. The amount of concrete at the tip of the crack (i.e. at the top of the specimen) is much more limited than the amount of concrete at the crack walls and near the crack mouth, meaning that it will be saturated faster, after which the driving absorption force will decrease. The transition was taken into account by determining 2 sorption coefficients in addition to the standard sorption coefficient prescribed by EN 13057 from 10 min of water contact to 24 hours of water contact (SC_{0-24}). The first additional sorption coefficient was determined from 10 min of water contact to 6 hours of water contact (SC_{0-6}), and the second sorption coefficient was determined from 6 hours of water contact to 24 hours of water contact (SC_{6-24}). The determination of a sorption coefficient up to 6 hours is also prescribed by ASTM C1585 for uncracked concrete (as mentioned previously), although this standard requires the second sorption coefficient to be determined between 1 day and 8 days. Recent research has highlighted that the water uptake in an uncracked cementitious matrix shows a more linear behaviour when plotted against the fourth root of time [52, 53]. However, this did not give a satisfactory result for the cracked specimens. For the sake of consistency, the sorption coefficient of the uncracked specimens was calculated with regard to the square root of time.

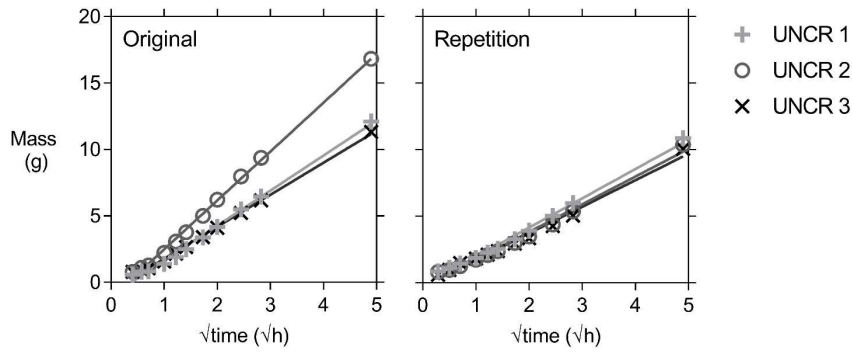
Fig. 9. Comparison of the cumulative mass gain versus the square root of time for the uncracked specimens of lab 6 with the individual linear regression lines, showing a more uniform behaviour for the repeated waterproofing with aluminium tape compared to the original waterproofing with aluminium tape.

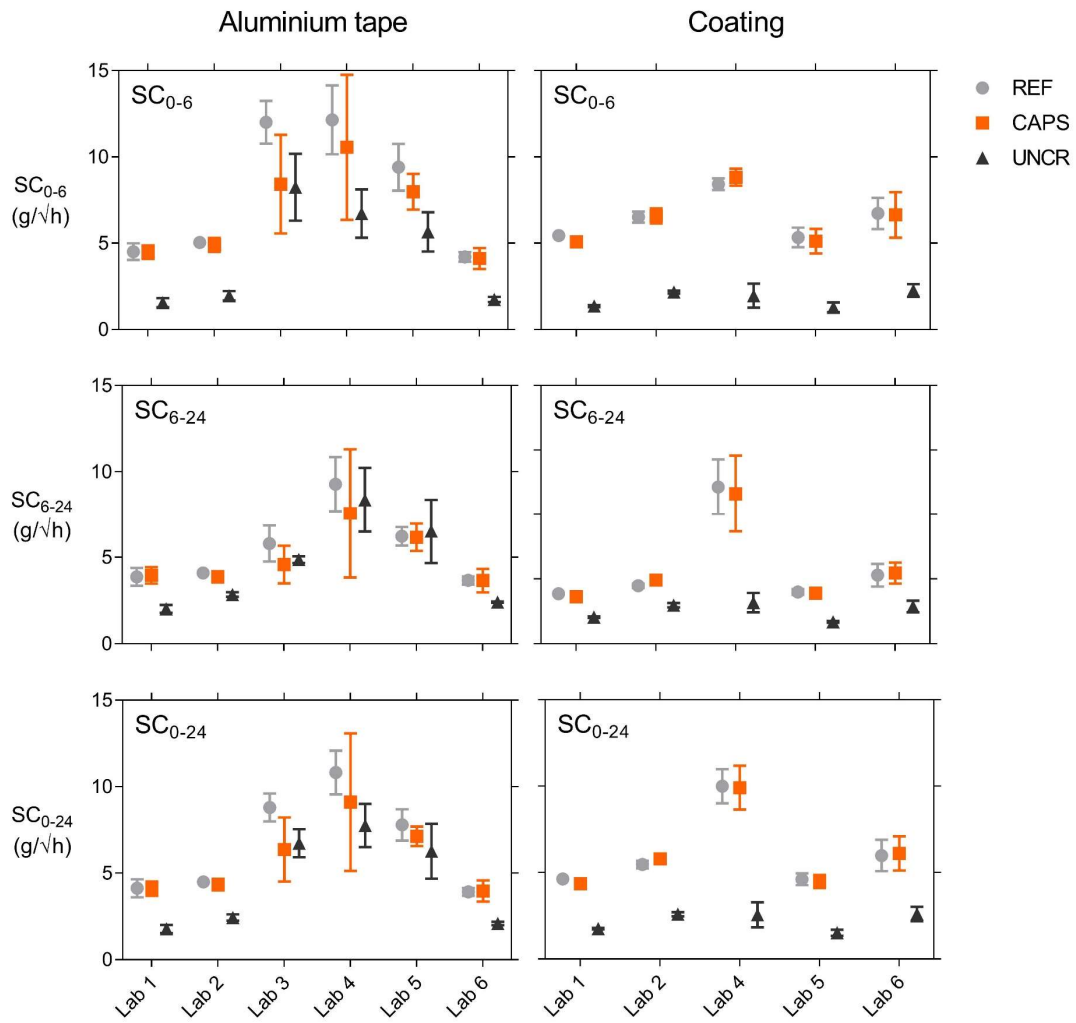
Fig. 10. Sorption coefficients SC_{0-6} , SC_{6-24} and SC_{0-24} of REF, CAPS and UNCR specimens highlighting that an improved waterproofing quality results in more homogenous results. Error bars indicate the standard deviation.

Fig. 10 gives a comparison of the three sorption coefficients, SC_{0-6} , SC_{6-24} and SC_{0-24} , in the case of waterproofing with aluminium tape and in the case of coating. The results with aluminium tape for lab 6 are the ones from the repeated test after removing and applying new aluminium tape. For the cracked specimens (REF and CAPS) it was clear that SC_{6-24} is lower than SC_{0-6} . As explained before, this was a result of the saturation of the concrete above the crack tip. All sets of specimens tested by the different labs exhibited this behaviour, but it was distinctly visible for labs 3, 4 and 5. On the other hand the sorption coefficient of the second period SC_{6-24} of the uncracked specimens is higher than the one of the initial period SC_{0-6} , as can for example be seen for the uncracked specimens of lab 5 with aluminium tape which gave a SC_{6-24} equal to that of the cracked specimens. While this was true for all labs, the large difference observed in lab 5 could have originated from an imperfect sealing of one of the specimens which led to an increase of the SC . The difference is less pronounced for the coated repetition. The uncracked specimens with aluminium tape of lab 3 were an exception to this observation that SC_{6-24} is higher than SC_{0-6} . Many of these specimens, also the cracked ones, had a jump in their cumulative mass gain between 1 h 30 min and 2 h. This was the result of excessive water addition in the reservoir to compensate for the drop in water level due to absorption and evaporation. Overall, looking at the results with aluminium tape, the same conclusions can be drawn as for the results in Fig. 8: lab 1, 2 and 6 obtained similar results, the results of lab 3, 4 and 5 were significantly higher and also had a higher variation, which in some cases was not explained by a higher mean value.

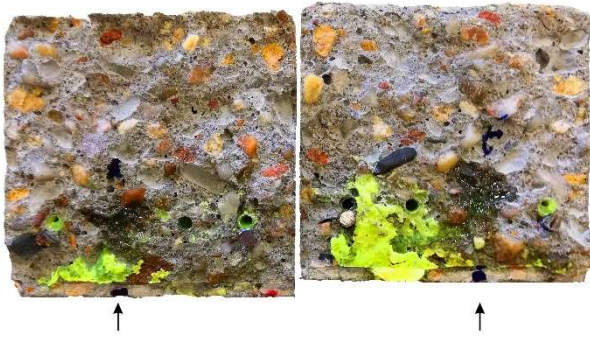
Fig. 11. Crack surfaces (60 x 60 mm²) of one of the best performing CAPS specimen of lab 1. The hardened PU can be seen as fluorescent yellow. Arrows indicate the capsule from which fresh PU (visible as a dark stain) leaked on the surface when the specimen was broken. Image is highly saturated to improve visibility.

The sealing efficiency SE was calculated for each lab three times using either SC_{0-6} , SC_{6-24} or SC_{0-24} , all determined from the results of the coated samples. All labs obtained a nearly negligible sealing efficiency (< 14 %). To investigate the poor sealing efficiency, some specimens with capsules were opened completely. Fig. 11 shows the crack surfaces of one of the best performing specimens of lab 1. The PU which was hardened and present in the crack at the moment of capillary water absorption testing is clearly visible as fluorescent yellow. The PU outflow from some of the capsules appears

to have been limited, explaining the low sealing efficiency. For the displayed specimen the crack mouth was not completely filled with PU. When splitting the specimens to investigate the crack surfaces, some fresh PU leaked onto the crack walls, seen as dark stains on Fig. 11. This indicates that after cracking a minor amount of PU leaked into the crack and polymerised, thereby resealing the broken capsules and preventing the slightly reacted PU inside the capsules from polymerising completely. When splitting the specimens, this PU plug failed. The PU that was still in the capsules was pushed out as a result of the trapped CO₂ inside the capsule, formed by the initial incomplete polymerisation reaction. The sealing of the capsules used in this study was done using epoxy, instead of methyl methacrylate as was done in previous studies [25, 26, 28, 30, 32]. A comparison of these two techniques pointed out that the PU inside capsules sealed with methyl methacrylate undergoes to some extent an initial polymerisation reaction prior to cracking which pressurizes the capsules with CO₂. As a consequence, the PU is pushed out at the moment that the capsule breaks. In the case of capsules sealed with epoxy, the rate of the initial polymerisation reaction is significantly lower. This might be the result of a better sealing of the capsule, since epoxy is less permeable to gas and moisture than methyl methacrylate (although it should be noted that the permeability is amongst others also dependent on the thickness). Consequently, the PU inside the capsules sealed with epoxy in this study was not pressurised at the moment of cracking the specimens, explaining the low outflow of PU in the cracks.

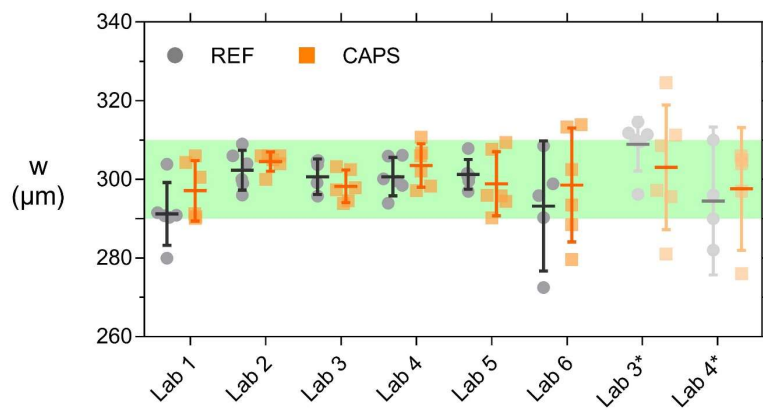
Fig. 12. Crack width w of individual mortar specimens for which the mean of the series is indicated by a horizontal line and error bars give the 95 % confidence interval on this mean. Most mortar specimens had a crack width w within the desired crack width range (shaded area).

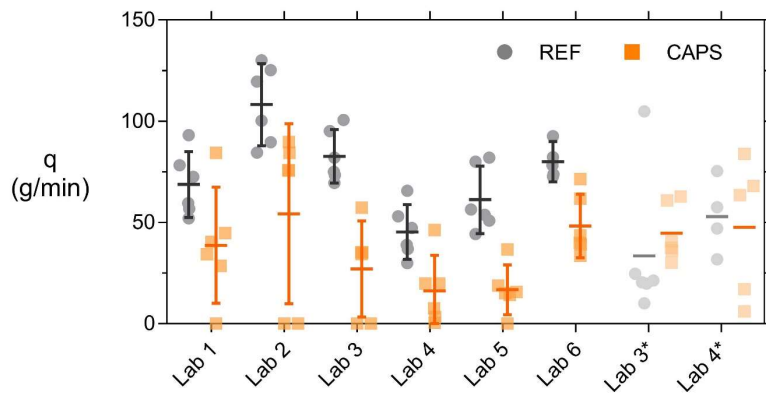
Fig. 13. Individual flow rates q and the means of the different specimen batches indicated by horizontal lines. Error bars give the 95 % confidence interval on the mean.

Following the active crack control of the specimens and the subsequent submersion, the specimens were subjected to a water flow test (see section 2.3.3). Fig. 13 shows the water flow q (g/min) leaking from the samples during the test. The results of lab 3* and 4* were inconsistent with the rest of the results, as already mentioned in section 3.2.2. For example, for lab 3* one of the REF specimens obtained a flow more than 4 times higher than the second largest flow within that series. For lab 4* the coefficient of variation on the REF values was higher than for any other lab (excluding lab 3*; $COV_{la\ 4*} = 34.5\%$). Additionally, the CAPS flow value of lab 3* and 4* was uncharacteristically high in comparison with the REF flow value – for lab 3 the flow was even higher for the CAPS specimens than for the REF specimens. These inconsistent results can be explained by the high variation on the crack widths and the fact that the screw jacks were not actively controlling the crack due to a limited crack opening when the specimens were removed from of the loading setup. Similar as for section 3.2.2, these results will not be taken into account in the further discussion.

Looking at the results of the REF specimens in Fig. 13, the same conclusions can be drawn as for the statistical analysis. Lab 2 has the highest flow rate and its confidence interval overlaps with that of labs 3 and 6. Lab 4 has the lowest flow rate and has overlap with labs 1 and 5. It should be noted that, unlike all other labs, lab 4 did not keep the water head constant. As a result, the driving force decreased over time. For the specimen with the largest flow, the water drop at the end of the test was about 14 % with respect to the prescribed water head of 50 cm. This partly explains the somewhat lower results of lab 4. Even though not all labs obtained a (REF) flow which was statistically equal, the results have the same order of magnitude and are as such comparable, which is a significant improvement compared to a previous Round Robin Test [44].

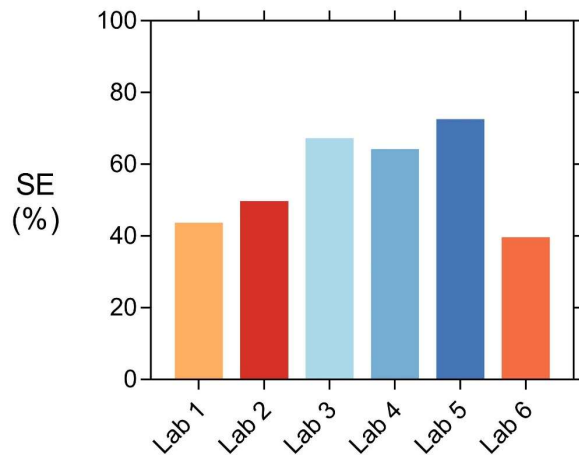
Fig. 14. The sealing efficiency SE_{flow} measured in the different labs.

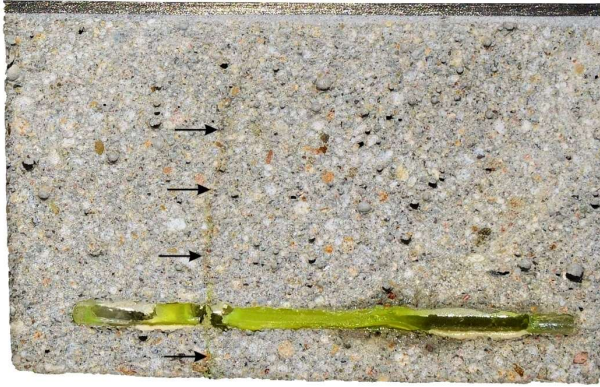
Fig. 15. Mortar specimen with mortar removed from the side up to the location of a capsule (length approximately 55 mm) showing that most of the PU was retained in the capsule. Arrows indicate the location of the crack.

overall the results of all labs point in the same direction; the sealing efficiency is promising but definitely not perfect. This imperfect sealing of the cracks has the same reason as for the concrete specimens: an insufficient leakage of PU into the crack. This is demonstrated by Fig. 15 which shows a mortar specimen with the mortar removed up to the position of a capsule. It is clear that only part of the PU leaked into the crack, the other part polymerised inside of the capsule.

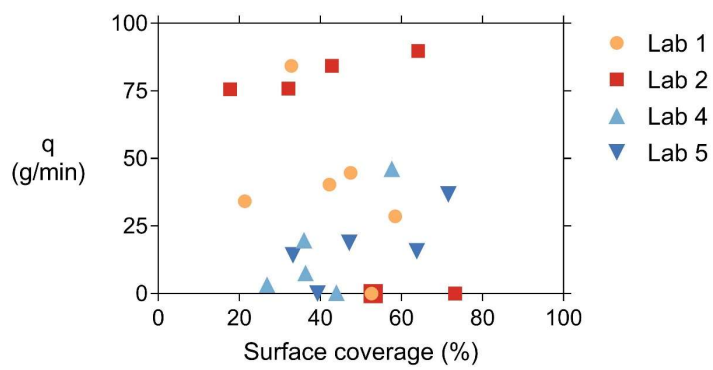
Fig. 16. Water flow q versus the PU surface coverage for labs 1, 2, 4 and 5.

From Fig. 16 it could also be concluded that a high surface coverage does not directly translate into a good sealing efficiency. There seems to be no strong relationship between the surface coverage and the water flow. Indeed, the surface coverage only has an indirect influence on the water flow. Fig. 17 shows a crack surface overlaid with its filtered segmented image determined using the Trainable Weka Segmentation plugin in ImageJ, see section 2.3.4. The surface coverage of this sample was one of the highest (71.6 %), yet the zone below the hole was not completely covered with PU, leaving a path for the water to leak out of the specimen. To seal a crack, it is sufficient if the crack mouth is filled with healing agent, or in the studied specimens if the water-inducing hole is surrounded with healing agent. For many specimens it was noted that the PU spread regions from the individual capsules did not connect, and thus a barrier to withstand the water pressure could not be created.

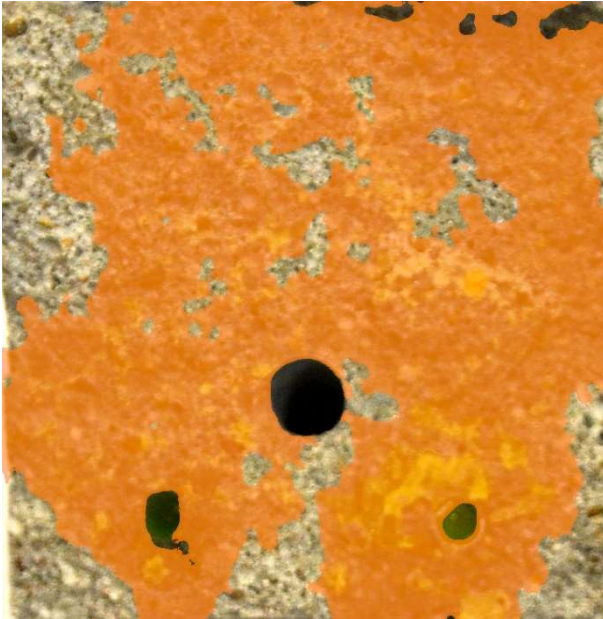
Fig. 17. Crack surface (40 x 40 mm²) of one of the specimens with the best PU surface coverage but still a significant flow due to an unconnected crack filling below the cast-in hole (through which water was induced during the permeability test). The crack mouth through which water leaked out of the specimen is oriented to the bottom, like in the water flow test.

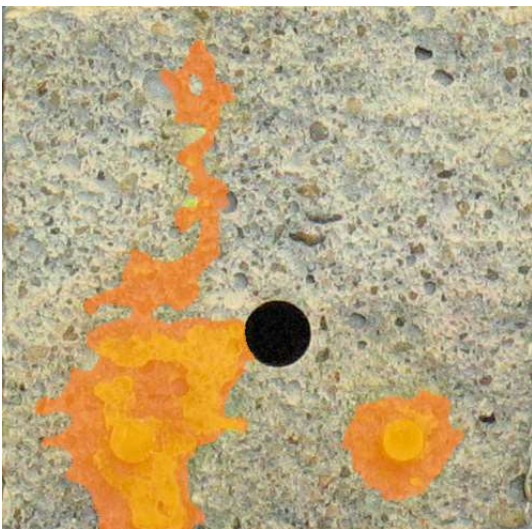
Fig. 18. Crack surface (40 x 40 mm²) of specimen with limited PU surface coverage.

The crack mouth through which water leaked out of the specimen is oriented to the bottom, like in the water flow test.
