# **Treatment with nano-silica and bacteria to restore the reduced bond strength between concrete and repair mortar caused by aggressive removal techniques**

Removal of degraded concrete during repair activities might have a detrimental impact on the bond strength between the concrete and the repair mortar. This research aims to improve the bonding strength in case aggressive removal techniques were used, by the singular and combined application of bacterially induced CaCO<sub>3</sub> and colloidal nano-silica (CNS) treatments. Water jetting (WJ) and jackhammering (JH) were compared and the treatments were performed on the substrates prepared with the technique causing the lowest bonding. Pull-off test results on crushed stone concrete (CC) substrates showed that JH substrates possessed the lowest bond strength compared to WJ and unprepared substrates. To assure that reported results are reproducible, pull-off tests were also performed on another type of concrete, gravel concrete (GC). The results showed that in both cases JH-substrates achieved a lower bond strength than unprepared- and WJ-substrates. The reduced bond strength by JH was restored by the CNS treatment irrespective

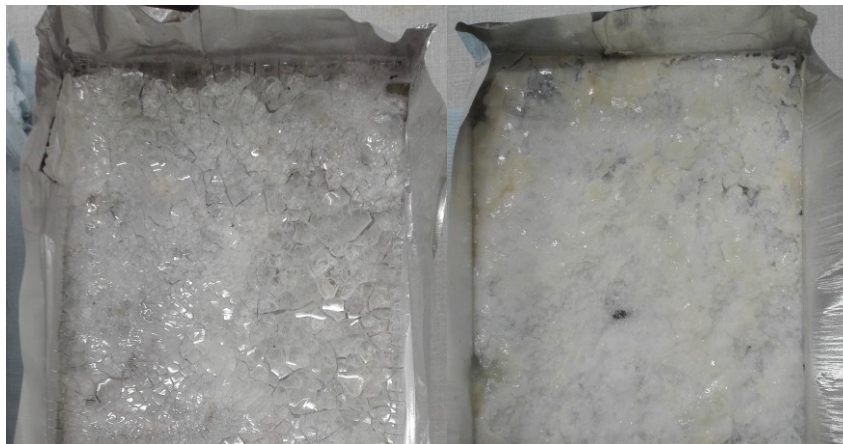
**Figure 1.** The plan view of dry silica gel layer for samples treated with CNS (left) and the combined application (right).

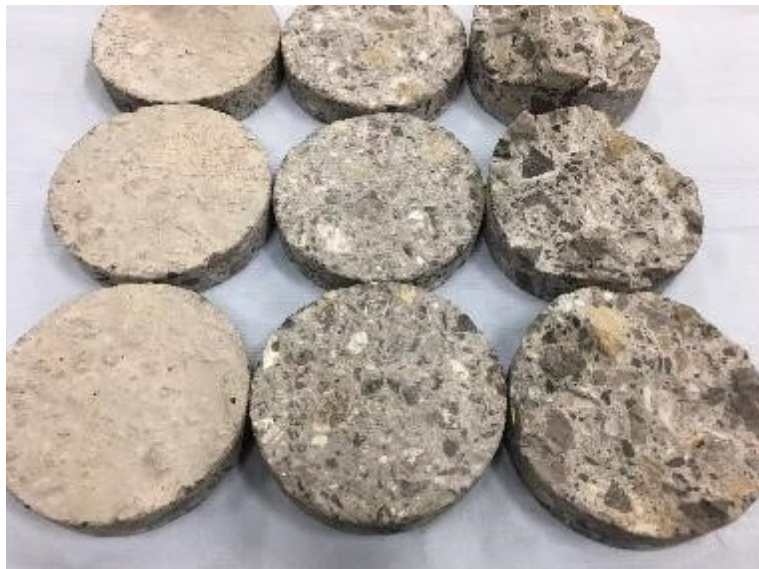
**Figure 2.** Prepared thin samples of CC for vacuum absorption test.

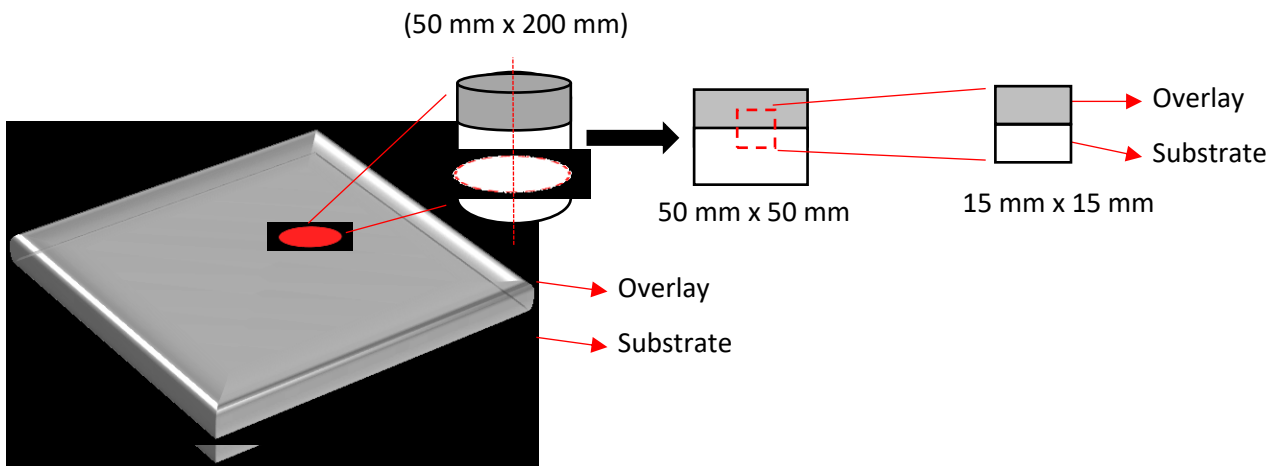
**Figure 3.** Schematic view of the slab (330 mm x 330 mm x 200±5 mm) and the preparation of the interface for the SEM-EDX analysis. Dashed lines show the cut line.

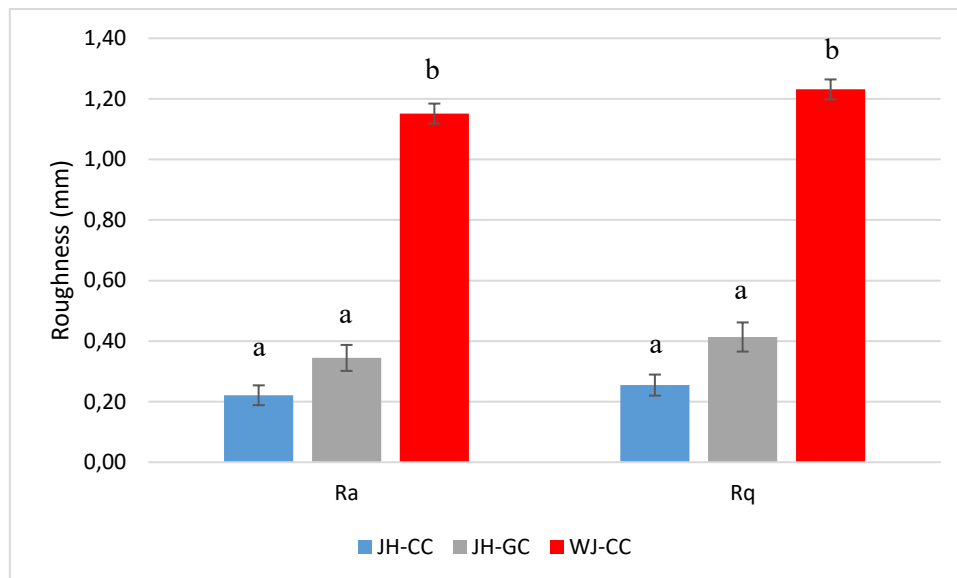
**Figure 4.** Roughness of CC and JH-GC substrates after concrete removal. Error bars represent the standard error. Means with the same letter indication are not significantly different.  $R_a$  is the centre-line roughness value and  $R_q$  is the root-mean-square roughness value.

Figure 4 presents the roughness created at the substrate surface by each removal technique. A similar trend is observed for both the  $R_a$  (the arithmetic average deviation of the absolute values of the profile heights from the centre line) and the  $R_q$  (the root-mean-square roughness value). Results shown in the Figure are the average values of the ALM measurements in X and Y direction achieved from two samples per concrete composition and surface treatment. According to Figure 4, WJ led to a much larger roughness compared to JH. This has also been reported in other publications [1, 2]. Yazdi et al. [1] reported the importance of the test method to compare the surface roughness of concrete mixtures exposed to concrete removal techniques such as water jetting or jackhammering. It was found that the sand patch test in comparison with the ALM test was not accurate enough to show the difference between the surface roughness of the studied mixtures exposed to gritblasting, WJ and JH techniques. Based on the statistical analysis, the difference in the roughness caused by different removal techniques is significant. However, when the JH-CC is compared with the JH-GC an insignificant difference is observed. There is a misconception over the influence of roughness on the pull-off test results. Although, it might be in general expected that surface roughness will improve the bond strength, some publications [1, 4, 36] have reported the ineffective role of surface roughness on the tensile bond strength. The authors think that the influence of roughness is highly dependent on the state of stress applied during the bond experiment. Further explanation in this regard is given in section 3.4.

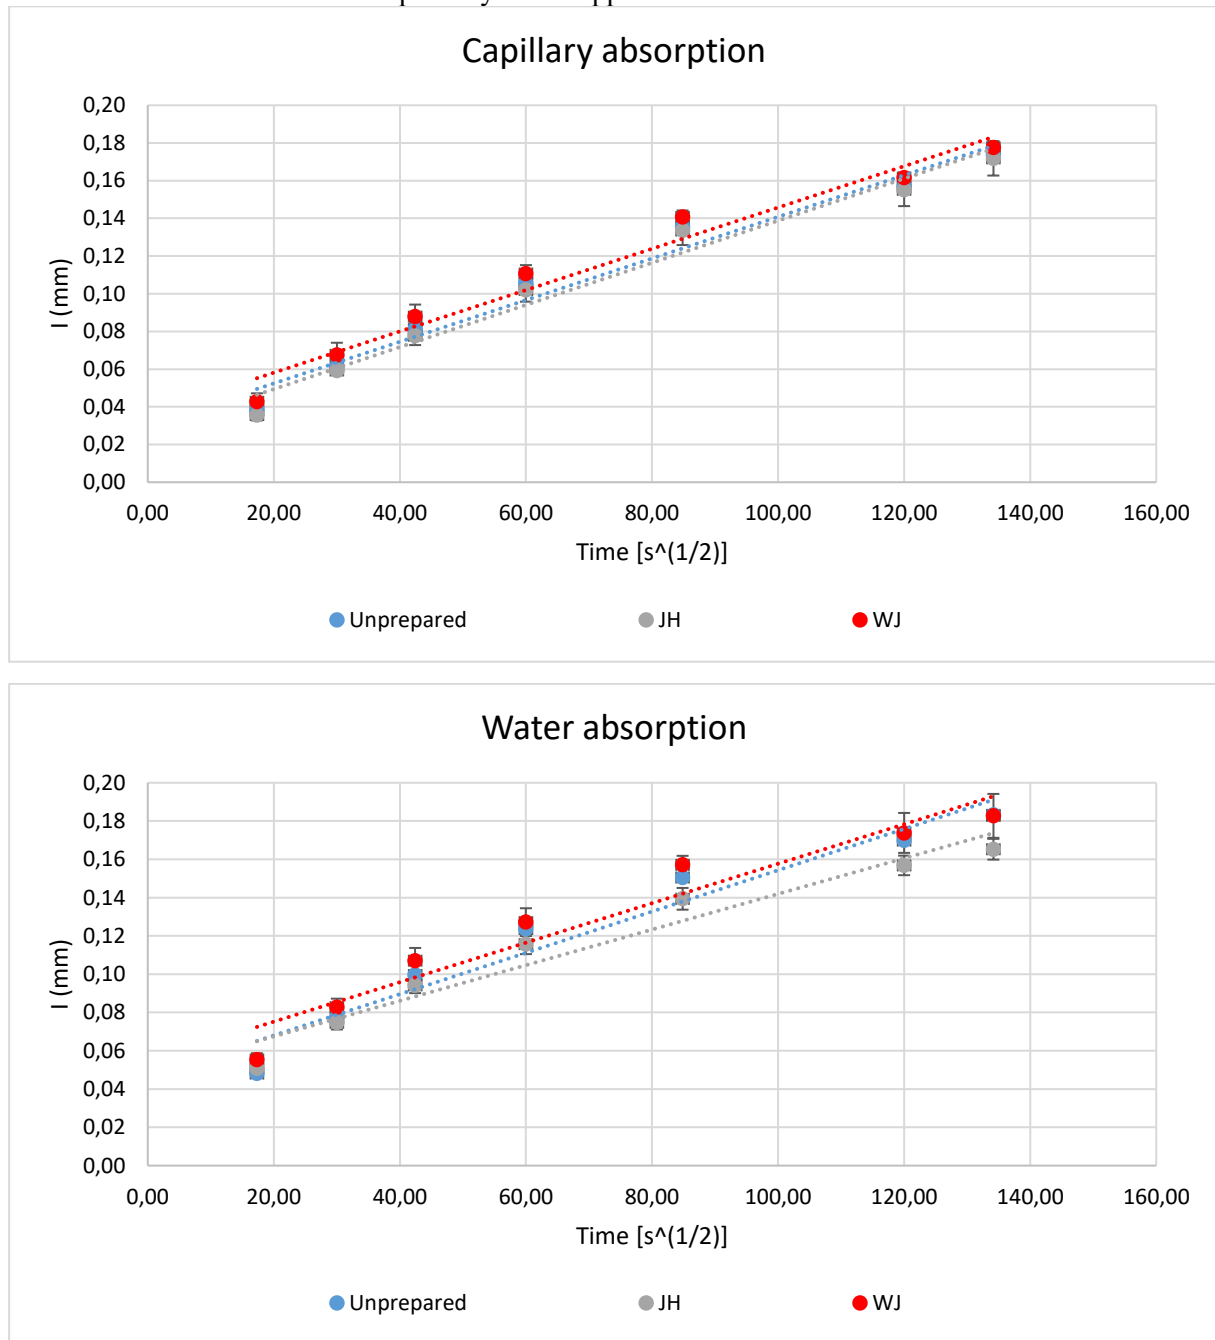
**Figure 5.** Capillary and water absorption of CC substrates. Error bars represent the standard error.

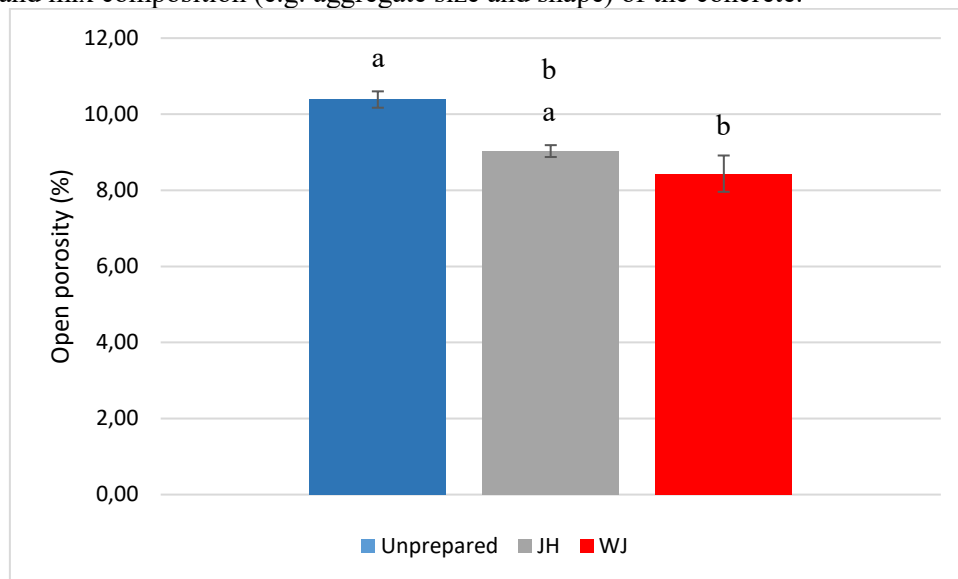
**Figure 6.** Open porosity of CC substrates. Error bars represent the standard error. Means with the same letter indication are not significantly different.

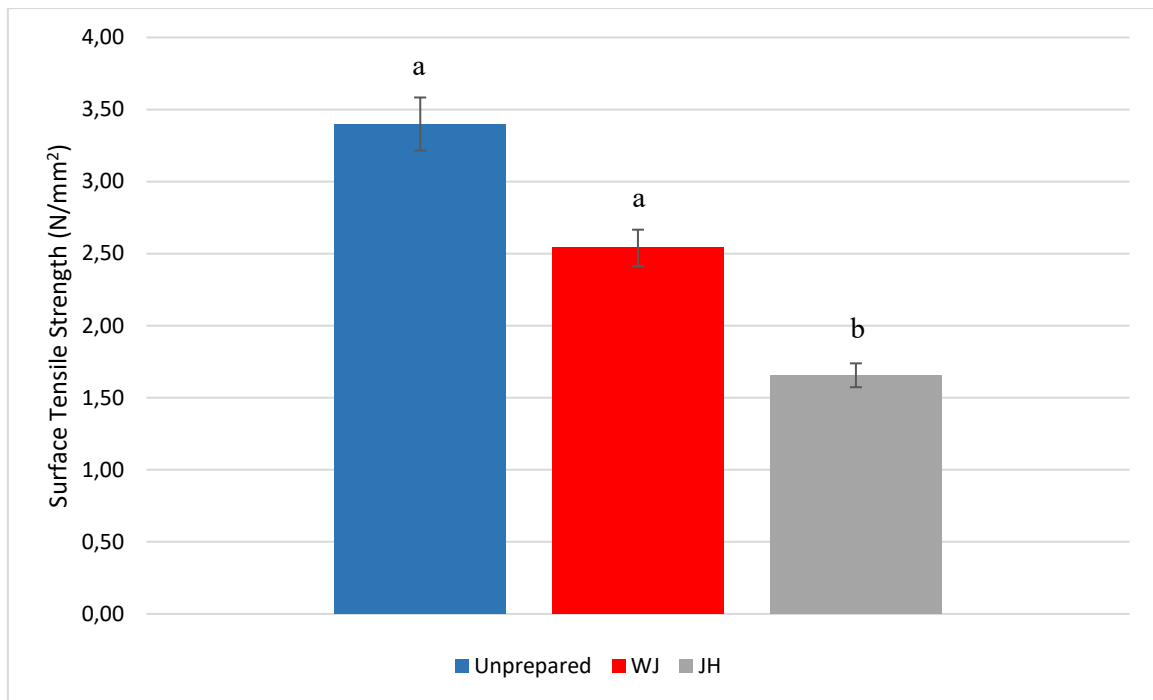
**Figure 7.** Surface tensile strength results of CC samples. Error bars represent the standard error. Means with the same letter indication are not significantly different.

Figure 7 expresses that the highest average value of the surface tensile strength (STS) was obtained when the sample was not exposed to any removal technique. WJ and JH samples achieved lower STS compared to unprepared samples. Statistical analysis indicates the insignificant difference between the STS of unprepared and WJ samples. However, the difference between JH and WJ or the unprepared sample was significant. The reduction in the STS of JH samples has been reported in other publications [1, 3] and is attributed to the microcracks created during the removal. Figure 8 shows an example of failure modes for different samples under STS testing. For JH substrates, 100% of the failures occurred at the superficial layer (an example is shown in Figure 8), this number is 20% for WJ samples. Failures in the unprepared slab were quite similar to WJ. What differentiates the failure modes of WJ and JH from each other is the fact that for the former (WJ), failures are mainly irregular and occur at the interfacial transition zone (ITZ) between aggregates and binder. It is also the same for samples with an unprepared surface. However, JH failures are at the subsurface of the substrate in the aggregates and binder damaged during the JH. Yazdi et al. [1], claimed that the irregularity in the failure mode is dependent on the aggregate size apart from the removal technique. The results of this section confirm the necessity of studying the STS of concrete substrates after application of removal techniques as it clearly shows the impact of the removal techniques on the old concrete.

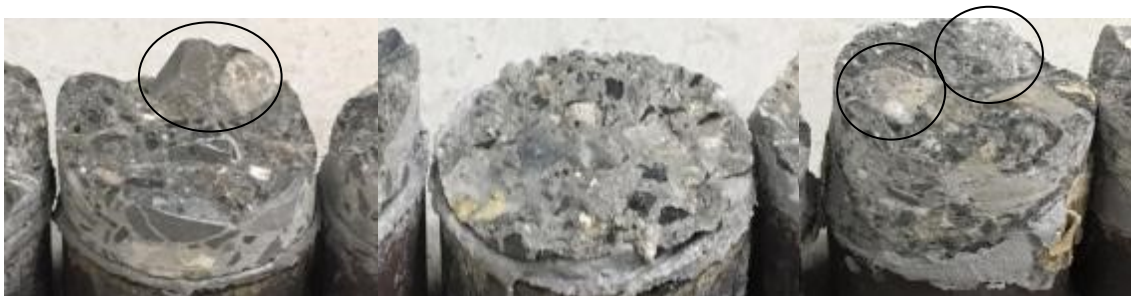
**Figure 8.** Example of failure modes of unprepared-CC (left) JH-CC (middle) and WJ-CC (right) substrates under STS testing. The encircled zones show failures at the interfacial transition zone (ITZ).

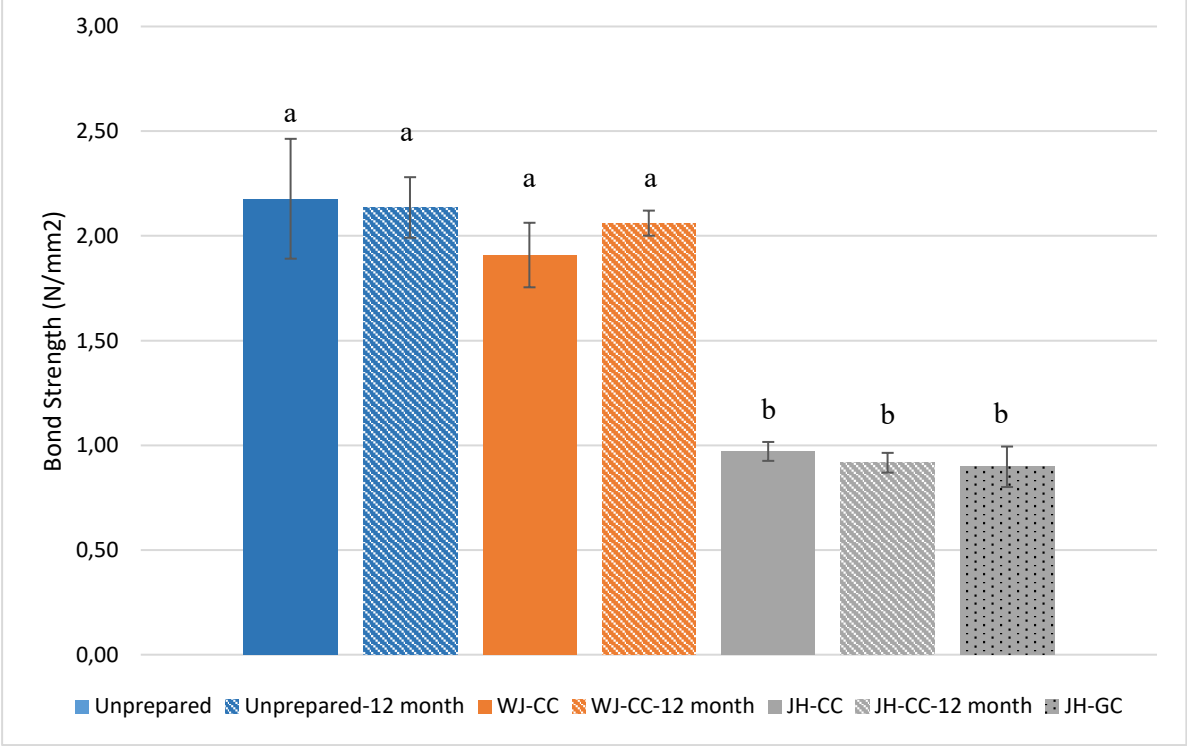
**Figure 9.** Bond strengths results. Error bars represent the standard error. Means with the same letter indication are not significantly different.

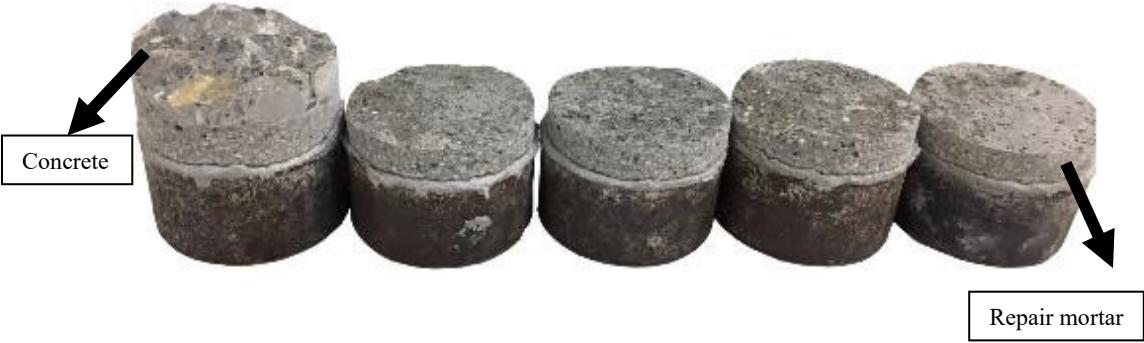
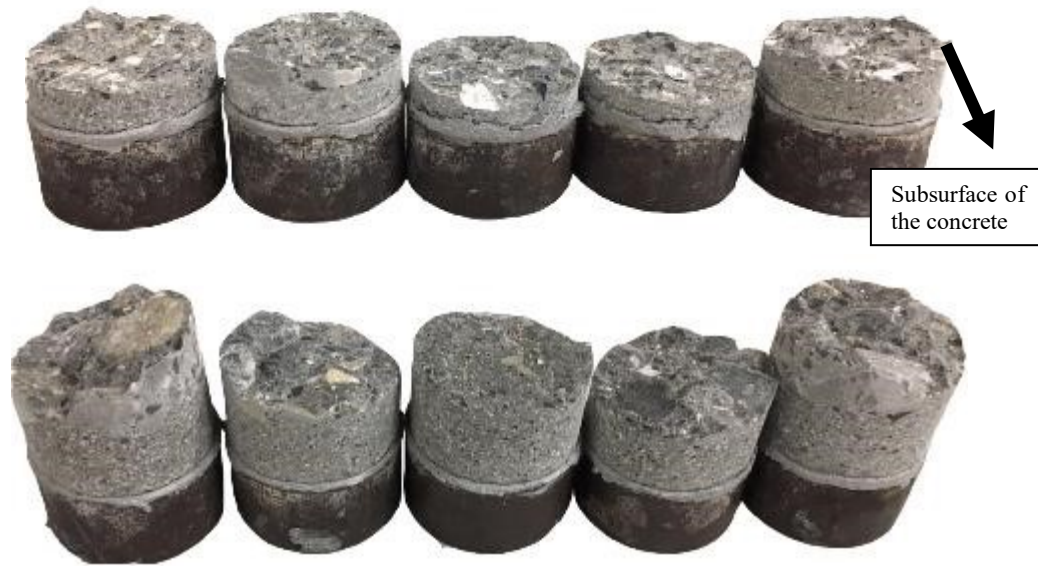
**Figure 10.** Bond strength failure modes of unprepared-CC (top) JH-CC (middle) and WJ-CC (bottom) samples at 28 days.

Concerning the failures shown in Figure 10, for unprepared samples (28 days) 80% (4/5) of ruptures were adhesive failures, occurring at the interlayer. Failures were 100% at the interlayer for these samples after 12 months. For JH samples (28 days and 12 months) almost all failures happened at the subsurface of the old concrete (close to the interface), also considered as adhesive failure. However, cohesive rupture was observed for 80% of WJ samples (28 days and 12 months) with failures deeper in the substrate. The influence of the roughness and removal techniques on the pull-off failure modes was explained in [1]. It was also reported that failures of WJ samples are mainly at the interfacial transition zone of aggregates and cement paste in the substrate.

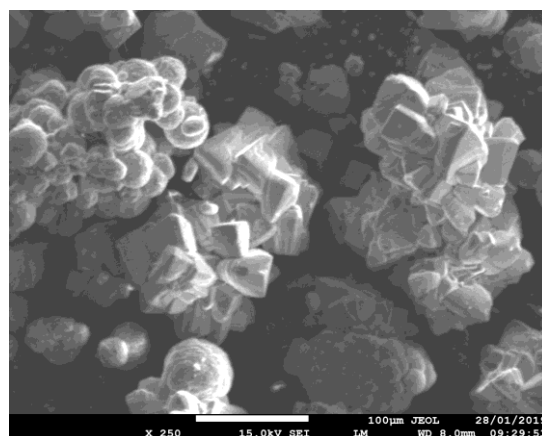
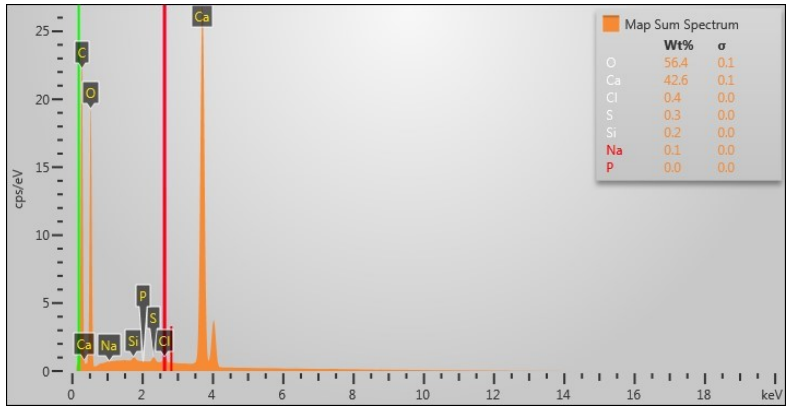
**Figure 11.** SEM (top) and EDX (bottom) taken from powder of biodeposited layer. Scale bar equals 100  $\mu\text{m}$ . X-axis and Y-axis indicate kilo-electron-volt (KeV) and counts per second per electron-volt (cps/eV), respectively.

Biodeposited crystals were scraped off the surface of a pour-applied bacterially treated sample for microstructural analysis. Figure 11 shows the SEM image and its corresponding EDX spectrum of the deposited crystals. One can see that carbon, oxygen and calcium are present in large amounts which implies the precipitation of  $\text{CaCO}_3$  crystals during the bacterial activation. An example of the deposited products is given in Figure 12. As shown, flower-, cube- and sphere-shaped crystals are present (see Figure 12). The mineralogical composition was analyzed using XRD and the results are given in the spectrum of Figure 13. XRD results show the existence of calcite and vaterite and SEM images shown in Figure 12, confirm their presence. Calcite and vaterite are known to have cubic, and flower and sphere morphologies, respectively [43].

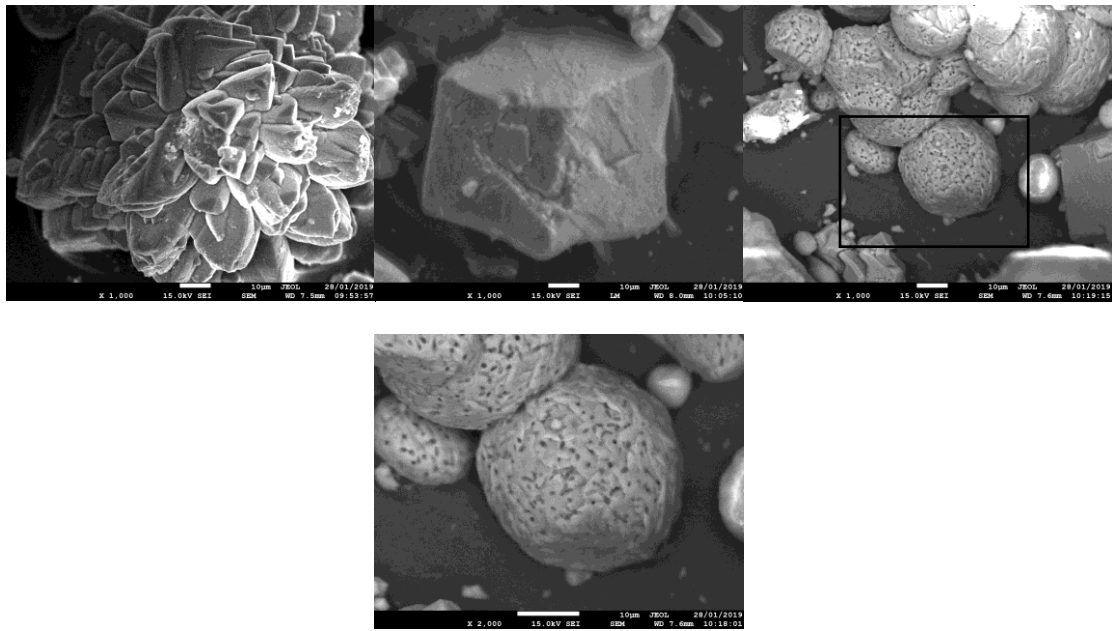
**Figure 12.** Flower-, cube- and sphere-shaped crystal formations respectively from left to right. The image at the bottom is a magnification of the zone in the black square. Scale bars equal 10  $\mu\text{m}$ .

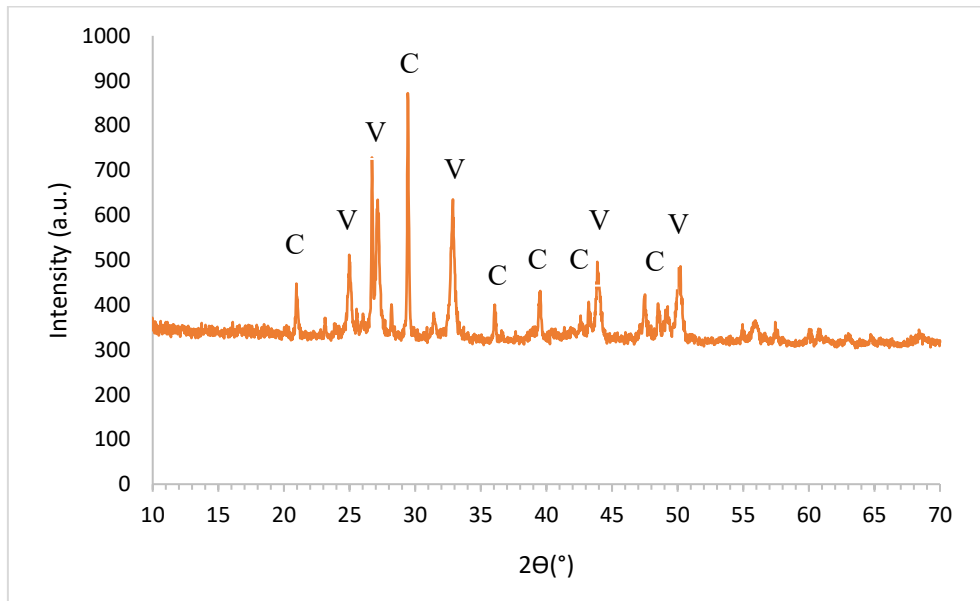
**Figure 13.** XRD pattern of the crystal formations induced by the biodeposition. C and V stand for calcite and vaterite, respectively.

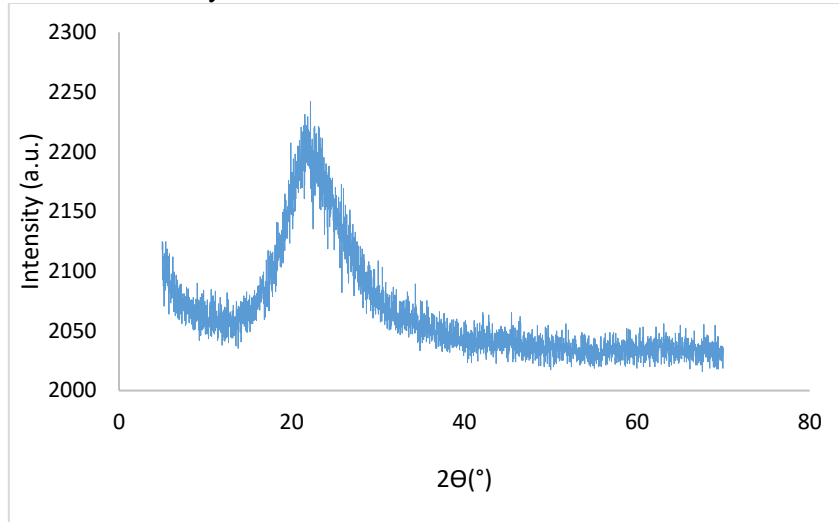
**Figure 14.** XRD pattern of CNS crystals.

The XRD pattern of a scraped CNS layer is shown in Figure 14. Similar to the characterization of samples treated with bacteria, crystals from the surface of a CNS-treated sample were scraped for XRD analysis. As shown in Figure 14, CNS has an amorphous structure exhibited by the large hump between  $13^{\circ}$ - $40^{\circ}$ . Therefore, it possesses a high potential to react with the reaction products of concrete such as  $\text{Ca}(\text{OH})_2$  and also influences the hydration of cementitious materials.

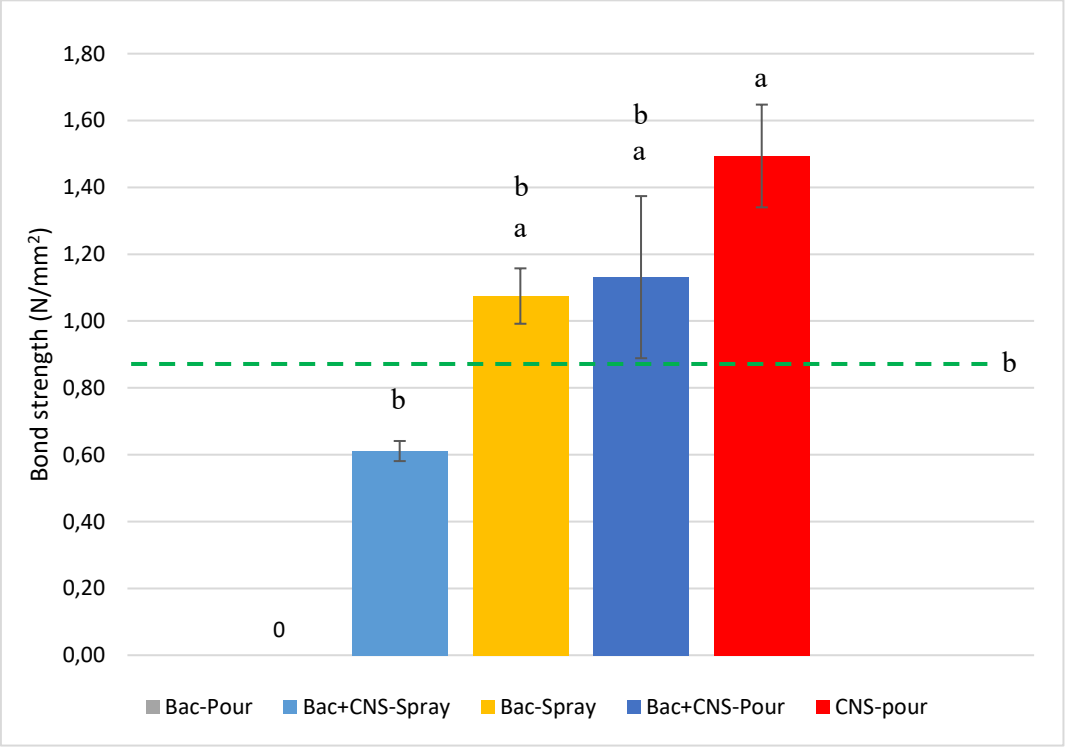
**Figure 15.** Bond strength results of JH-CC samples. Dashed line represents the control sample (JH-CC). Bac indicates bacterial treatment. Error bars represent the standard error. Means with the same letter indication are not significantly different.

The main goal of this section is to propose an effective solution to restore the lost bond strength of the JH substrate. Bond strength results of the JH samples and those treated with single and combined surface treatments are given in Figure 15. Different methods of application (pouring and spraying) were tried for the bacterial treatment and the combined mix. In terms of the single bacterial treatment, as shown, the spraying application gives a larger bond strength compared to the treatment with poured bacteria. Bacteria-pouring is not shown in the Figure as the repair mortar came off during drilling of cores before the performance of the pull-off test (Figure 16), therefore, the bond strength of zero was considered for these samples. The difference in the results of spray- and pour-applied bacterial treatment might be because of the presence of a thin  $\text{CaCO}_3$  layer precipitated at the surface of samples when the latter application was employed. This layer acts as a bond-breaker and therefore weakens the bond between the layers. As mentioned in section 2.4.1, the exposure of pour-applied bacterially treated samples to the pressurized air did not lead to the full removal of the  $\text{CaCO}_3$  layer from the surface. Two potential zones of weakness are created with the existence of the  $\text{CaCO}_3$  layer: at the interfaces of this  $\text{CaCO}_3$  layer with the substrate and the repair mortar. Moreover, the calcium carbonate layer has a low tensile strength and has the risk of cohesive failure within the precipitated layer itself. The authors' suggestion is to avoid the creation of an extra interface between the old and the new layer. This issue has also been reported in some studies conducted on bonding agents in repair systems. Some researchers claimed that bonding agents start to deteriorate the bond when a layer of the agent is created on the substrate [45, 46]. However, results show that with the elimination of this layer through the application of the spray-method the bond is improved remarkably. The impact of concrete carbonation on the bond strength of sandblasted and jackhammered samples was investigated in [41]. According to the results, accelerated carbonation during 2.5 months reduced the bond strength of the latter samples by 16% and did not influence the adhesion of the former samples. The more detrimental impact of carbonation on JH samples compared to sandblasted samples was attributed to the microcracks or any other defects in the subsurface of the substrate which lets carbon dioxide easily access through the concrete surface. This can create a dense and soft surface layer, and act as a pore-blocker, decreasing the chemical ion exchange between the substrate and the repair material. Yazdi et al. [1] reported a higher microcrack density at

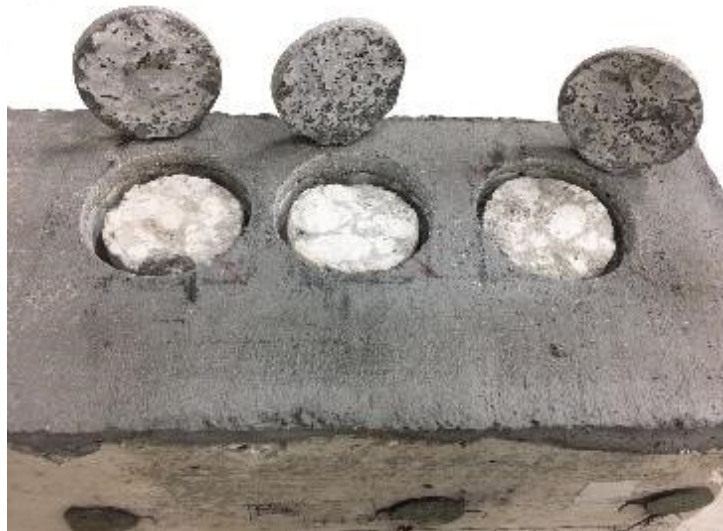
**Figure 16.** Pour-applied bacterial treatment - failure while drilling cores.

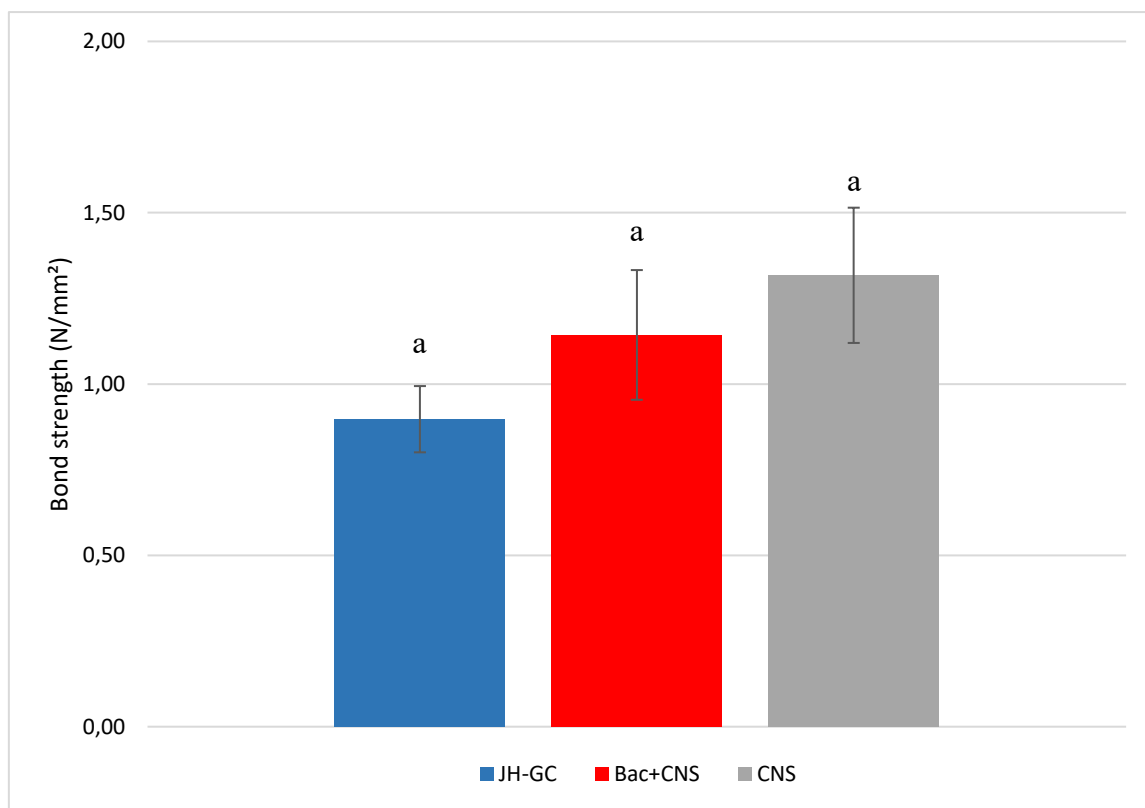
**Figure 17.** Bond strength results of JH-GC samples treated with the pouring technique. Error bars represent the standard error. Means with the same letter indication are not significantly different.

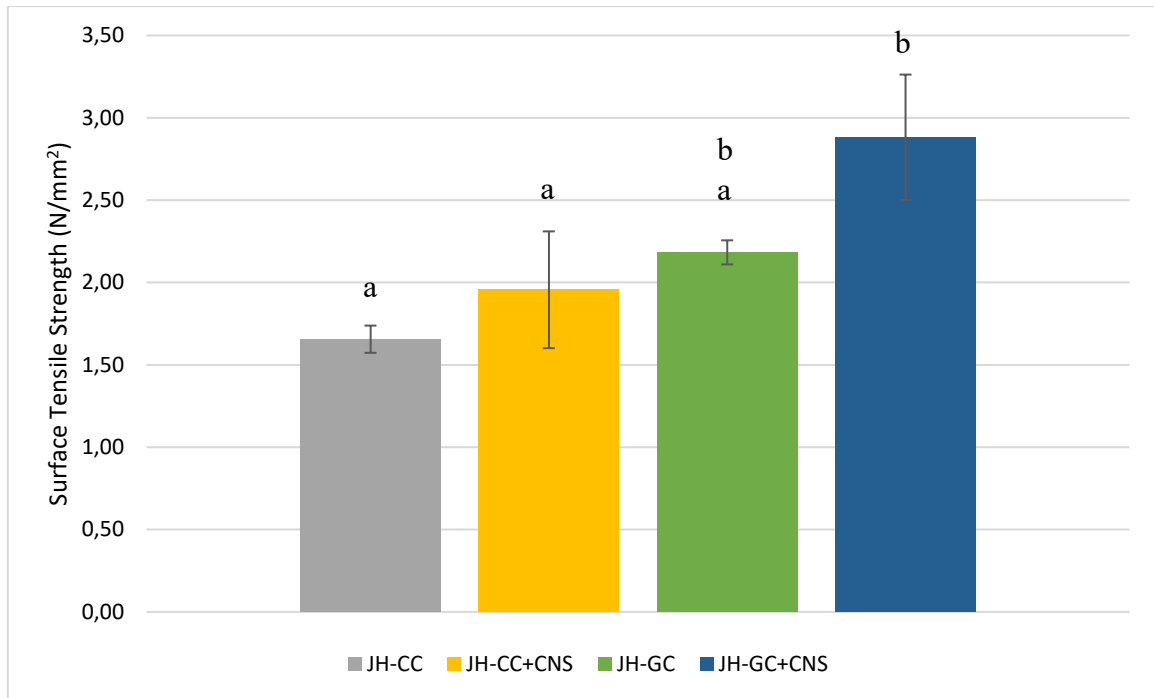
**Figure 18.** Surface tensile strength results of JH-CC and -GC samples with and without CNS treatment. Error bars represent the standard error. Means with the same letter indication are not significantly different.

Figure 18 shows the improvement of the STS of JH-CC and -GC samples after treatment with CNS. The increase in the STS is probably due to the chemical reaction between the NS and the  $\text{Ca}(\text{OH})_2$  in the old concrete to form C-S-H. It can be inferred that the NS can react with the binder in the existing concrete and strengthen the deteriorated superficial layer of the substrate caused by the JH. The reaction between the silicon dioxide and calcium hydroxide to form calcium-silicate-hydrate has been reported widely [17, 19, 20, 49]. Kupwade-Patil et al. [49] reported a reduction in  $\text{Ca}(\text{OH})_2$  by 8% resulting from nanoparticle (alumina-coated silica) treatment of hardened concrete samples. They transported nanoparticles to the surface of reinforcement through capillary pores for the mitigation of corrosion. One additional finding of their study was the higher production rate of C-S-H gel by the reaction of the  $\text{Ca}(\text{OH})_2$  within the hardened concrete and the silica component of the transported nanoparticles. Sanchez et al. [19] also confirmed the possibility of the reaction between CNS and the cement paste when hardened samples were treated with CNS. Hou et al. [20] compared nano-silica with silica fume in consumption of  $\text{Ca}(\text{OH})_2$  and reported that the former only needs 7 days compared to the 28 days for silica fume to complete the reaction, expressing the fast reaction of NS. In this study, the STS experiments were performed 6-7 days after the application of CNS. The authors aim to further study the reaction between the silica gel and hardened paste and also the STS of CNS-treated substrates in the near future.

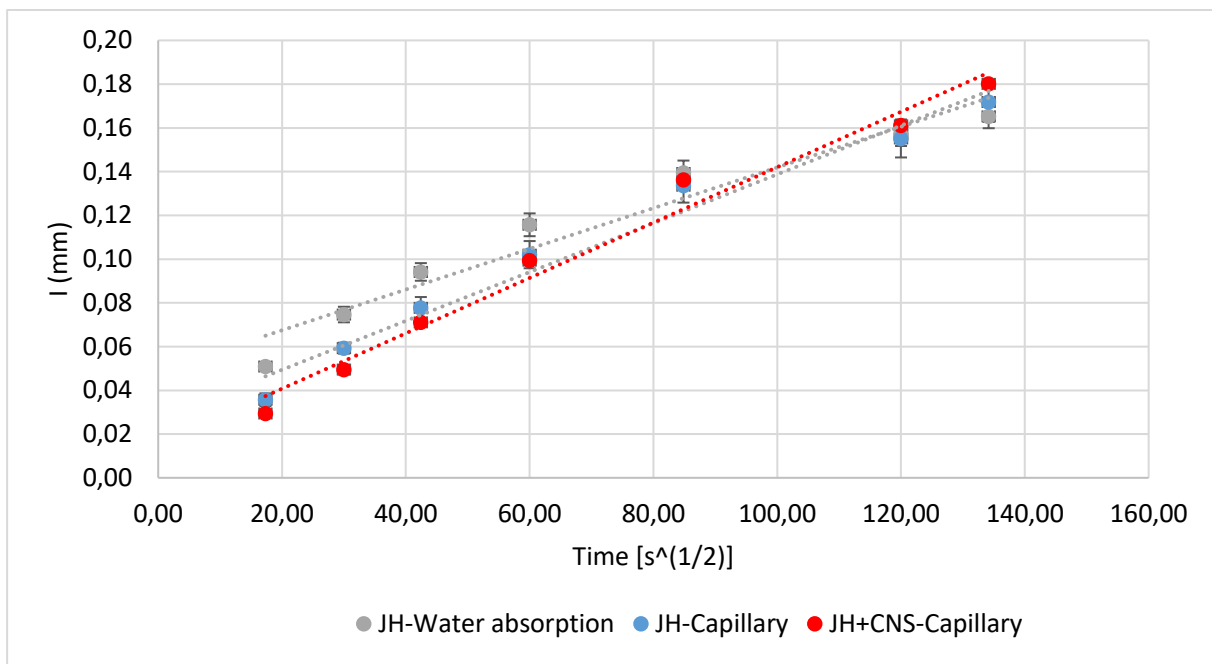
**Figure 19.** Water uptake of JH-CC and CNS-treated JH-CC samples. Error bars represent the standard error.

Moreover, in Figure 19 it is observed that the water uptake of samples treated with CNS is initially (up to 120 min) slightly lower than that of the unaltered JH sample. The later increase in the water uptake of CNS-treated samples might be because of the reduction in the density of the silica gel at the surface of the concrete throughout the experiment. However, the initial reduction in the water uptake might be due to the pore-blocking effect of the precipitated amorphous NS. It implies the existence and activity of NS at the superficial layer of the substrate. In this case, NS in turn has the potential to contribute to the further nucleation of reaction products of the repair mortar when the overlay is applied, boosting the interlocking between the two composites. Application of the overlay will enhance the moisture content at the interface and therefore provide an optimal environment for the activity of the remaining NS at the subsurface of the concrete substrate. One could take this observation to explain why JH samples treated with CNS achieved the largest bond strength with the overlay. CNS was claimed to precipitate and condense at the surface of hardened cement pastes, leading to the domination of amorphous  $\text{SiO}_2$  at the surface [17] and acting as nucleation sites on anhydrous cement particles [19]. Hou et al., explained that an additional C-S-H gel with a higher stiffness compared to that of the plain paste is formed on the surface of hardened samples treated with CNS [17, 20]. In [21] the initial water absorption of cement paste after surface treatment by CNS was studied. They showed that the effect of surface treatment on the water uptake of samples is dependent on the porosity of the mixture; for samples with w/c ratios of 0.6 and 1, a great reduction in the water uptake was observed. The pore-refining of hardened samples treated with CNS was also observed [17, 21]. As the surface treatment in this study was performed on JH samples, CNS may have a higher chance of penetration into the substrate because of the microcracks caused by the JH. Nevertheless, the water uptake results of this study show the negligible impact of removal techniques. The influence of silicates acting as pore-blockers has been reported in [12, 13, 15]. Some claim that the efficacy of the silicates in improving the performance of concrete is by the consumption of free Ca or calcium hydroxide at the surface of the concrete and production of C-S-H [15, 17, 21, 50]. In both the soluble silicate-based impregnation treatments (e.g. water glass) and the proposed treatment in this study the pore-blocking takes place by the reaction products of silica and paste and/or the precipitation of  $\text{SiO}_2$  in the pores (in the hardened sample) [15] not by a physical coating-barrier.

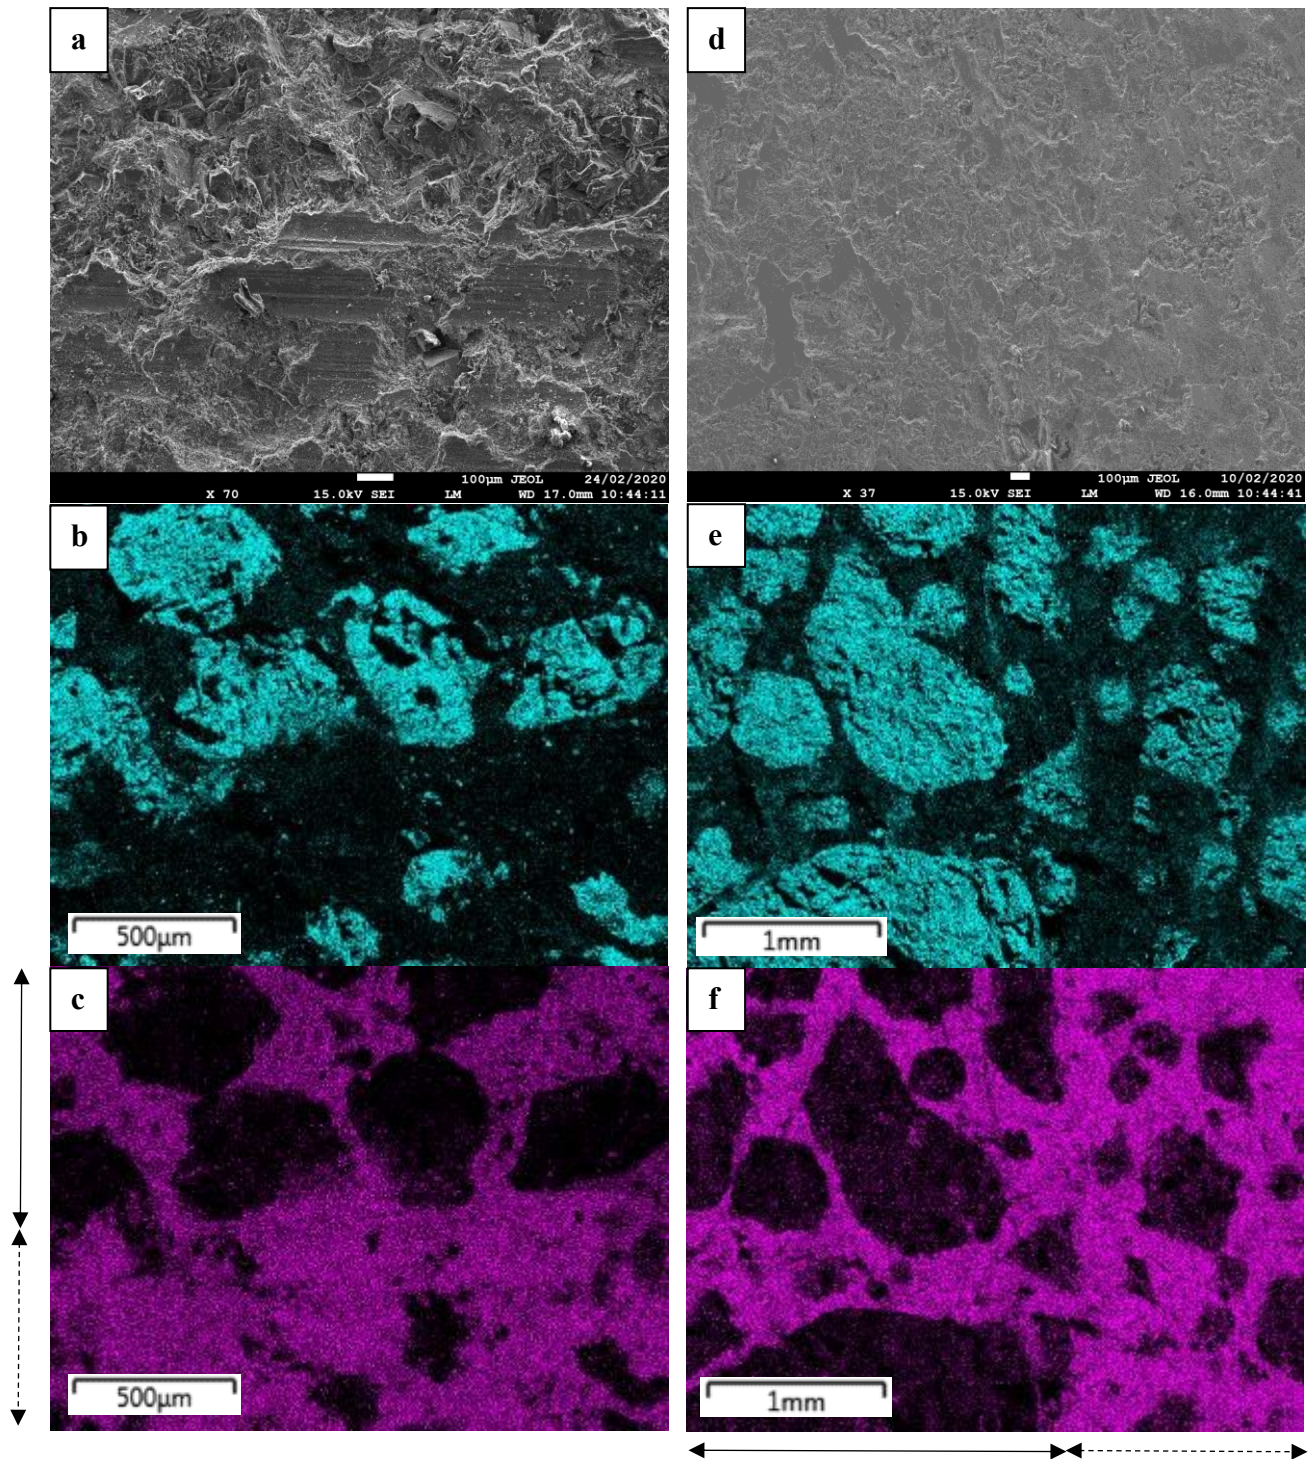
**Figure 20.** SEM-EDX images of CNS-treated JH-CC samples. Images a-c belong to sample 1 and d-f to sample 2. Scale bars equal 100  $\mu\text{m}$  for the SEM images a and d, 500  $\mu\text{m}$  for images b and c and 1 mm for images e and f. Images b and e as well as c and f show the silicon and calcium in green and red, respectively. Dashed arrows show the overlay and solid arrows show the concrete substrate.

a large bonding which are almost monolithic such as CNS-treated samples in this study, see Figure 20 (a) & (d). The transition zone that is formed when the existing concrete is covered with repair material is very similar to the interfacial transition zone between aggregates and cement paste in concrete [4, 52], being very porous. Figure 21 shows a clear example of interaction between the aggregates of the substrate and the paste of the overlay. This supports the theory that an ITZ exists between an old and new concrete, representing a zone of weakness. In terms of the CNS treatment, it is expected that the remaining CNS on the substrate will boost the hydration and therefore strengthen the interfacial zone in between the two composites. Jamsheer et al. [18] revealed that the reaction of NS and cement paste produces additional Si polymerization in C-S-H gel and also facilitates its nucleation. In a study performed by Ping et al. [53] aggregate surfaces were coated with a layer of silica fume to enhance the microstructure in the transition zone. Researchers in [45] improved the ITZ between the concrete substrate and the overlay using a fly ash-modified primer. Silicon dioxide coating of carbon fibers was reported to improve the bond strength between the fibers and the concrete matrix by the local formation of C-S-H gel [54].

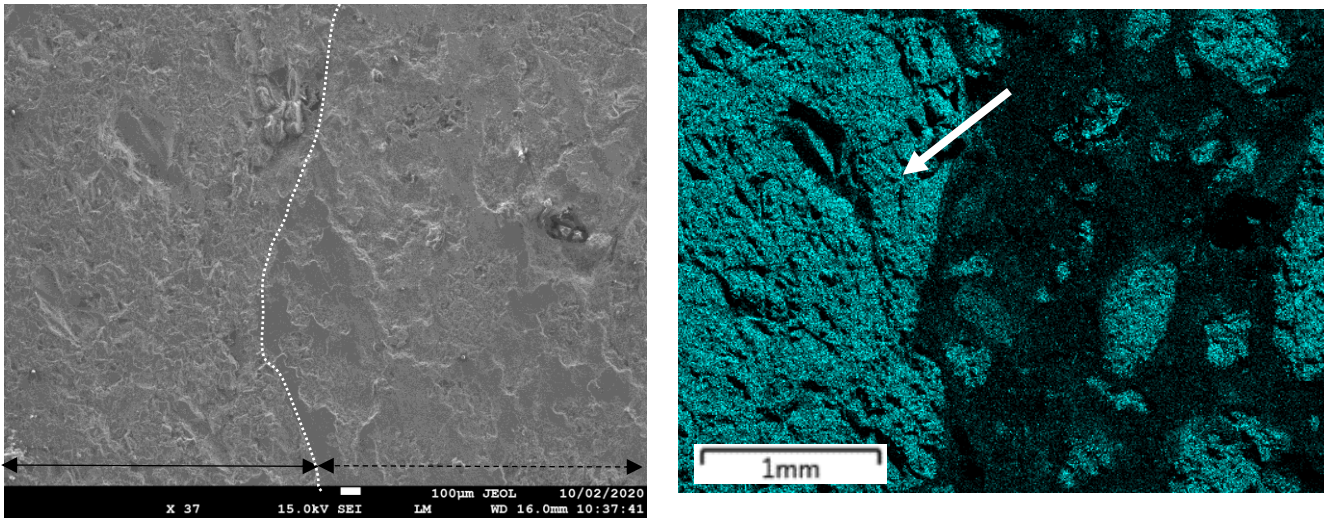
**Figure 21.** SEM (left) and EDX (right) images of CNS-treated JH sample 2. Scale bars equal 100  $\mu\text{m}$  for the SEM image (left) and 1 mm for the EDX image (right). Green in the image (right) shows the silicon; an example of a siliceous grain is also shown by the arrow. In the SEM image (left), dashed arrow shows the overlay and solid arrow shows an aggregate in the concrete substrate. The Dashed line in the middle of the SEM image (left) indicates an approximation of the boundary between the layers.

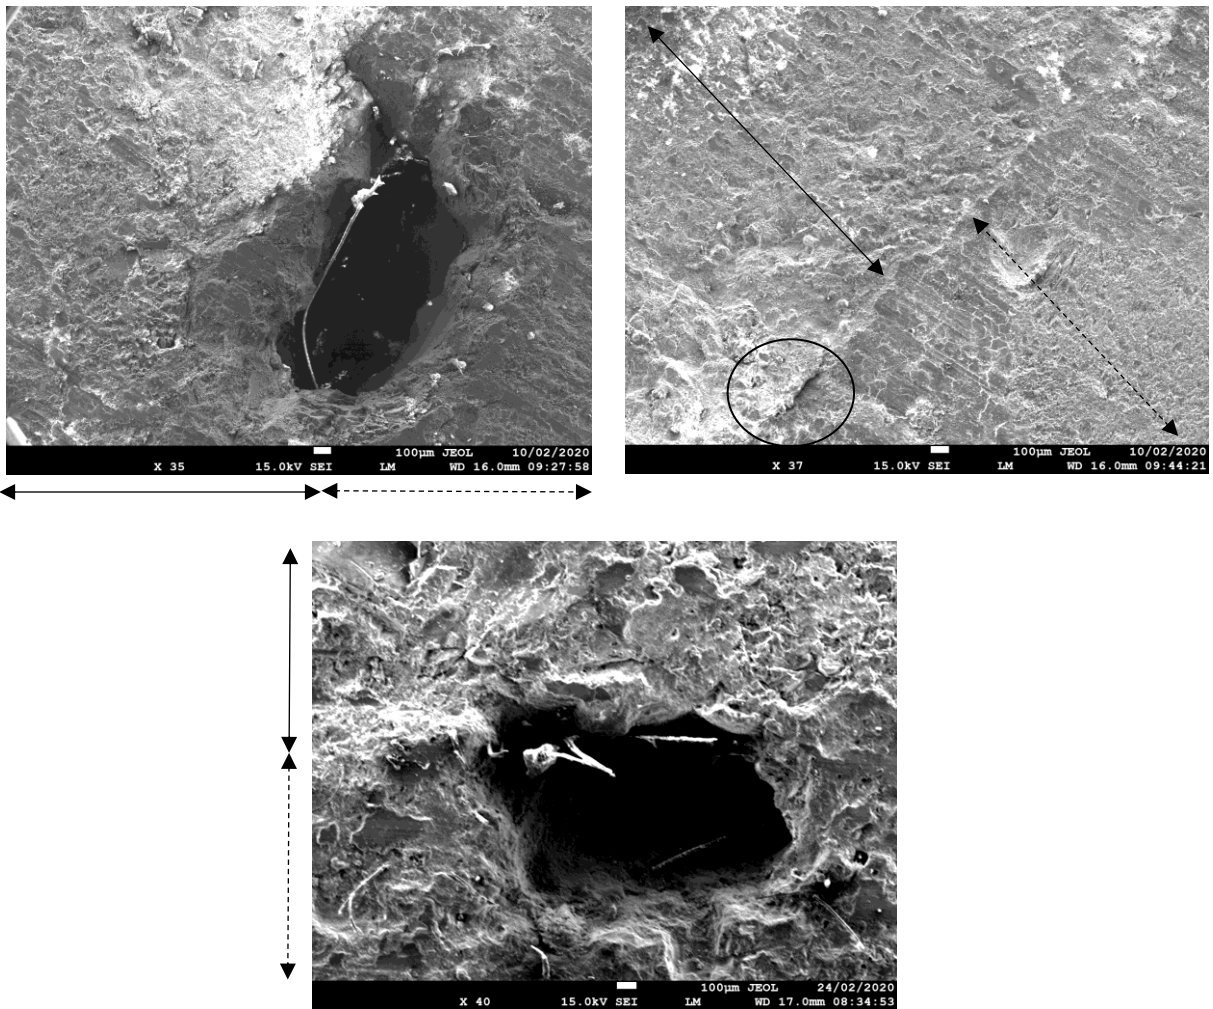
**Figure 22.** SEM images of JH samples. Sample 2 (top) and sample 1 (bottom). Scale bars equal 100  $\mu\text{m}$ . Dashed arrows show the overlay and solid arrows show the concrete substrate. The encircled zone shows debonding.
