Sunken lanes - Development and functions in landscapes

To appear in: *Earth-Science Reviews*

Sunken lanes - development and functions in landscapes

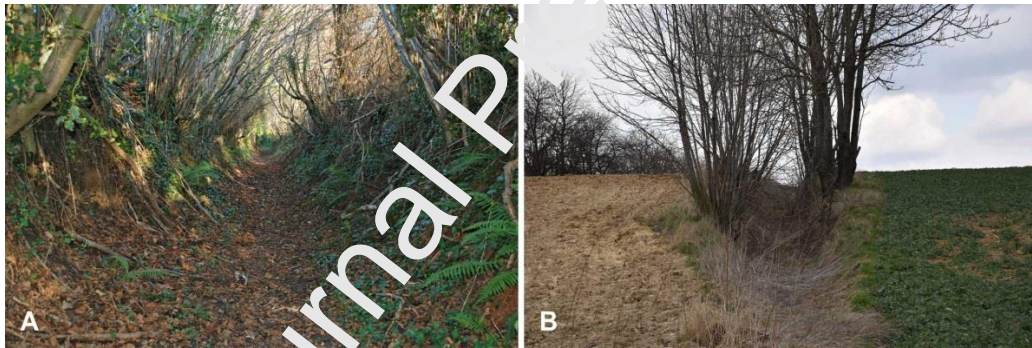
Figure 5. Abandoned sunken lanes: A - Hungers lane, West Sussex, UK, photo: J. Boardman), B – Carpathian Forelands, S Poland; photo: W. Zgłobicki)

footpath and a sunken lane is not clear cut, which is similar to the distinction between a rill and a gully channel. In order to classify rills and gullies quantitatively, a critical channel cross section of 929 cm² (square foot criterion) has been proposed (Poesen et al., 2003). Along the same lines, a minimum bottom width of 2.0 m over most of its trajectory is therefore proposed to distinguish between a sunken footpath and a sunken lane. The transition from an incised footpath to a sunken lane represents a continuum, and any classification of these anthropogenic landforms is, to some extent, subjective. However, after abandonment the bottom width of sunken lanes may decrease to less than 2 m due to deposition of sediments (colluviation) originating from the lane banks (Figure 5).

Based on historical maps and archaeological data, it was found that some road patterns currently observed in southern England (UK) date from prehistoric and Roman times (Boardman, 2013). In the Midhurst area many sunken lanes link Saxon age villages (5th century AD), at river crossing points, to forest, heathland and grazing on uplands to the north and south (Boardman, 2013). They are likely to have been part of a system of transhumance, of seasonal movement of animals to upland pastures. Barton (1987) stated that “*while in most cases downcutting is of considerable antiquity the existing cutting slopes may be of much more recent age*”. Many sunken lanes are now paved and downcutting has ceased. Hungers Lane (West Sussex, UK) was abandoned in 1800 as a major routeway linking the towns of Chichester and London (Figure 5; Vine, 1985). It is 1.3 km long and used today as a footpath.

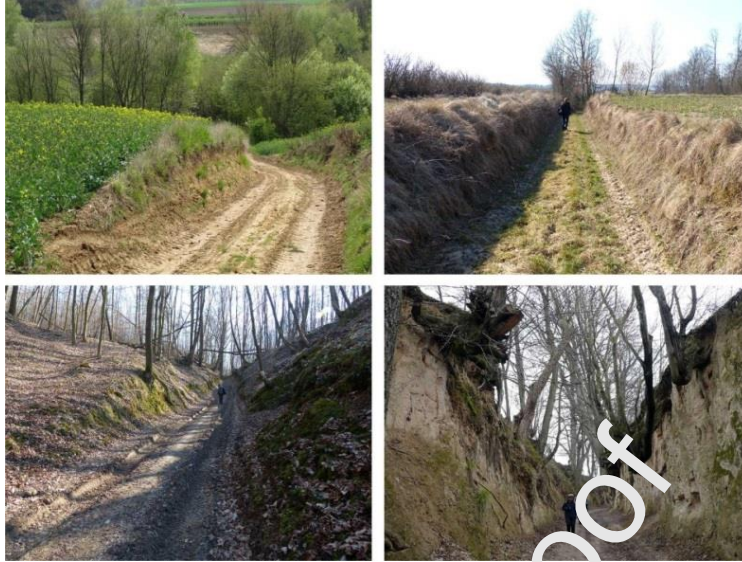
Figure 7. Active sunken lanes. Illustration of successive downcutting stages of unpaved roads by traffic and water erosion in the western part of Nieleczów Plateau (E Poland) (Photo: W. Zgłobicki).

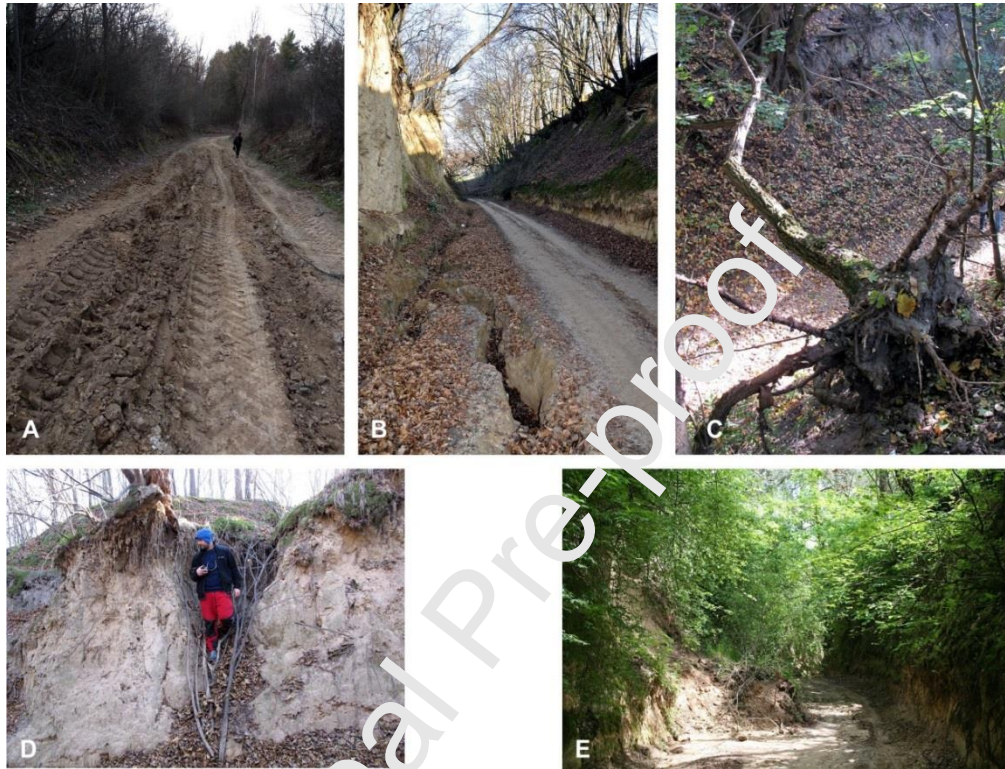
Figure 8. Common soil degradation processes in sunken lanes formed in loess. A – wheel compaction and soil detachment during traffic, B – rill erosion on the lane bottom, C – tree fall on the bank, D – piping and pipe roof collapse on a lane bank resulting in a bank gully, E – soil slumping on sunken lane bank (Lublin Upland, Sandomierz Upland, E Poland). (Photo: W. Zgłobicki, J. Rodzik).

Colluvial/alluvial fans may be formed at the outlet of sunken lanes (Figs. 8c and 9; Rodzik et al., 2014; Latocha, 2014; Superson et al., 2014). Sediment transport intensity within sunken lanes, and sediment accumulation at their outlet may be high, but their geomorphological significance in the landscape also depends on their density. Few studies on this aspect for regions with high sunken lane densities have been made. Research along this line was conducted in the Carpathian Mountains (S Poland), where it was observed that unpaved field and forest roads (not all of them were sunken lanes) are important sources of sediment for fluvial transport (Krocak 2010, Wałdykowski and Krzemiń, 2013; Krocak et al., 2016). According to Froehlich and Walling (1997) sunken lanes represent the main suspended sediment source due to the fact that most sediments eroded in the bottom of the roads are directly transferred to the stream channels. Froehlich (1982) estimated that unmetalled roads account for ca. 60-70 % of the load in the

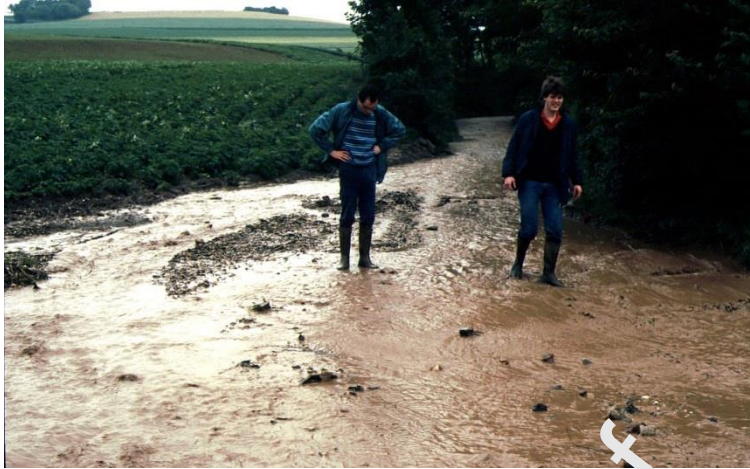
Figure 10. Illustration of the role of sunken lanes in increasing the runoff and sediment connectivity in a landscape. Outlet of a sunken lane with concentrated flow transporting large amounts of coarse sediments that are deposited at the outlet of the sunken lane, typically where the slope gradient drops below 0.04 m m^{-1} (Lorburg, The Netherlands, 06.1987) (Photo J. Poesen)

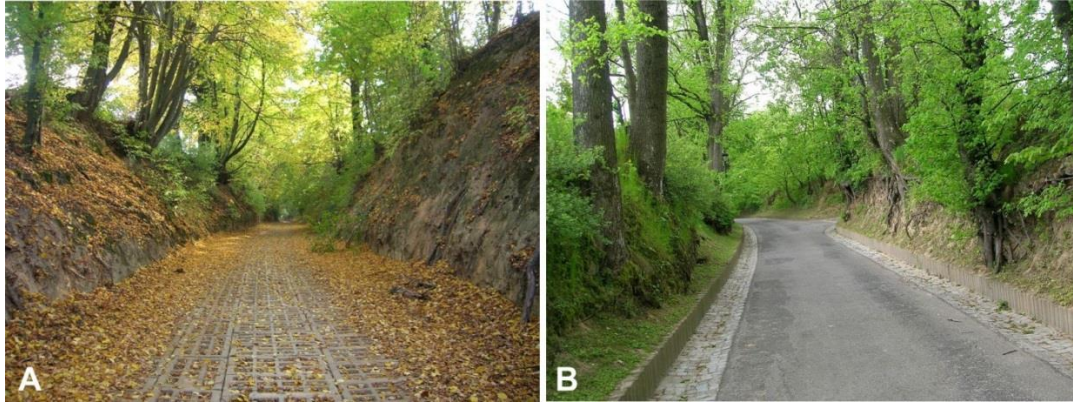
Figure 11. Different methods of paving bottoms of sunken lanes. A - openwork concrete slabs (Nałęczów Plateau, E Poland, loess), B – asphalt (Roztocze Region, E Poland, loess). (Photo: J. Rodzik).

In many regions, the erosion rate of the road surface has been reduced by paving the road (with cobble stones, concrete or asphalt) (Figure 11), but this has often caused excessive erosion at the road sides. Unpaved and often vegetated sunken lanes allow for a reduction of runoff velocity and higher infiltration rates which help to reduce the incidence of muddy floods. Moreover, the dynamic equilibrium of the sunken lane is completely disturbed by paving the road surface (RLD, 2004; Stevens, 1997). What should be done is addressing the origin of the erosion problems which are mostly located within the catchment draining towards the sunken lane (Mazur, 2007; Stevens, 1997). Erosion also occurs during the widening of the sunken lanes when these become too narrow for modern agricultural vehicles. Very steep and even vertical bare walls of sunken lanes are very sensitive to mass movement processes (RLH and Proclam, 2009). A very common erosion problem in sunken lanes is the development of bank gullies (Poesen, 1989; Poesen et al., 1996). These are mostly initiated when the neighbouring land is cultivated too close to the sunken lanes or landsliding occurs on the banks. Hortonian runoff and possibly also saturated runoff will then flow through and over the banks causing piping and ultimately bank gully erosion. These gullies can rapidly evolve by regressive erosion and then result in deep incisions of the bank shoulder, producing large sediment volumes (Poesen, 1989, 2018; Poesen et al. 2016; RLD, 2004; Stevens, 1997). The solution is to prevent or reduce runoff from neighbouring land to flow through or over the banks into the sunken lanes (Mazur, 2007). This can be achieved by either a land use change or the application of soil and water conservation techniques within the gully catchment and in the zones adjacent to the sunken lane. One effective way to prevent bank gullying, is the application of biological control measures on the bank

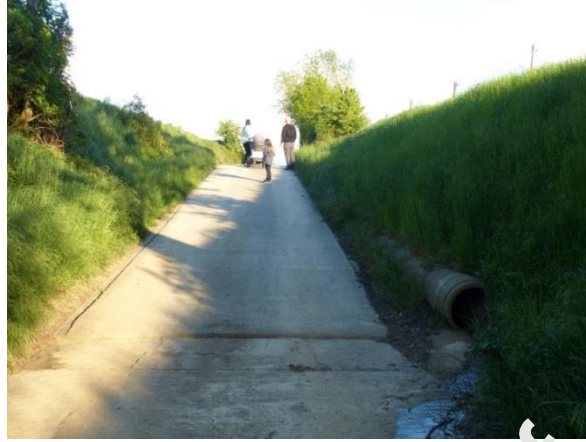
Figure 12. Sunken lane converted into a temporary flood retention pond by installing a concrete dam and a pipe to allow for bypass flow (Sluizen, Belgium 2019) (Photo: J. Poesen).

In several countries (e.g. Belgium, The Netherlands, Czech Republic) some sunken lanes have been converted to temporary water retention ponds by the construction of small dams (with a spillway) across the sunken lane (Figure 12; Zlatuska, 2012). Most of such temporary ponds aim at reducing peak runoff rates towards valley bottoms, thereby reducing the flash flooding hazard. In Belgium, several regional organizations produced detailed manuals providing guidelines on how to manage sunken lanes in order to conserve these multifunctional geomorphosites and to use them in a sustainable manner (e.g. RLD 2004; RLH 2009). Criteria to value both surface and embedded values of sunken lanes as long-standing heritage elements in landscapes as a basis to protect them are discussed by Verdurmen (2018).
