Material research and monitoring related to consolidation and strengthening of existing historic masonry structures

Luc Schueremans, Els Verstrynghe, R.A. Silva, D.V. Oliveira, R. Hendrickx,
Katrien Bruyninckx, Dionys Van Gemert

June 18, Darmstadt - Germany

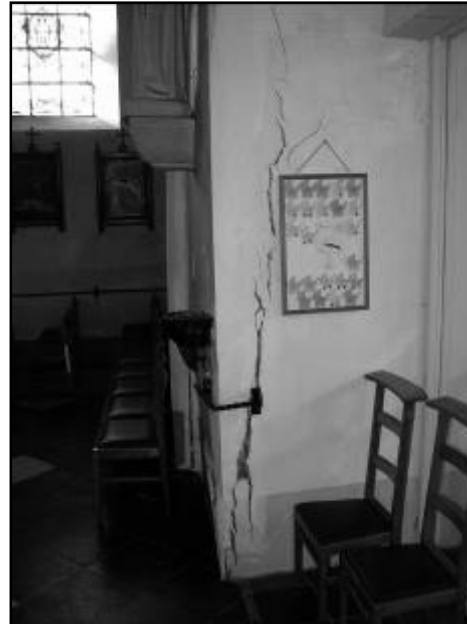
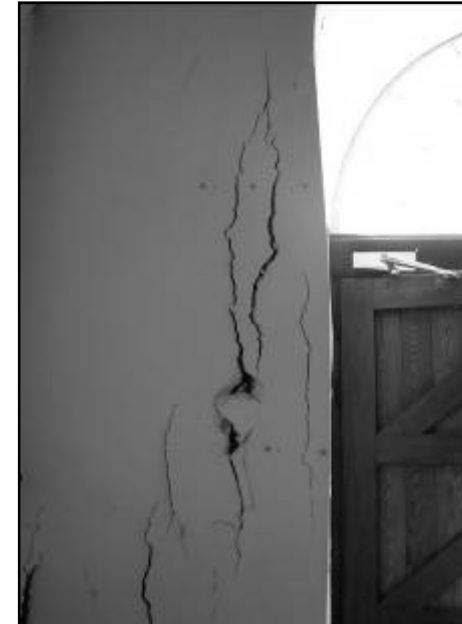
Bell tower of the Sint-Willibrordus Church at Meldert, Belgium
(14th (church) – 17th (tower) century)
(collapse: 07/07/2006)

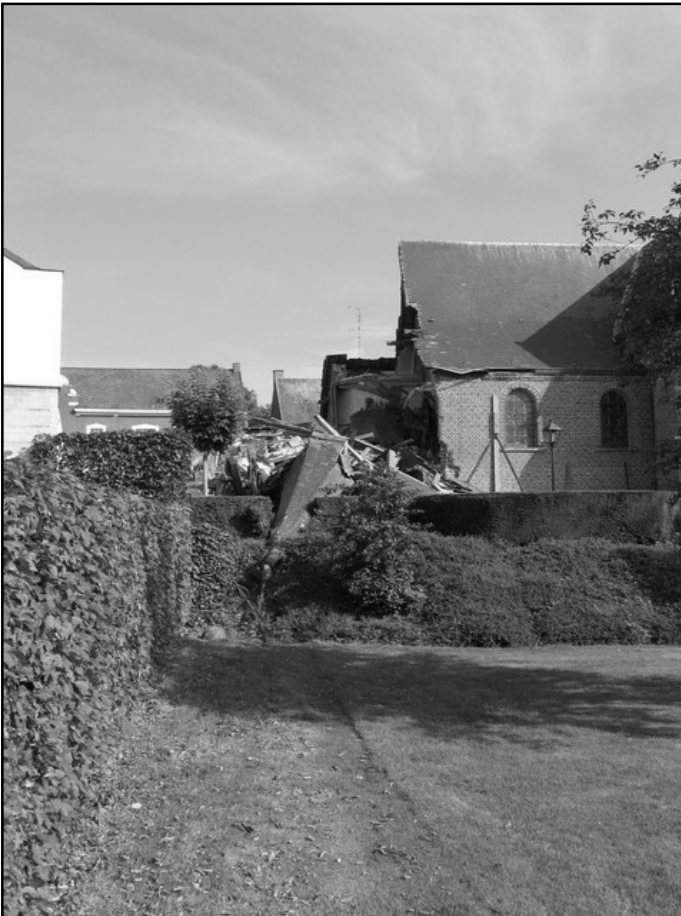
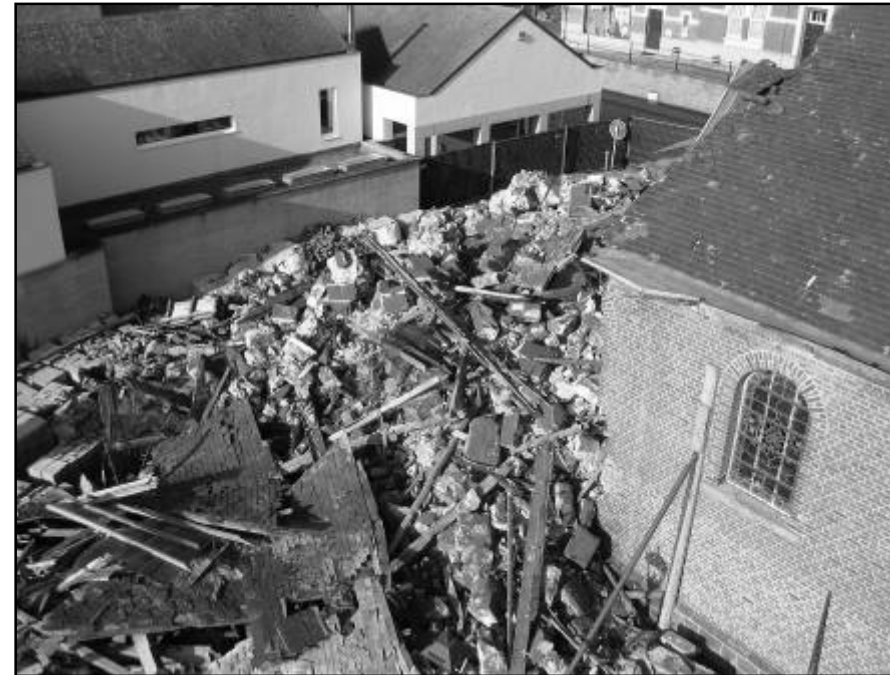
Bell tower of the Sint-Willibrordus Church at Meldert, Belgium

(collapse: 07/07/2006)

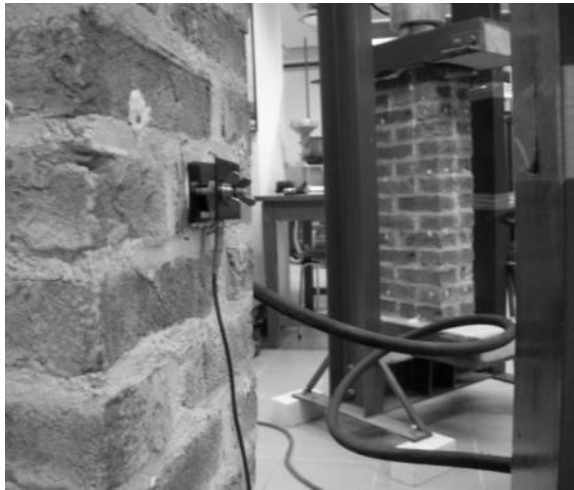
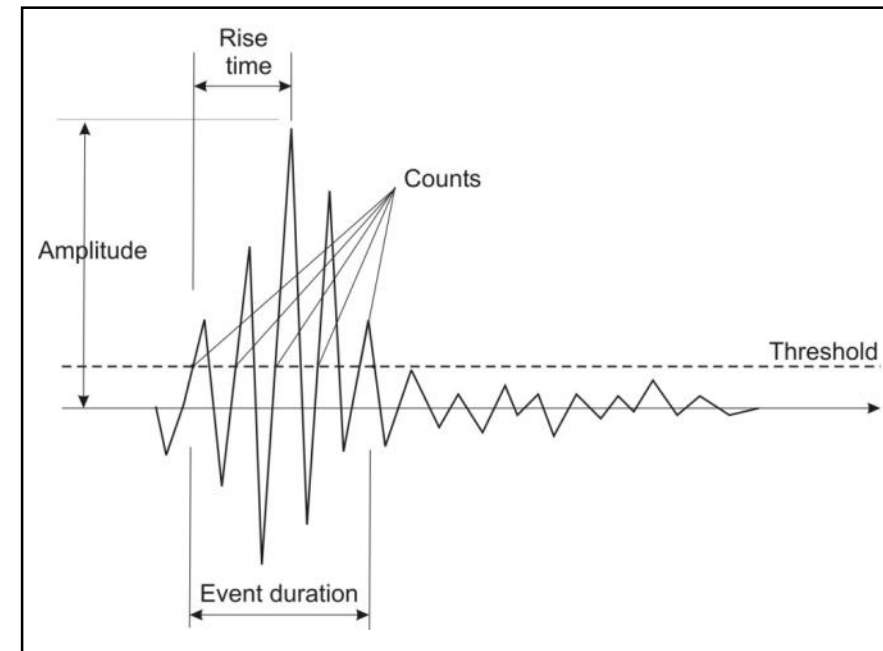
- “listening” to the appearance of cracks
- detection of high-frequency energy waves (250-700 kHz)
- possible “online-monitoring” of damage-accumulation in masonry

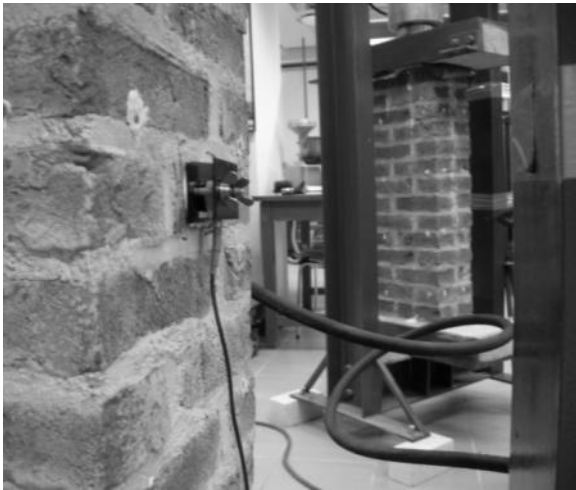
- Two sensors / specimen
- Preamplifier: 34 dB gain
- Threshold level: 34 dB
- AE system from Vallen Systeme, type AMS-3 (2 channel) and AMSY-5 (4 channel).
- Simultaneous monitoring of two specimens

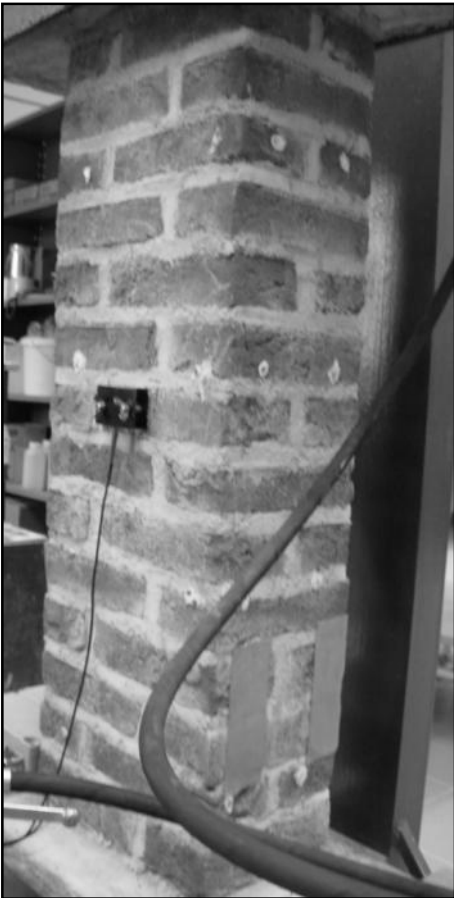
Stress increase $85 \rightarrow 90\%$ of f_c ,

persistent damage increase:
premonition of failure 10-20 hours after
stress increase.

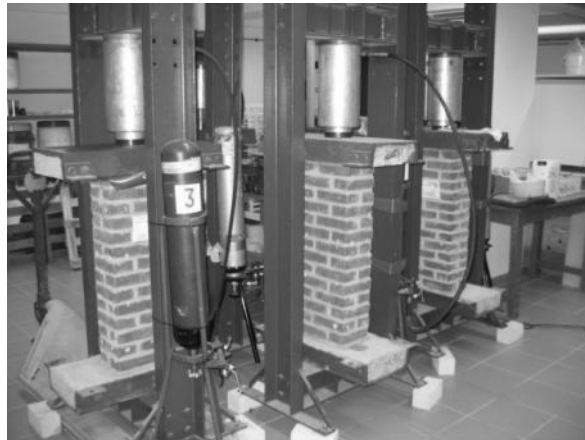
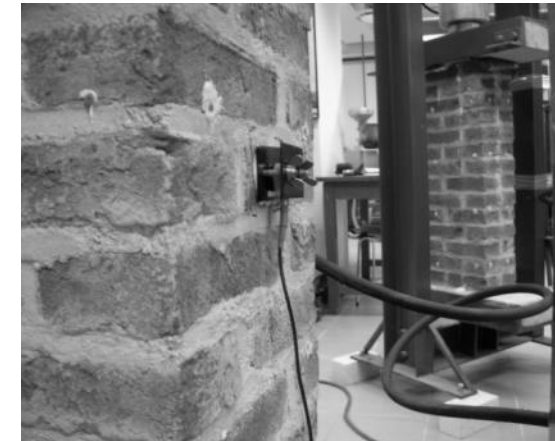
AE monitoring before, during and about a week after the small stress increase steps, in order to capture the different phenomena:

- The elastic deformation during stress increase;
- The dissipation of the AE events after the stress increase;
- The AE-events emission level during a constant stress interval;
- The accelerated damage-accumulation during the tertiary creep phase.

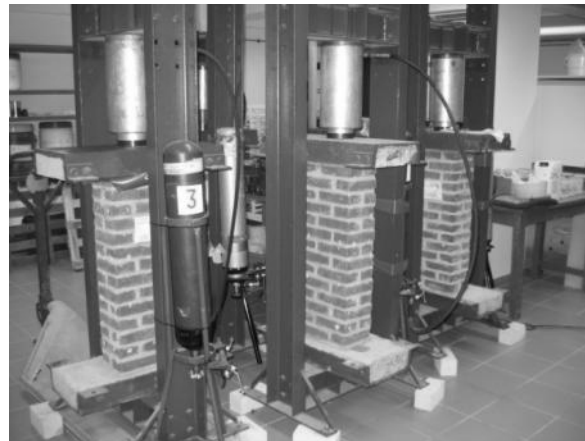
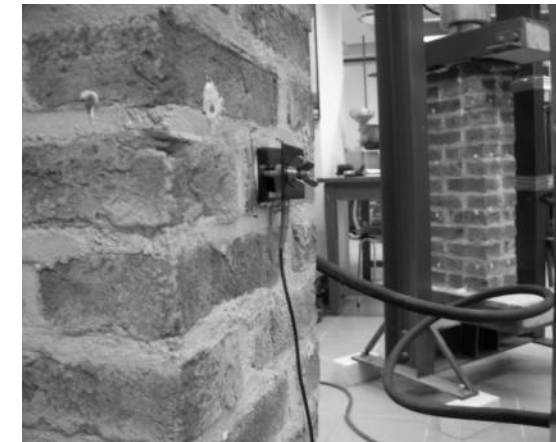
AE during creep tests – test program

Specimen	Successive stress increase steps (in % of compressive strength f_c)				Days to failure after last stress increase
	(0)	(1)	(2)	(3)	
28	50 → 60 %	60 → 65 %	65 → 70 %	70 → 75 %	8 days
30	-	85 → 87 %	87 → 90 %	90 → 93 %	5 days

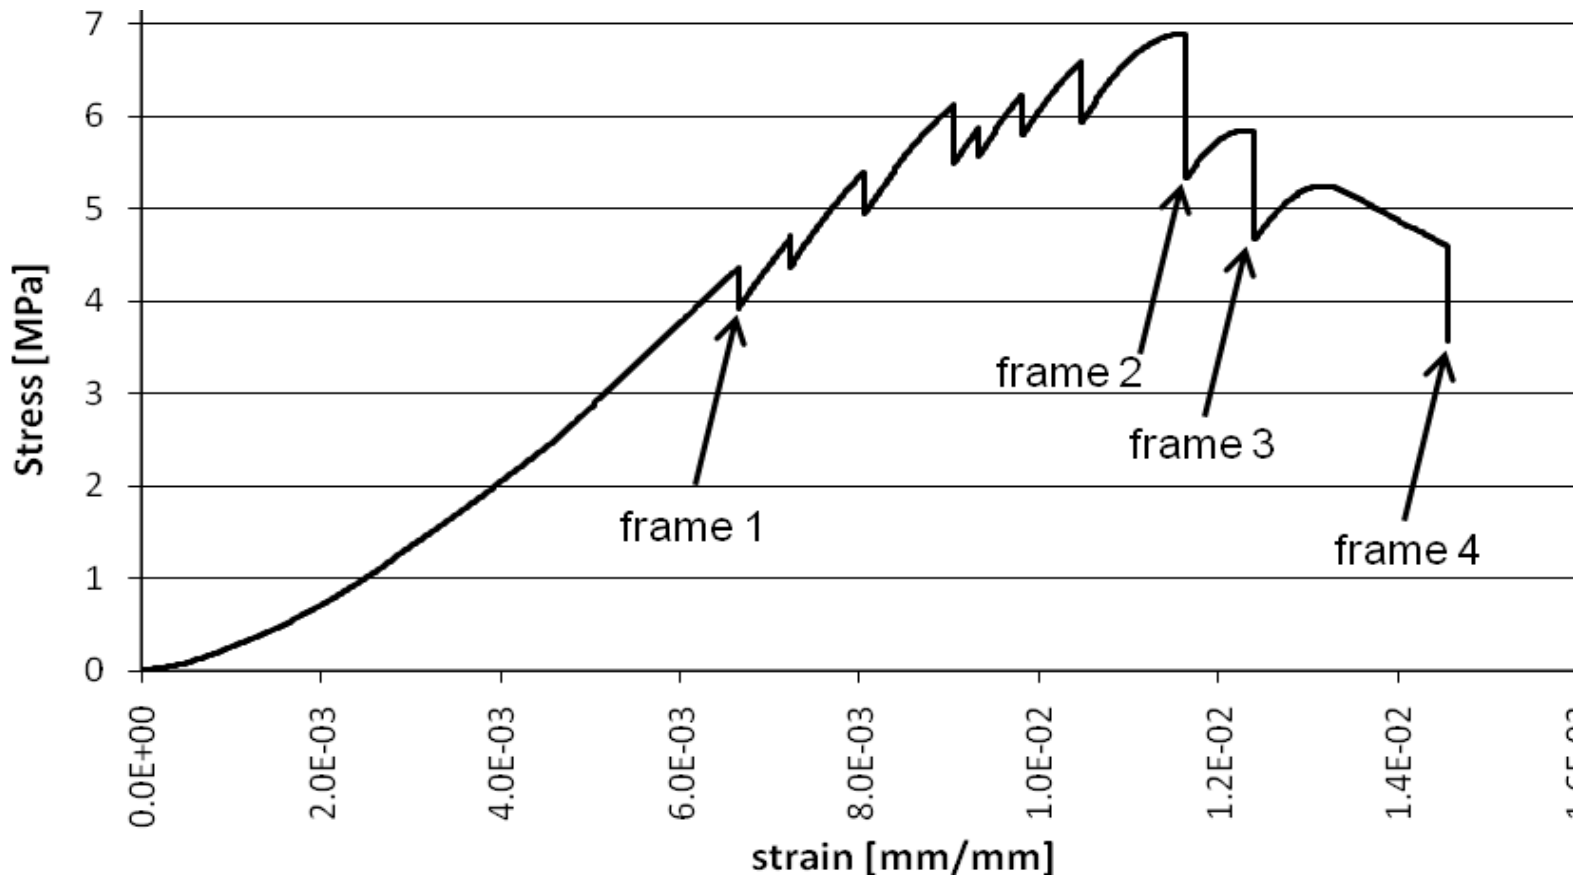
- Micro-focus CT-scanning + compressive test
- Scanning at each load step

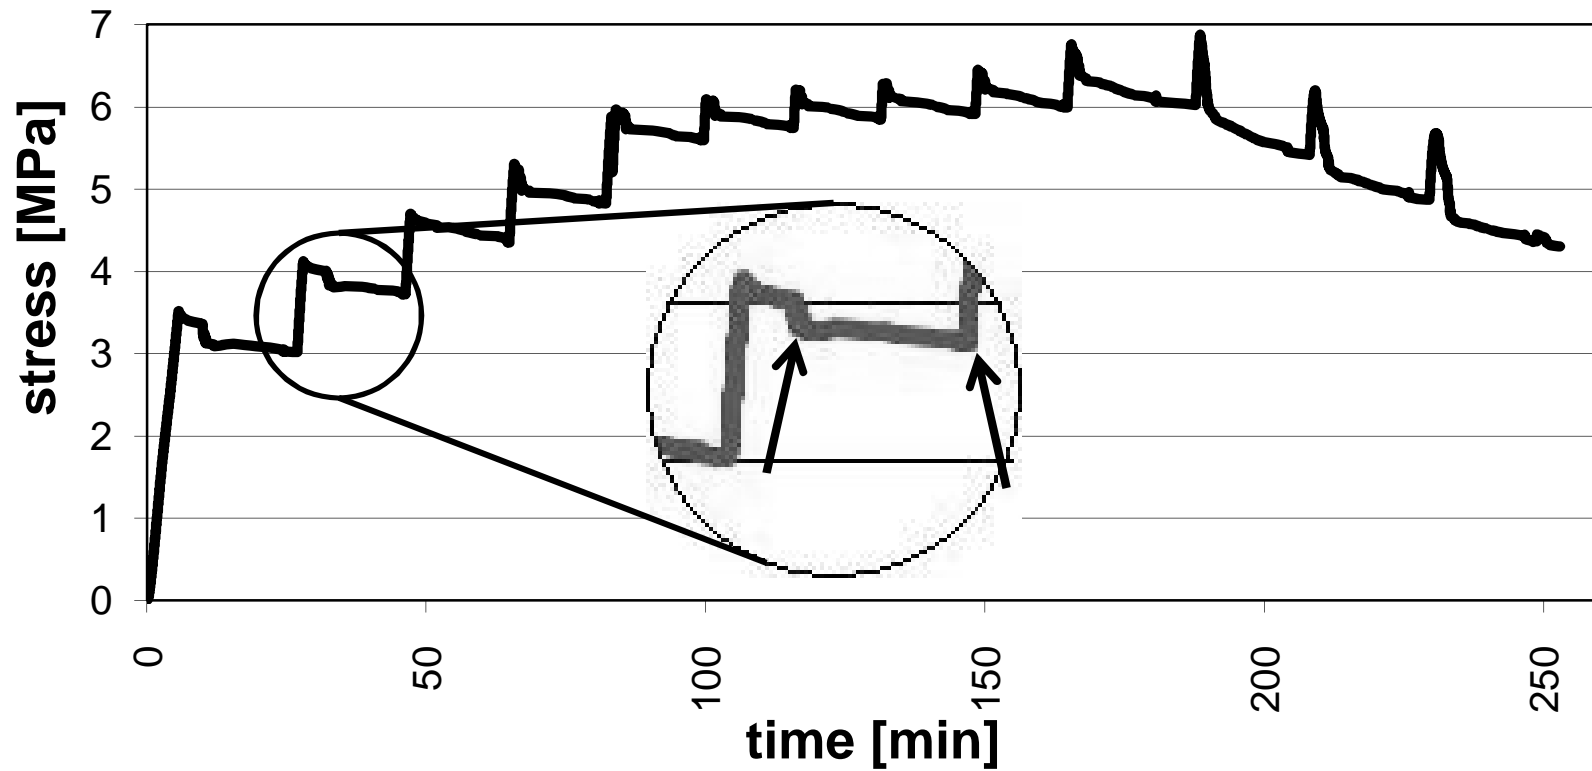
Scanning after relaxation

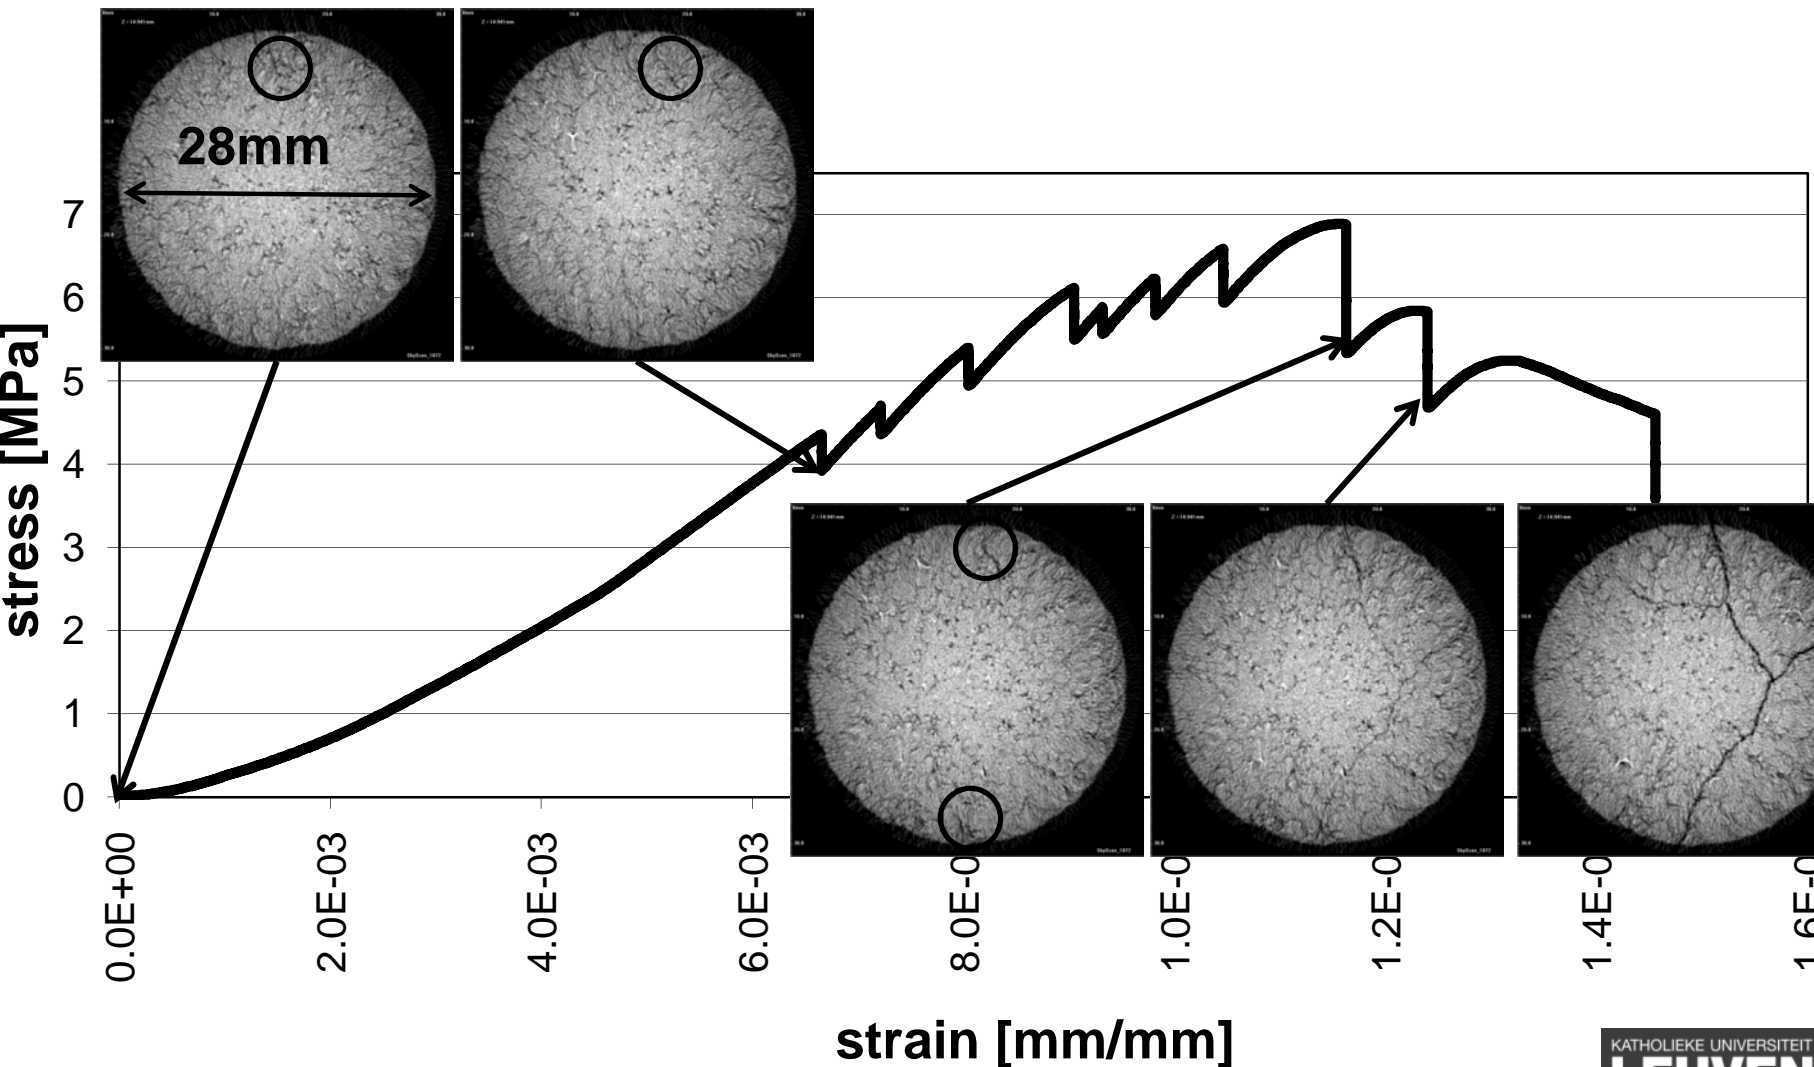
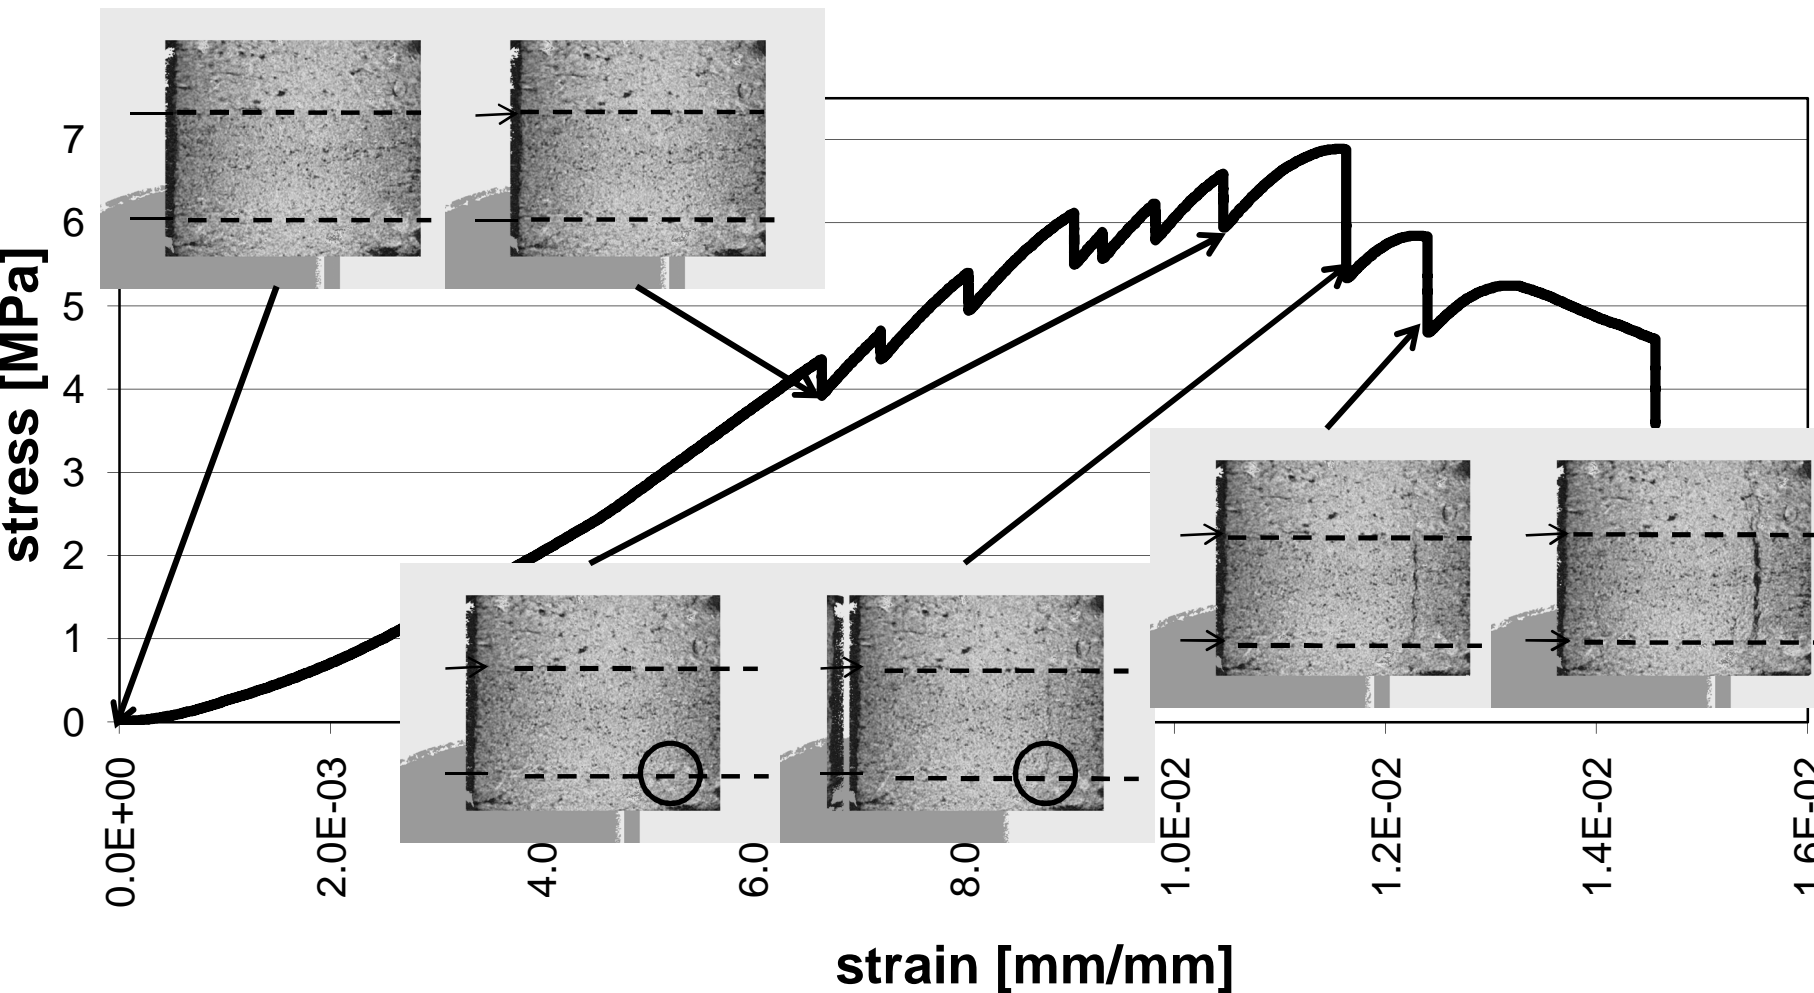
Crack development - hybrid mortar

- Lateral displacements for brick $>$ mortar ($E_m > E_b$)
→ lateral compression in brick;
→ tensile stresses in mortar – exceeding f_t –
- crack occurrence at initial deficiencies within the material (to be confirmed)
- Spatial resolution: $31\mu\text{m}$ – occurrence of crack tip not directly visible within the images

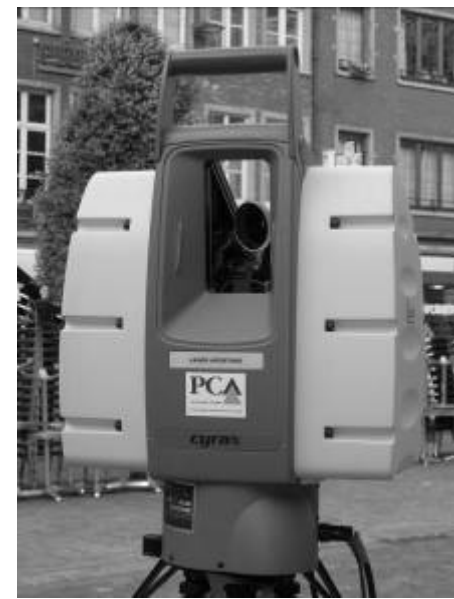
Leica HDS3000 Laser scanner

Point cloud processing: cyclone, rapidform

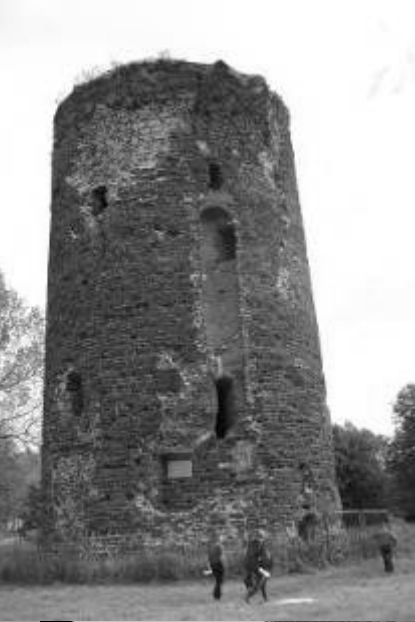
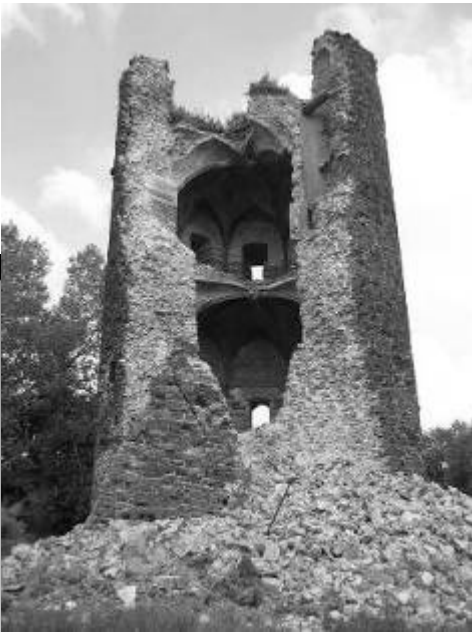
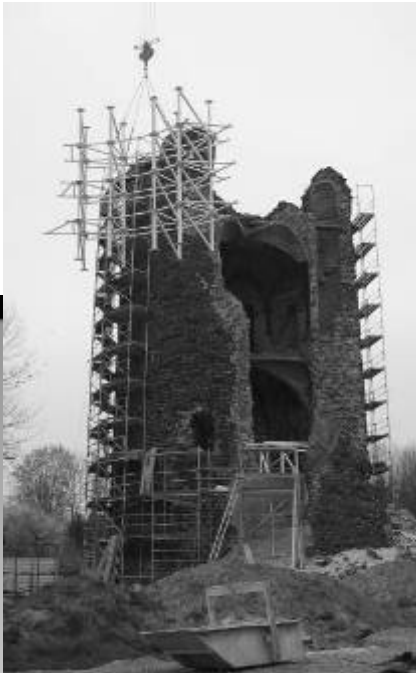
Maagdentoren te Zichem (B)

- Partial Collapse - 01/06/2006 of external wall and some vaults
- Residential tower (donjon), 13th century.
- owner: Flemish Government;

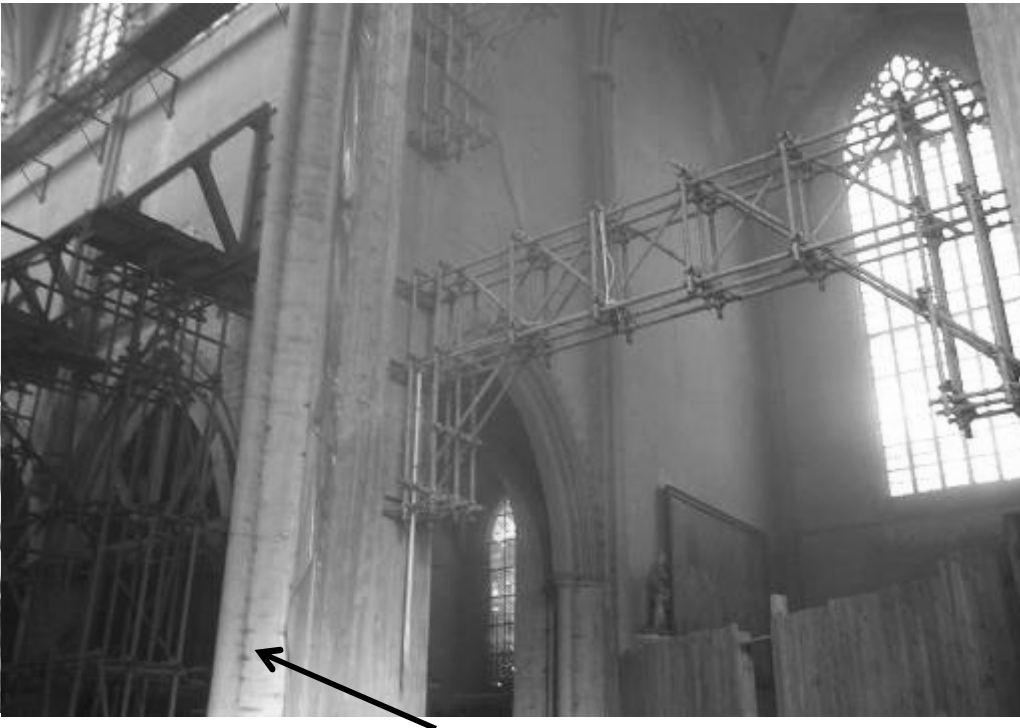
Hole Drilling Technique – on site stress measurement

Sint-Jacobschurch

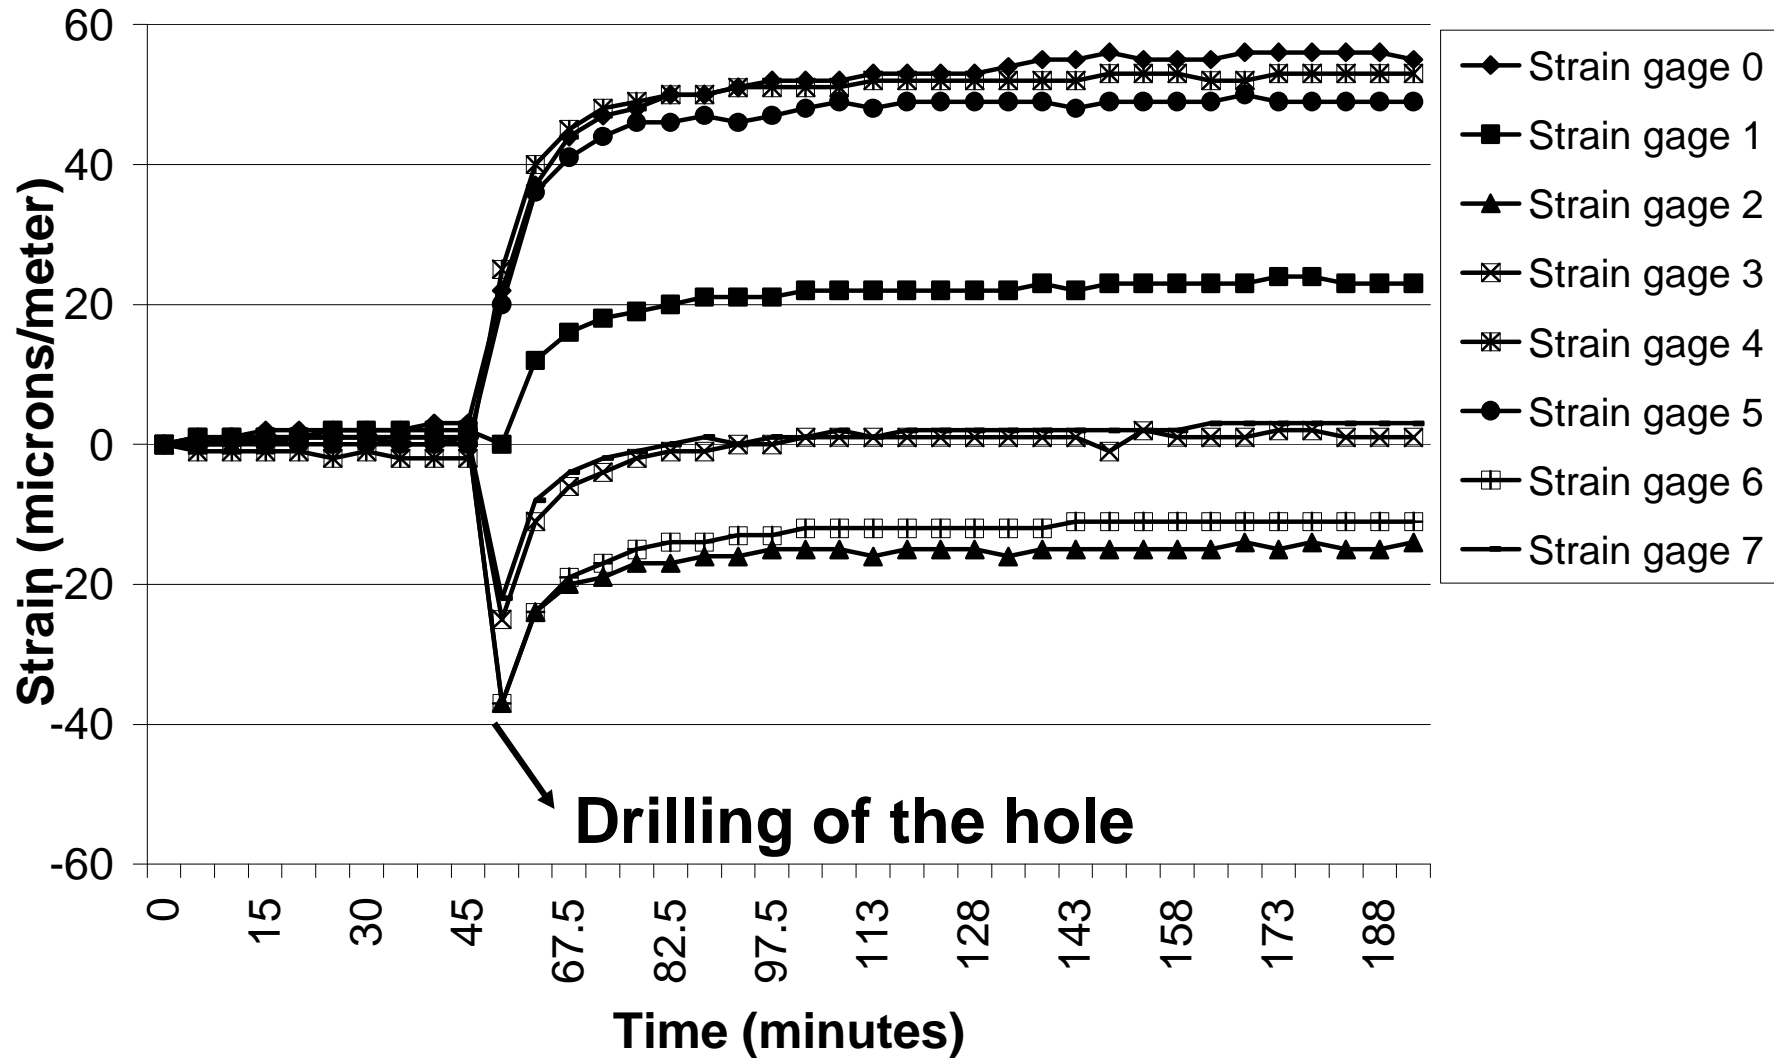
Strains recorded versus time: Pier of central nave

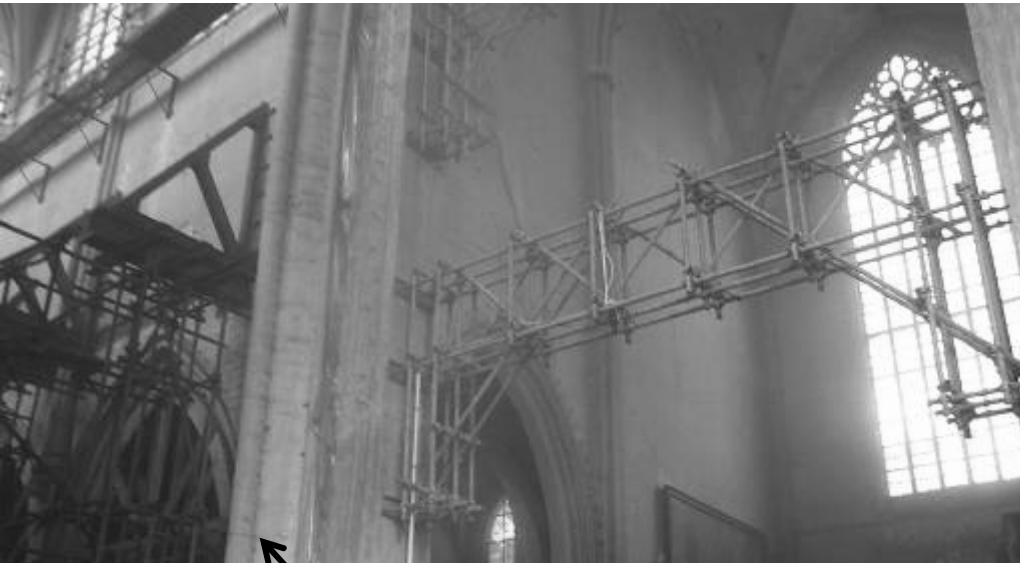
Hole Drilling Technique – on site stress measurement

Sint-Jacobschurch

Pier 1

Pier 2

- vertical forces caused by dead weight of of the structure
- Horizontal forces caused by thrustline of arches (crossing)
