Study of ancient mortars from Sagalassos (Turkey) in view of their conservation

P. Degryse^{a,*}, J. Elsen^a, M. Waelkens^b

Since 1990, regular archeological excavations are done in the Roman city of Sagalassos (southwestern Turkey) by the Catholic University of Leuven (Belgium). The mineralogy and petrography of the lime mortars at Sagalassos have been studied in detail as part of an investigation of the provenance of mineral raw materials present in the territory of Sagalassos. The samples were analysed with optical microscopy on thin sections followed by XRD analyses to design a suitable repair mortar. The lime used as binder was burnt from local Triassic limestones and prepared by dry slaking. Three main types of aggregates have been identified: limestone from local Mesozoic limestones, crushed ceramics from locally produced coarse wares and volcanic tuff from a nearby volcanic region. To preserve the excavated remains in very harsh climatic winter conditions, experimental mixtures of restoration mortar have been tested for strength and frost resistance using similar raw materials as in ancient times. The proposed mortar for further on-site conservation and restoration consis

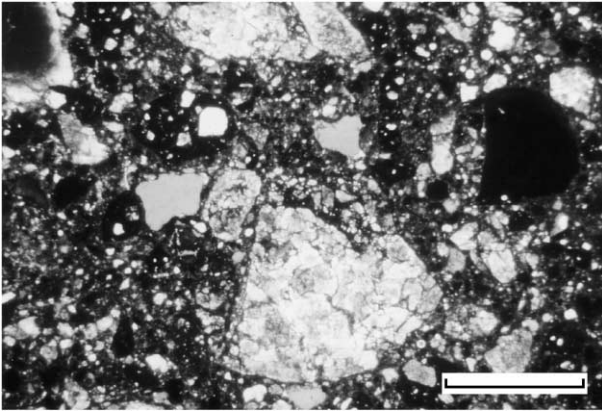
The first type of aggregate is a pure limestone (Fig. 2), which originated, as the lime itself, from the local limestones of the Lycian nappes, omnipresent in the vicinity of

Fig. 2. Microphotograph of limestone aggregates in the Roman lime mortar, scale bar is 250 μm , crossed polaroids.

the city and composed of Mesozoic to early Tertiary marine sediments. The limestone aggregate fragments show the same characteristics as the limestones identified in the building stones of Sagalassos [9]. The limestone around Sagalassos is rather pure, and it is logical that the inhabitants of the Roman period should have chosen it as a raw material [10]. Because lime lumps can be found in the mortars, dry slaking is assumed [11]. Dry slaking is the technique in which lime (CaO) is combined with the minimum amount of water necessary to alter all lime present into portlandite (Ca(OH)_2). It is opposed to the technique of wet slaking, in which an excess of water is used [11].

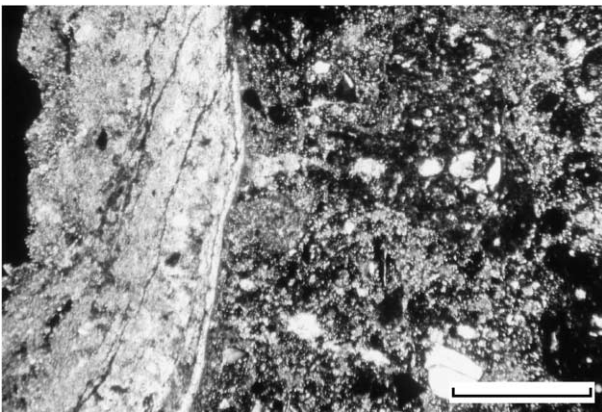
Crushed ceramics as an aggregate (Fig. 3) are found from early Hellenistic to early Byzantine times in mortars related to water-bearing constructions. Samples taken in a context of water-related constructions containing no ceramics belong to load-bearing parts of the construction or surround terracotta water pipes, keeping the pipes in place rather than making the construction watertight. At Sagalassos, crushed ceramics also occur in mortars not directly related to water-

Fig. 3. Microphotograph of ceramic aggregates in the Roman lime mortar, scale bar is 250 μm , crossed polaroids.

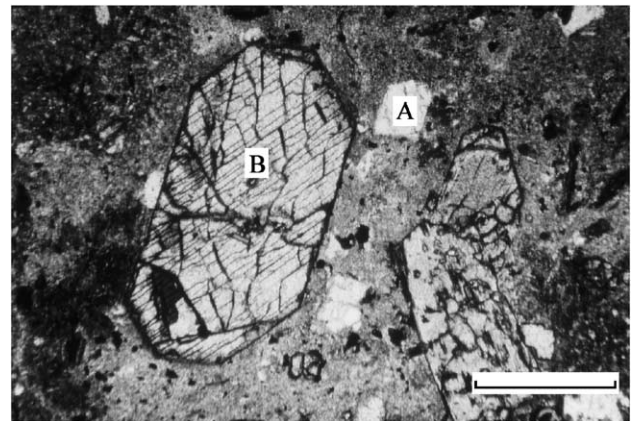
The third type of aggregate used at Sagalassos consists of volcanic material (Fig. 4), which was added to mortars by both Greeks and Romans to improve their quality, as it was noticed that this improved the hardness of the mixture and produced mortars that harden even underwater (Vitruvius, *De architectura* II, 4–5, VII, 4 and VIII, 6 and 14). Mortars with volcanic aggregates were used for construction purposes where higher compressive strength was necessary, for instance, in the masonry of the Roman Baths in Sagalassos. Petrographically, the aggregates in these mortars are very similar to volcanic deposits from the region of Gölcük, NW of Sagalassos. Both lava and pumice fragments and zoned augites and plagioclases are observed in the mortars as in the rocks from the volcanic region. The fragments in the mortars often have broken rims, indicating that the hard tuff and lava layers have been crushed. Samples from the volcanic deposits of the Gölcük region, mainly consisting of tuff layers, observed as cliffs and as loose sandy material, were collected for a more detailed study. The tuffs have a light-coloured matrix with many inclusions such as pumice, lava fragments and mineral grains. The lava layers have a grey, fine-grained matrix with phenocrysts of pyroxenes and biotites. Diopside and amphiboles are present in small amounts. Petrographically, the volcanic rocks consist of a cumulate of submicroscopic crystals and a glass phase (the matrix), with inclusions of varying size, from rock to monocrystalline fragments. The rock fragments consist of pumice, lava and sporadically sandstone. Plagioclases, alkali-feldspars, augites, diopsides, biotites and amphiboles occur as individual crystals. The crystals are strongly zoned. The matrix consists mainly of sanidine and anorthite crystals (determined by XRD) and an amorphous glass phase. The matrix is more important in the fine-grained tuff. The volcanic rocks of the area studied can thus be identified as aggregates in the mortars of Sagalassos.

Fig. 4. Microphotograph of volcanic aggregates in the Roman lime mortar [feldspar (A) and augite (B) as mineral constituents, together with and a glass phase], scale bar is 250 μm , crossed polaroids.

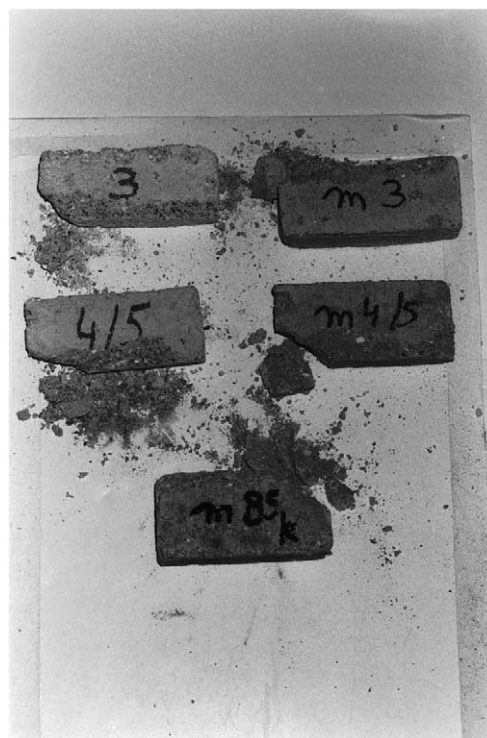
Fig. 5. Photograph of the test objects damaged and destroyed in the simulation of a high frost regime with a medium water content.

The results of this test are summarised in Table 1. These results are also illustrated in Figs. 5–7. It is clear from these results that the mortars containing crushed ceramics are not frost resistant to a high frost regime. The mortars with only limestone aggregates are frost resistant to a certain extent but disintegrate in the high frost regime simulation. The mortar samples with only volcanic aggregates have a good frost resistance. Remarkable is the difference in frost resist-

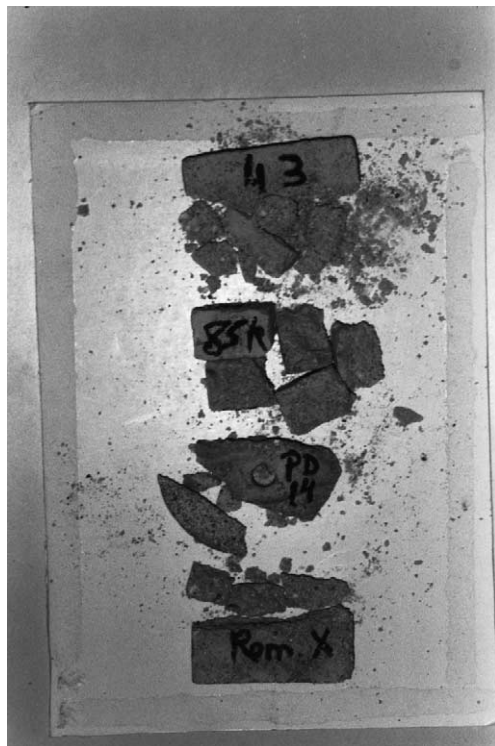
Fig. 6. Photograph of the test objects damaged and destroyed in the simulation of a high frost regime with a high water content.

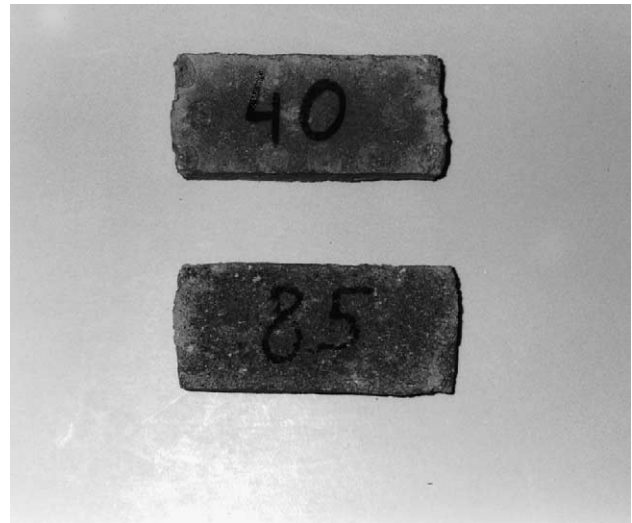
Fig. 7. Photograph of the test objects undamaged in the simulation of a high frost regime with a high water content.

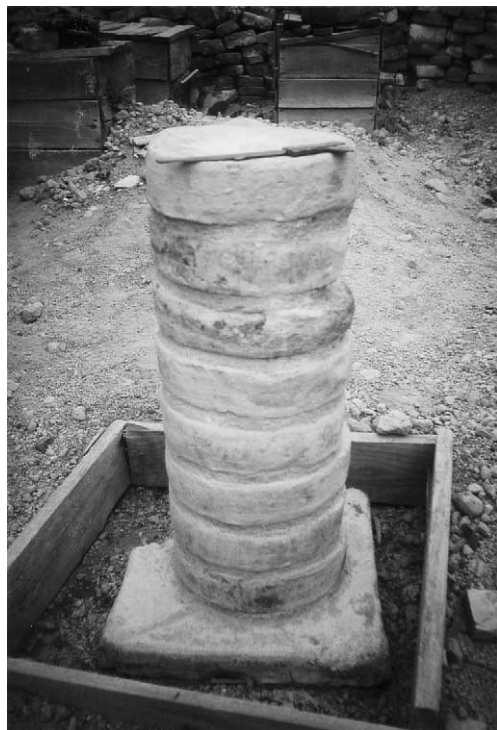
Fig. 8. Restoration mortar mix VO-1, undamaged after two winter seasons.
