Magnetic field imaging and light induced capacitance alteration for failure analysis of Cu-TSV interconnects

Ingrid De Wolf^{a,b,*}, Kristof J.P. Jacobs^b, Antonio Orozco^c

This paper discusses Cu-filled Through Silicon Via (TSV) failure analysis cases where known FA methods were used in an alternative way. Results are shown using magnetic field imaging (MFI) on a cross-sectioned chip to detect a leakage current path, and MFI and Light Induced Capacitance Alteration (LICA) to detect opens in TSV daisy chains.

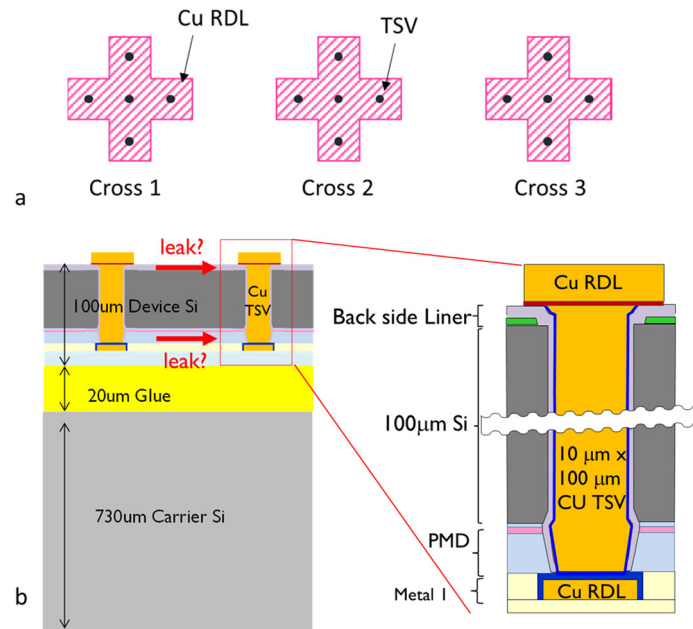
containing several 100 μm long Cu TSVs, 10 μm diameter. They are grouped by fives, connecting at the top and bottom on a Cu redistribution layer (RDL) in the shape of a cross, as shown in Fig. 1a. The crosses are electrically isolated from each other. Fig. 1b shows a cross-section schematic view.

During wafer level testing, a short resulting in a leakage current was measured between Cross 1 and Cross 3 in some chips of the wafer. Most of the tested chips have a leakage current < 1 nA at 20 V, which was considered normal, but some had a higher leakage indicating a failure. The failure analysis question was: Where is the location of this leakage path and what is the cause. This path can for example be located at the surface, or at the bottom, of the Si chip (see Fig. 1b). A chip with a leakage current between cross 1 and 3 of 110 nA at 20 V was selected for failure analysis. If TSV liner breakdown would be the cause of this short, photon emission microscopy (PEM) could be considered to identify the breakdown position [5]. However, it cannot locate the path of a leakage current, and in this sample, the Cu RDL layer and the fact that it covers 5 connected TSVs would make location of the failed TSV complicated. In addition, a leakage current does not necessarily go together with photon emission, especially if the problem would be in the metallization. And if the problem is located underneath the RDL metal, it will block photons from passing and thus either prevent its detection or go through transparent areas that may not coincide with the actual location of the failure. Similar considerations hold for OBIRCH, thermal imaging, LIVA and LICA. For this reason, it was considered to use MFI. The magnetic field passes unaffected through the different layers, not hindered by the RDL. MFI can detect the location of a current path, even for low currents, and can provide depth information [6,7]. Another option to obtain depth information would be

Fig. 1. a. Top view of the 3 RDL crosses. The black dots indicate the position of TSVs (5/cross). b. Cross-section view.

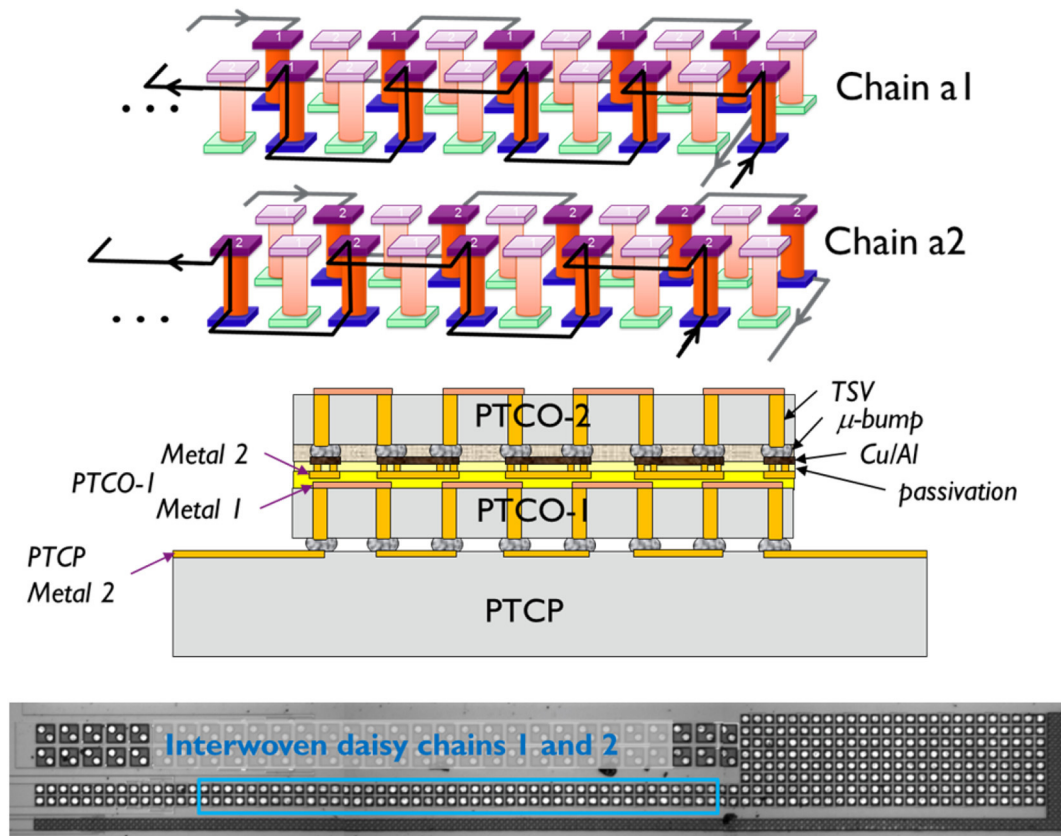
Fig. 5. Top: Schematic picture of interwoven daisy chain and test sample consisting of a stack of 3 chips. Bottom: top microscopy image of the interwoven daisy chain.

TSV daisy chains are often used during 3D technology development to control processing and stacking. In our test samples, these daisy chains consist of two interwoven arrays, a1 and a2, as shown in Fig. 5, top. In one failure case, an open was detected in one of these chains running in the central chip of a stack of 2 (PTCO-1, Fig. 5, center). The question raised whether magnetic field imaging, using radio-frequency (RF) space domain reflectometry (SDR) [3] can be used to locate the
