Fracture analysis of one/two-piece clinically failed zirconia dental implants

Objectives: Analyzing factors that may have led to fracture of zirconia implants by macro/micro-fractography.

Methods: Six one-piece and ten two-piece full-ceramic zirconia implants from two manufacturers, Z-Systems and CeraRoot, were retrieved after clinical failure. The time-to-failure ranged from 3 to 49 months. Optical and scanning electron microscopy (SEM) were used to analyze the fracture planes at the macro- and microscopic level. Treatment planning, surgical protocol, fracture-origin location and characteristic fracture features were assessed.

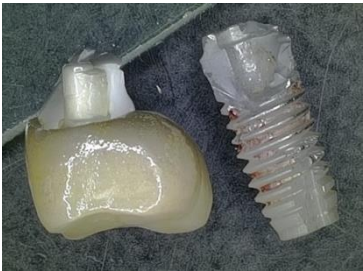
Position with the restoration margin 3 mm below the alveolar crest; disproportionately large crown.
Z-Systems 2p-45m	Two- piece Z5c	5	Maxillary first molar	03-04-2017 to 11-01-2021 3 Yr + 9 Mo

Disproportionately large crown to compensate for the large mesial and distal space in relation to the implant; positioning of this implant was too much above the gingiva, which was not esthetic by exposing the white zirconia implant; the clinician re- prepared the implant and the abutment by grinding the implant and abutment neck in order to get the shoulder at the level of the gum.
