***In-situ* imaging of inter- and intra-laminar damage in open-hole tension tests of carbon fibre-reinforced composites**

**ABSTRACT**

This paper investigates damage progression during Open-Hole Tension (OHT) test of carbon fibre-reinforced composites with different Quasi-Isotropic (QI) layups. Digital Image Correlation (DIC) and *in-situ* edge microscopy are utilized simultaneously to detect damage on the specimen's surface and in the inner plies, respectively. It is found that damage does not always initiate in the 90° plies, but also in the surface 45° plies, depending on the orientation of the adjacent ply. DIC resulting strain field on the surface does not necessarily have the same butterfly-shape concentration around the hole, in all layups. Some laminates show large free edge delaminations at 45°/90° interfaces. This study adds *in-situ* evidences to the existing data on damage during OHT test of QI laminates, providing quantitative and comparative information on different damage modes, and reveals new features of the damage phenomena.

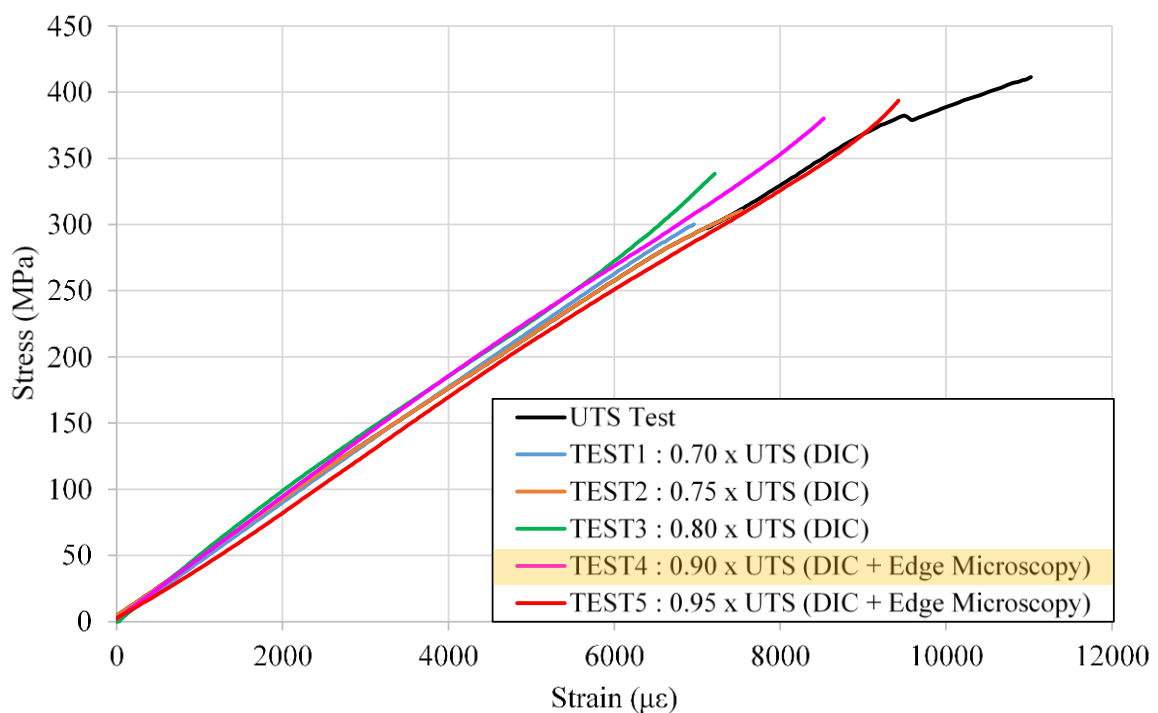
Figure 6. Stress-strain curves of the OHT test on the  $[90_2/-45_2/0_2/+45_2]_s$  specimens – the highlight in the legend represents the stress-strain curve corresponding to the damage progression shown in Figure 7.

Laminates consisting of  $90^\circ$  plies on the surface are favourable for DIC analysis of transverse cracks on the surface because numerous transverse cracks form in the surface  $90^\circ$  plies as the applied load increases [14,24]. The stress-strain curves corresponding to the six tension tests on the  $[90_2/-45_2/0_2/+45_2]_s$  specimens are shown in Figure 6. 4<sup>th</sup> test is chosen for investigation of damage progression (presented in Figure 7).

It is important to note that the matrix cracks in the inner  $-45^\circ$  plies initiate from the transverse cracks in the  $90^\circ$  plies. However, the  $0^\circ$  plies next to the  $-45^\circ$  plies prevent the matrix cracks to propagate into the  $+45^\circ$  plies. Unfortunately, large delaminations occur only around the hole but they are not observed in the edge study zone in this laminate type. It could be that large delaminations occur at strain levels beyond  $8500 \mu\epsilon$ , corresponding to the load drop in the “UTS test”, shown in Figure 6.

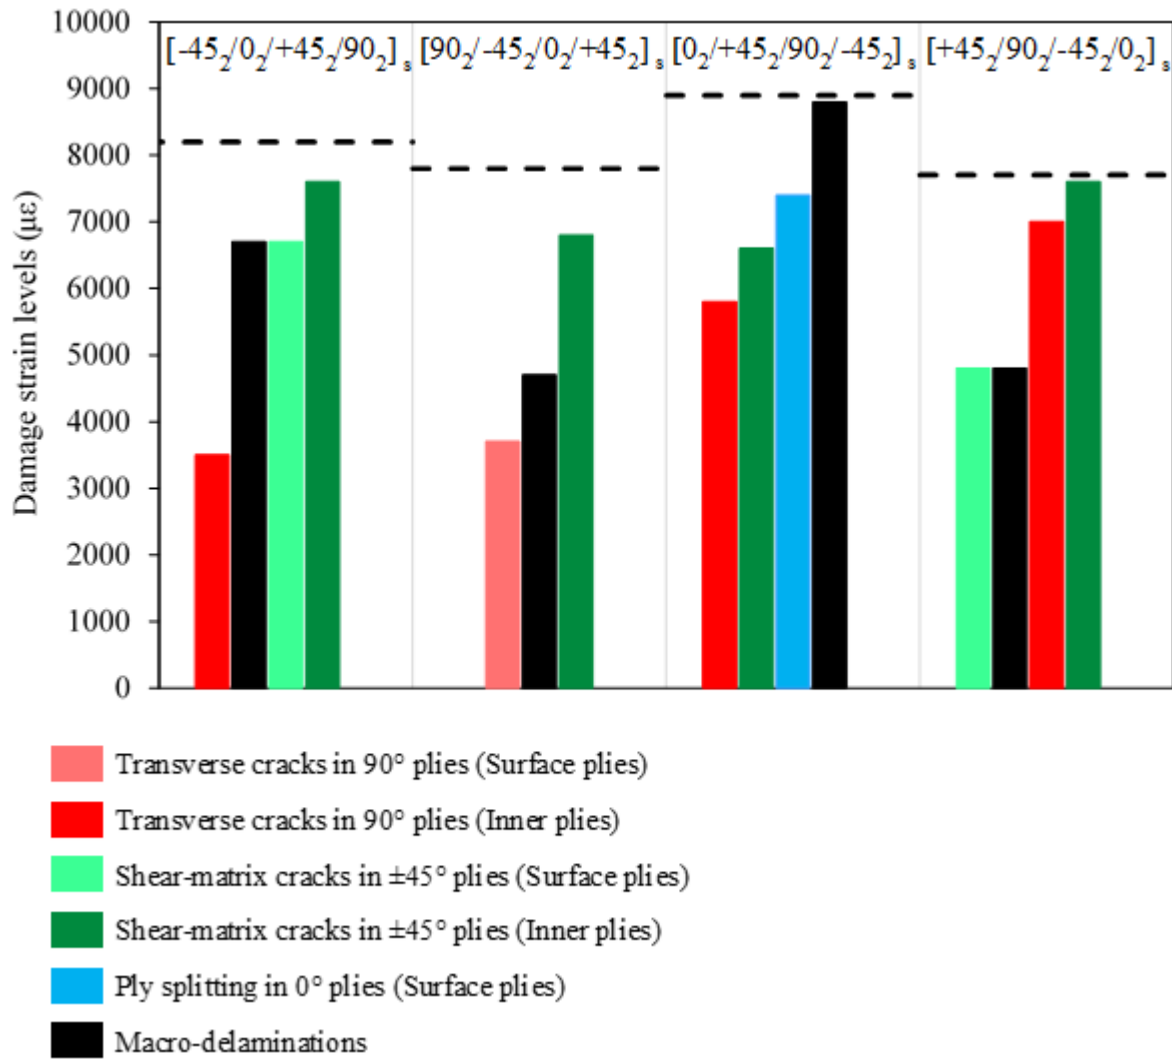
Figure 12. Strain thresholds of damage mode in different QI laminates.

Figure 12 shows that transverse cracking in 90° plies is usually the first damage mode to be observed. They appear at the same time with micro-delaminations. This happens very early (at around 3500  $\mu\epsilon$ ) when the 90° plies are the outer or middle plies, respectively due to the free surface effect and higher ply thickness. Large number of transverse and shear matrix cracks, in the inner 90° and +45° plies, and their quick propagation through the length of the specimen leads to large free edge macro-delaminations in the  $[-45_2/0_2/+45_2/90_2]_s$  specimen. On the other hand, the transverse crack through the width of  $[90_2/-45_2/0_2/+45_2]_s$  specimen and the possible localized shear-matrix cracks around the hole, leads to macro-delaminations at this region. The former laminate type may also have delaminations around the hole, but they cannot be visible in the strain maps in the presence of very large deformations near the free edges. In most cases, shear-matrix cracks in  $\pm 45^\circ$  plies are detected, next.

observed damage mode increase rapidly. These strain levels are named “intensive damage threshold” in Figure 12. It is found that  $7800 \mu\epsilon$  is the intensive damage threshold level for the  $[90_2/-45_2/0_2/+45_2]_s$  laminate and the only observed damage after this strain level is multiplication of surface cracks. On the other hand, propagation of matrix cracks and the progression of large delaminations are seen to continue in the  $[-45_2/0_2/+45_2/90_2]_s$  laminate after the intensive damage level ( $8800 \mu\epsilon$ ).
