Three-dimensional echocardiography of a subtotal mitral valve ring dehiscence

[Focus]

Philippe TIMMERMANS¹, MD; Patrick VERTONGEN², MD; Filip REGA³, MD, PhD

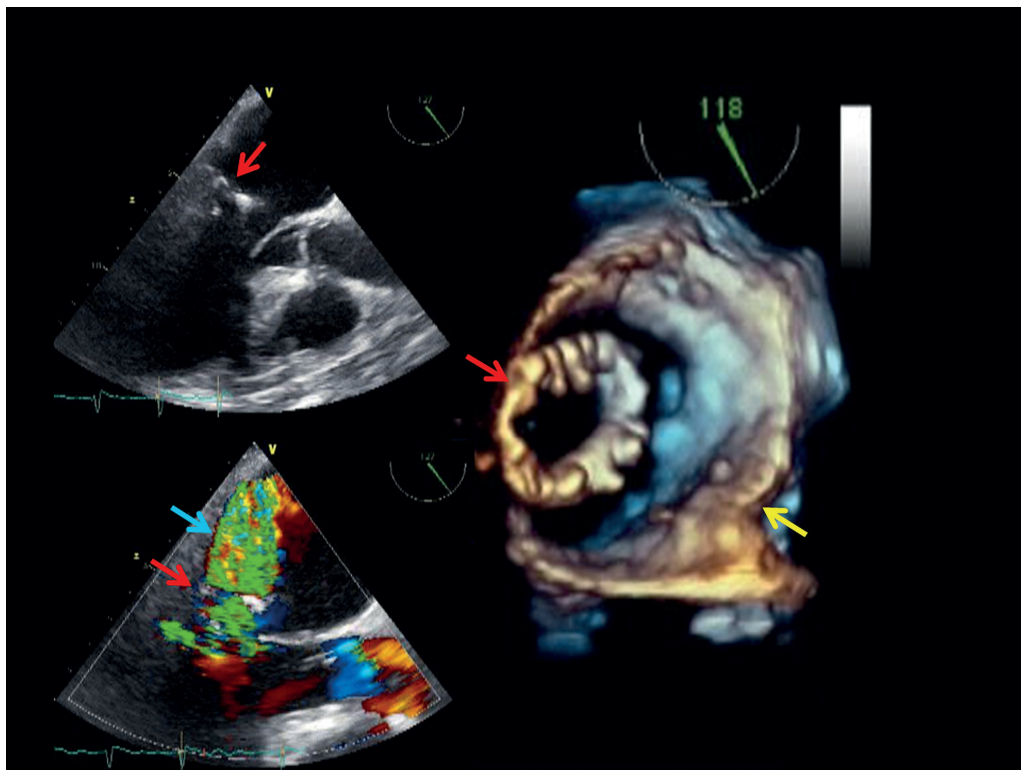
Fig.

This 77-year-old patient underwent a mitral valve repair during which a mitral valve ring size 28 was inserted. Postoperative echocardiography confirmed a competent valve with only a trace of mitral valve insufficiency. Five months later, the patient presented with subacute dyspnoea and lung oedema. After initial medical stabilization, a transthoracic echocardiogram was performed. This showed a new onset massive mitral valve insufficiency. The patient was referred to our hospital for further diagnostic and therapeutic workup. With transoesophageal echocardiography in a midoesophageal view at 120°, the mitral valve ring was visible just above the native posterior mitral valve leaflet (red arrow). Colour Doppler flow confirmed the massive mitral valve

insufficiency with a large regurgitating jet through the ring (red arrow) extending to the roof of the left atrium (blue arrow). High resolution three-dimensional reconstruction clearly showed the circumferential mitral valve ring dehiscence (yellow arrow) with residual attachment only at the posterior rim of the mitral valve apparatus (P3-A3, red arrow), and stitch material on the ring itself. Semi-urgent surgical repair was successfully performed by resecting the anterior leaflet with preservation of the posterior leaflet, and implantation of a biological 31-mm mitral valve. The postoperative observation was uneventful, and the patient was discharged from the hospital on the 15th days after admission. He is currently doing well and is in ambulatory follow-up.
